LEVELLOGGER REPORT FOR NOVEMBER 2021 – FEBRUARY 2022

JUNE 30, 2022

AMAFCA

BOHANNAN HUSTON, INC.
7500 JEFFERSON STREET NE
ALBUQUERQUE, NM 87109

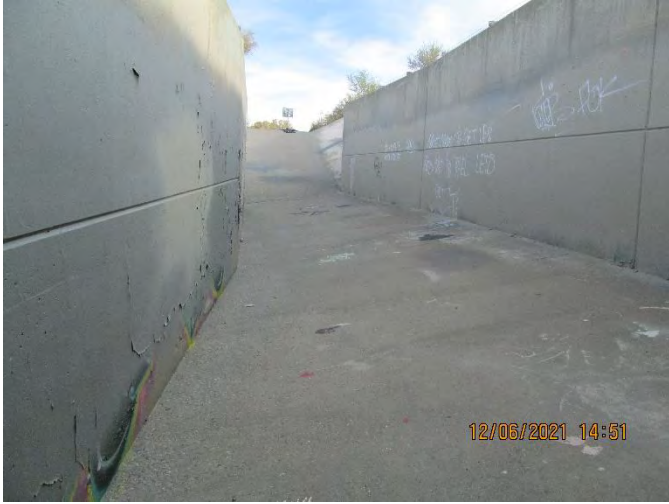
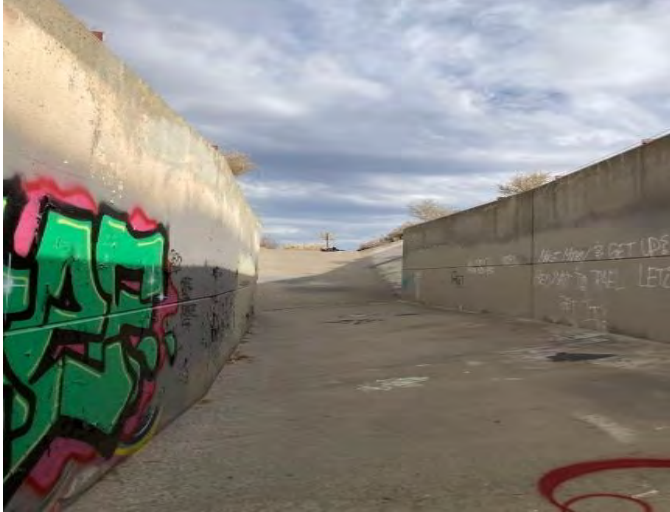
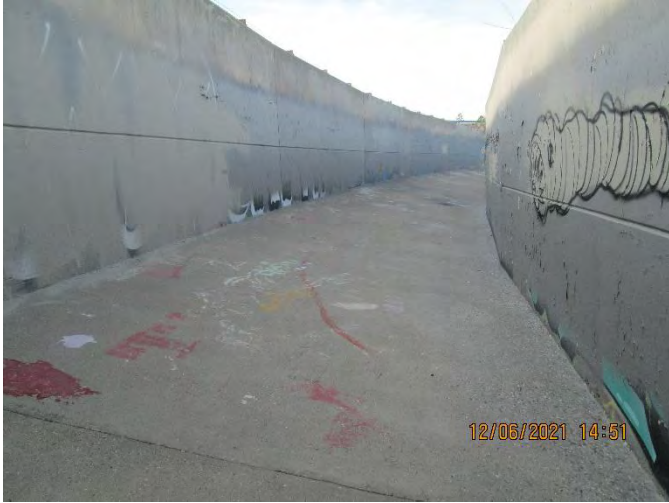
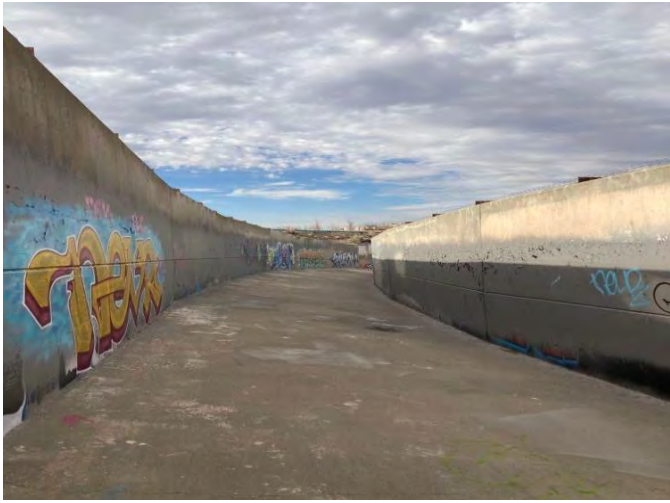
North Camino Arroyo	December 6, 2021	March 3, 2022

Photo 1: North Camino Arroyo – Looking Upstream	Photo 2: North Camino Arroyo – Looking Upstream

Photo 3: North Camino Arroyo Looking Downstream	Photo 4: North Camino Arroyo – Looking Downstream

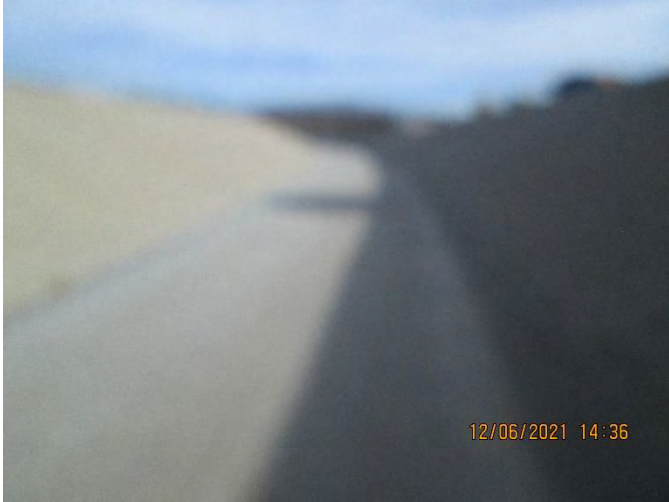
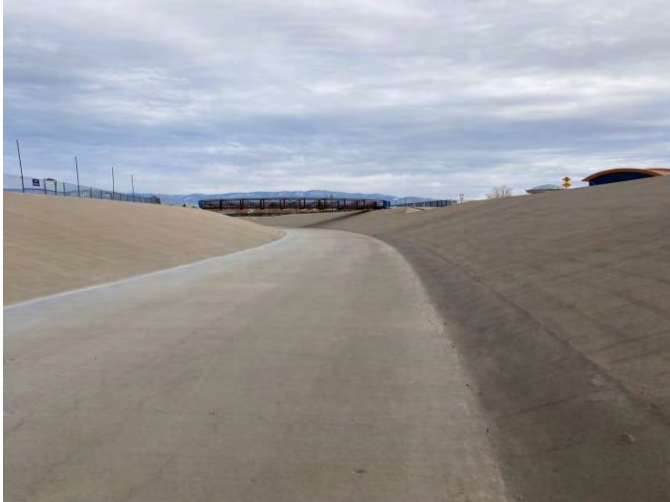
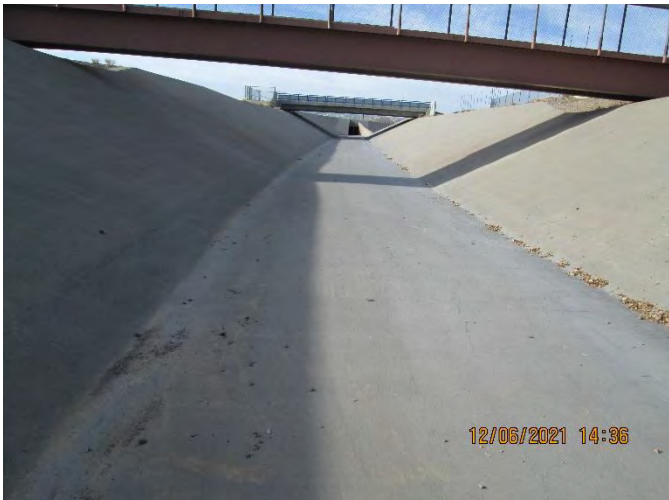
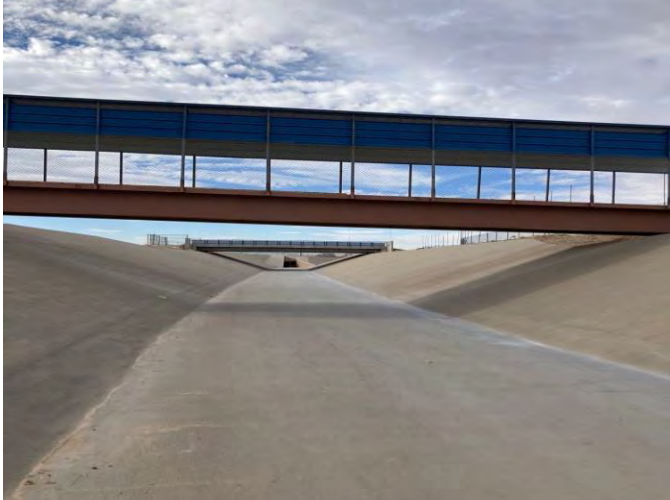
La Cueva Arroyo	December 6, 2021	March 3, 2022

Photo 5: La Cueva Arroyo – Looking Upstream	Photo 6: La Cueva Arroyo – Looking Upstream

Photo 7: La Cueva Arroyo – Looking Downstream	Photo 8: La Cueva Arroyo – Looking Downstream

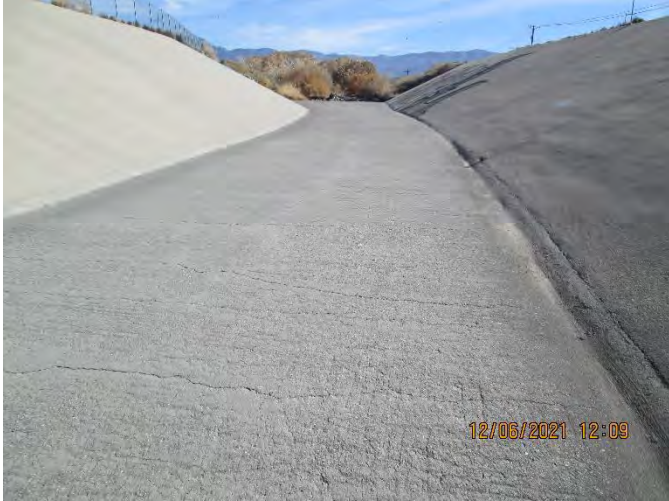
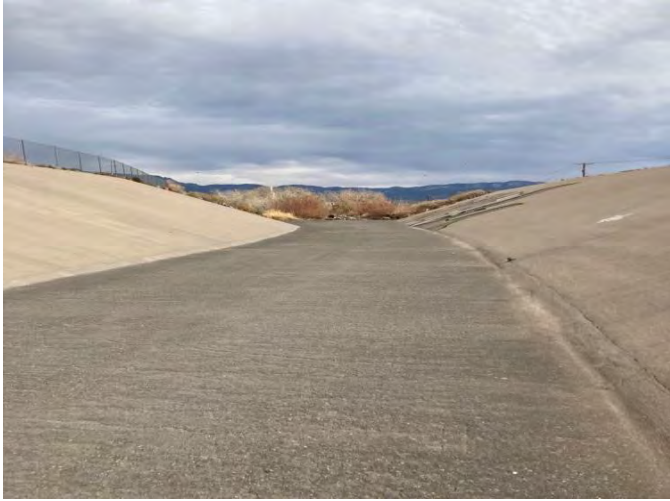
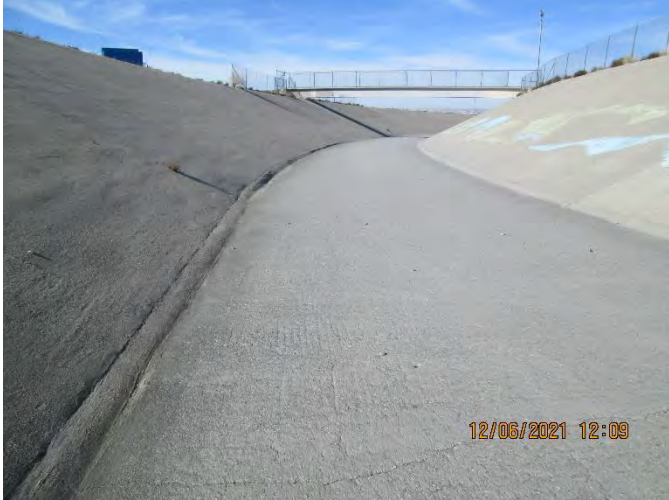
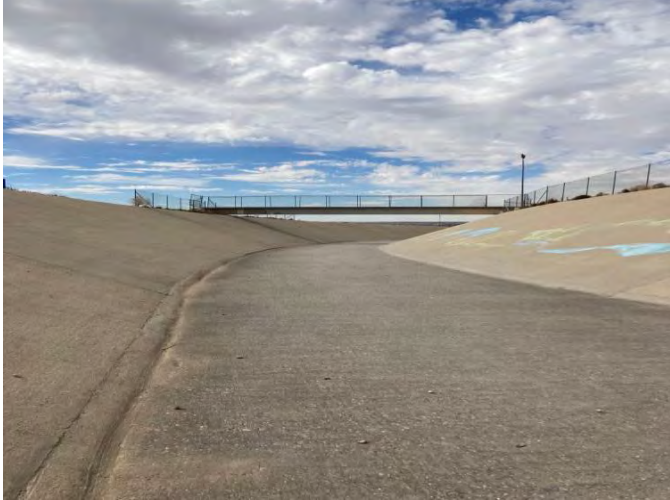
North Domingo Baca	December 6, 2021	March 3, 2022

Photo 9: North Domingo Baca – Looking Upstream	Photo 10: North Domingo Baca – Looking Upstream

Photo 11: North Domingo Baca – Looking Downstream	Photo 12: North Domingo Baca – Looking Downstream

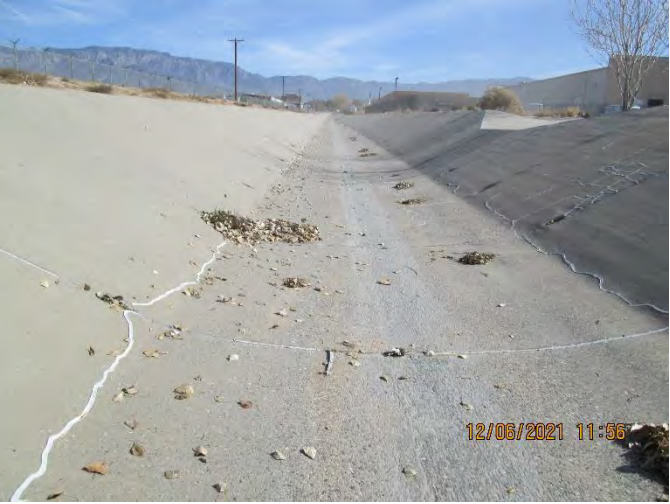
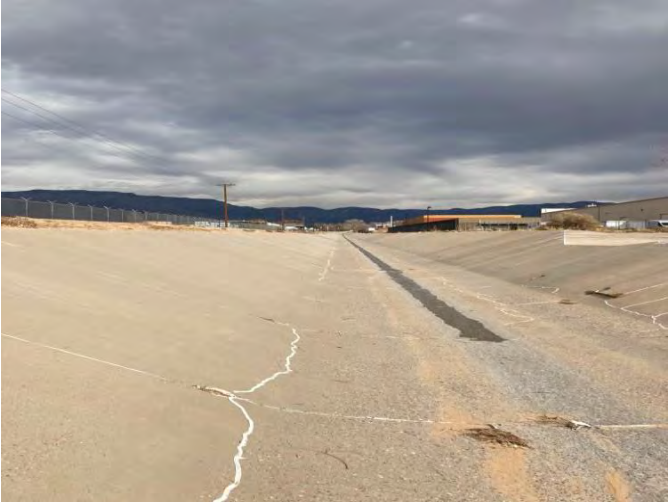
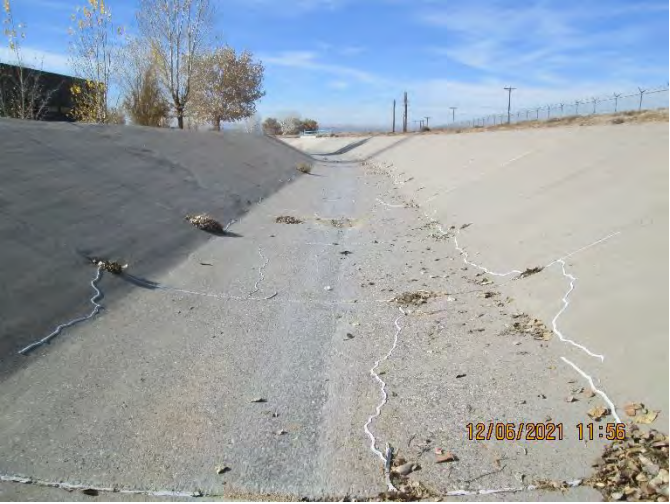
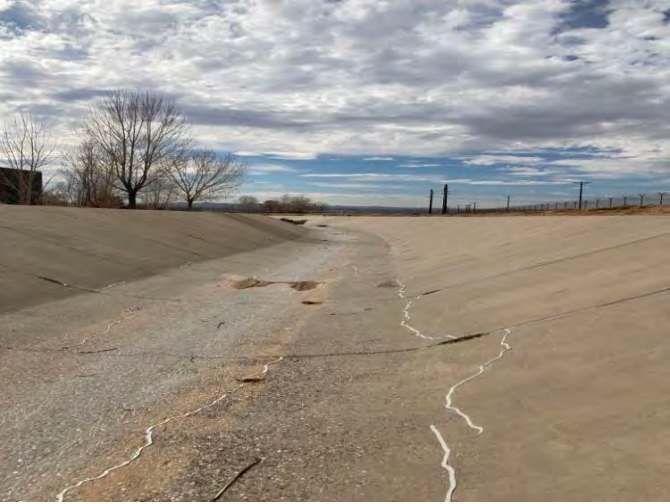
North Pino Arroyo	December 21, 2021	March 3, 2022

Photo 13: North Pino Arroyo – Looking Upstream	Photo 14: North Pino Arroyo – Looking Upstream

Photo 15: North Pino Arroyo – Looking Downstream	Photo 16: North Pino Arroyo – Looking Downstream

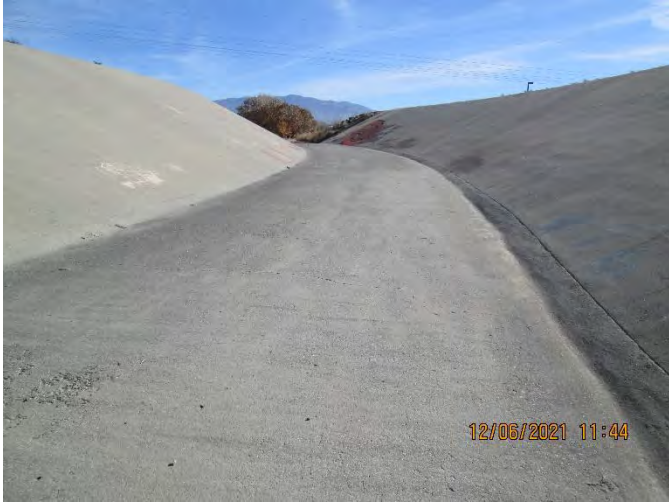
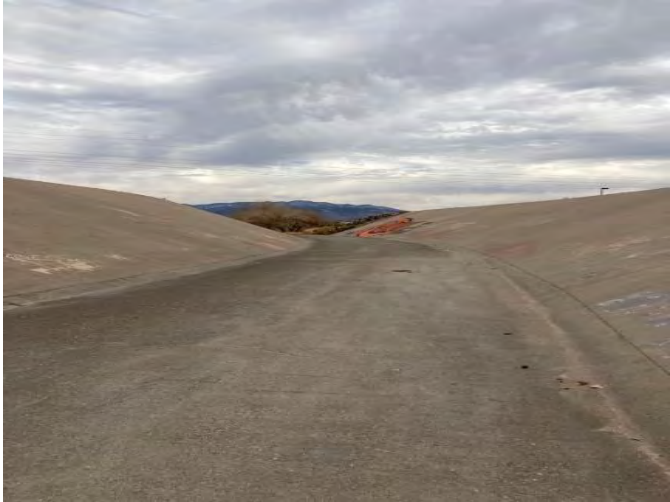
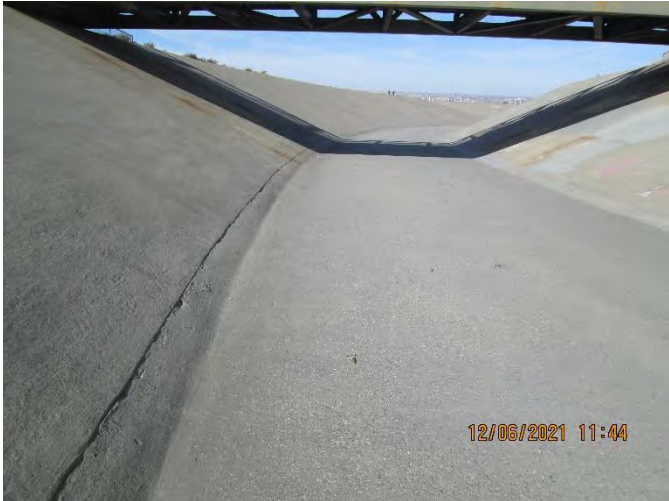
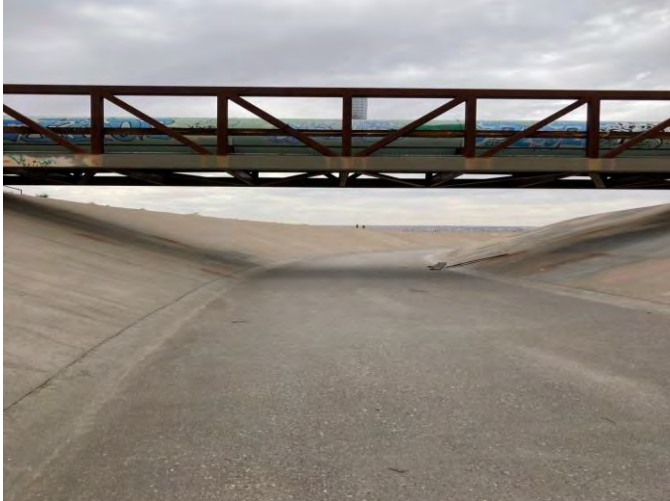
South Pino Arroyo	December 6, 2021	March 3, 2022

Photo 17: South Pino Arroyo – Looking Upstream	Photo 18: South Pino Arroyo – Looking Upstream

Photo 19: South Pino Arroyo – Looking Downstream	Photo 20: South Pino Arroyo – Looking Downstream

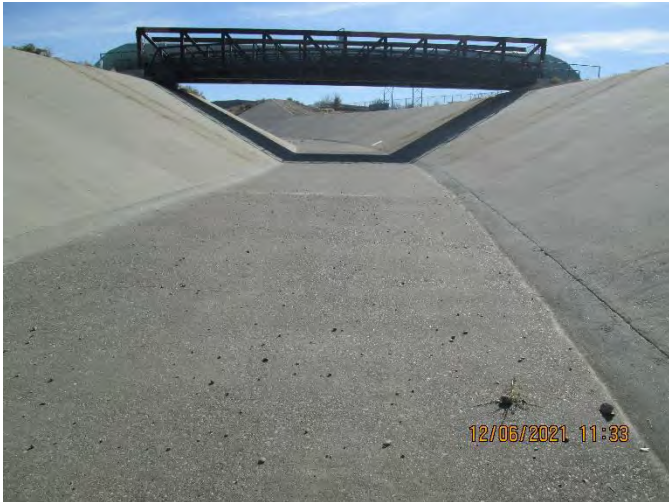
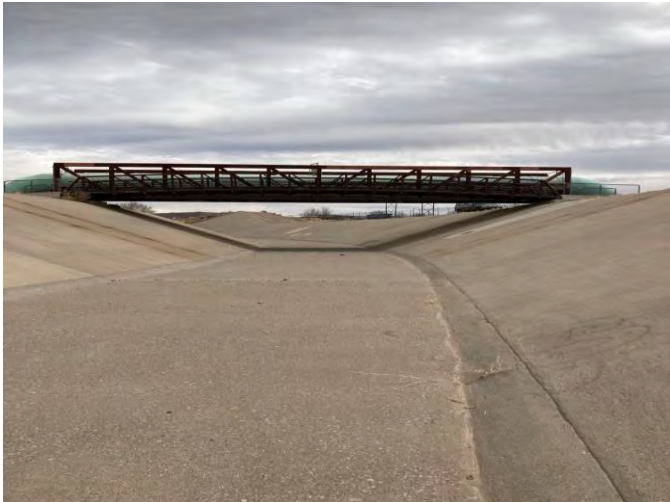
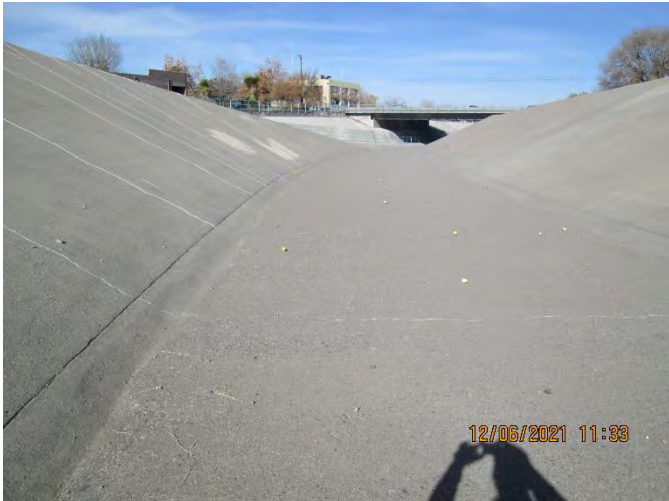
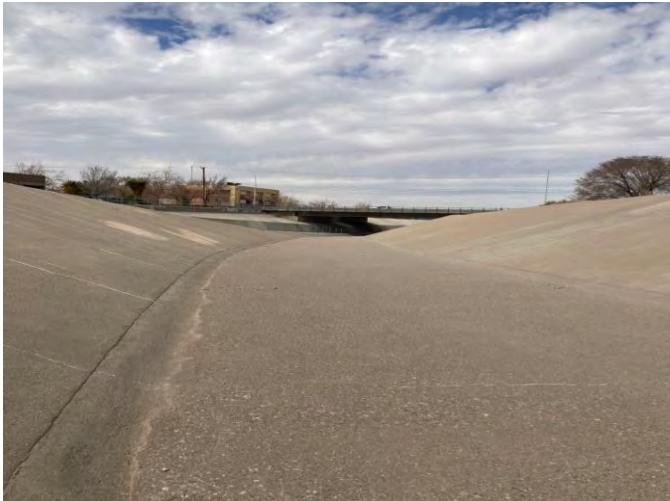
Bear Canyon Arroyo	December 6, 2021	March 3, 2022

Photo 21: Bear Canyon Arroyo – Looking Upstream	Photo 22: Bear Canyon Arroyo – Looking Upstream

Photo 23: Bear Canyon Arroyo – Looking Downstream	Photo 24: Bear Canyon Arroyo – Looking Downstream

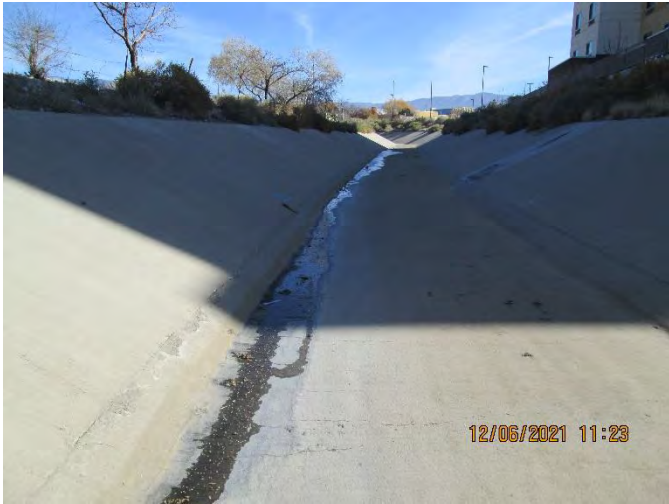
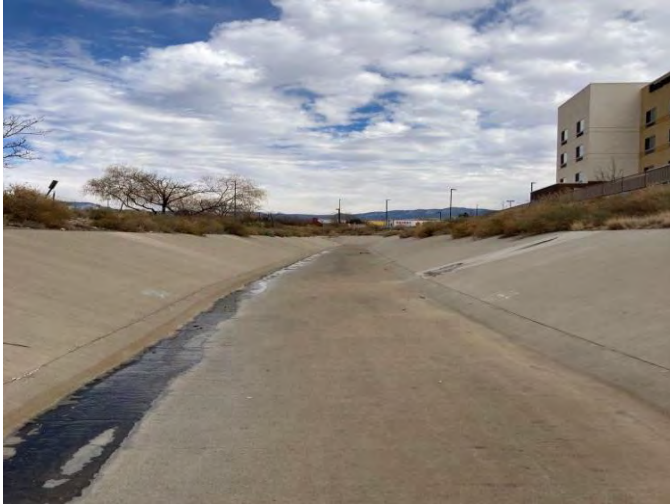
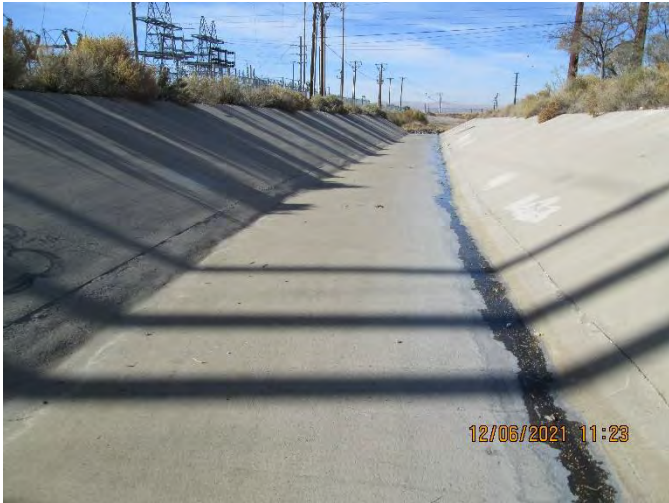
Vineyard Arroyo	December 6, 2021	March 3, 2022

Photo 25: Vineyard Arroyo – Looking Upstream	Photo 26: Vineyard Arroyo – Looking Upstream

<p>12/06/2021 11:23</p>	 
	Photo 27: Vineyard Arroyo – Looking Downstream	Photo 28: Vineyard Arroyo – Looking Downstream

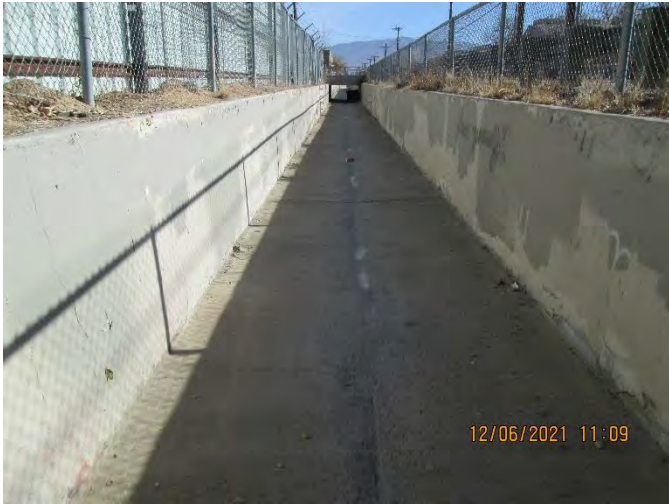
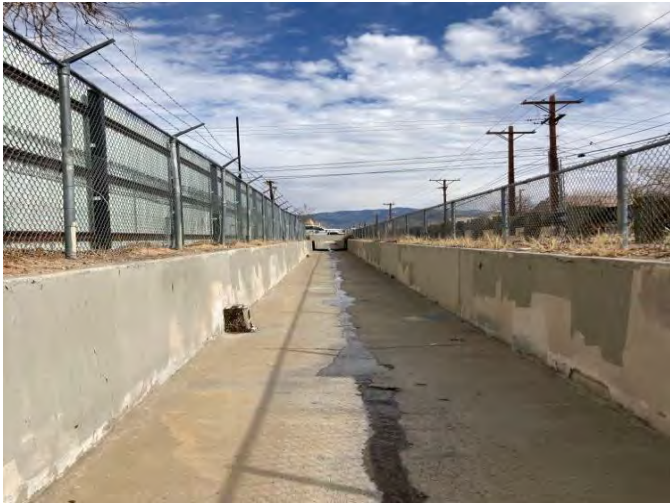
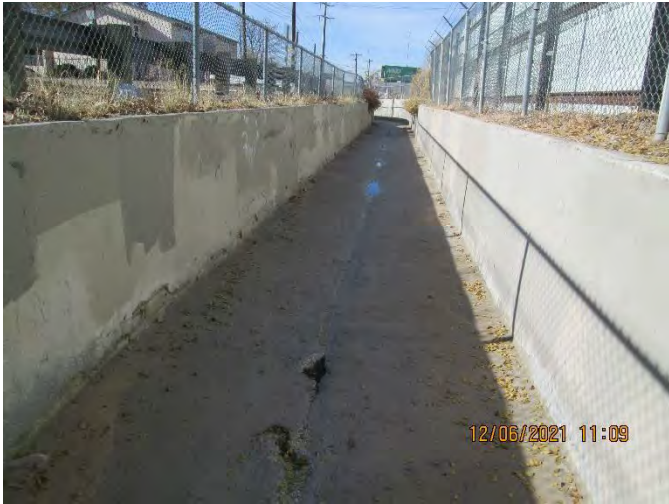
Grantline Arroyo	December 6, 2021	March 3, 2022

Photo 29: Grantline Arroyo – Looking Upstream	Photo 30: Grantline Arroyo – Looking Upstream

<p>12/06/2021 11:09</p>	 
	Photo 31: Grantline Arroyo – Looking Downstream	Photo 32: Grantline Arroyo – Looking Downstream

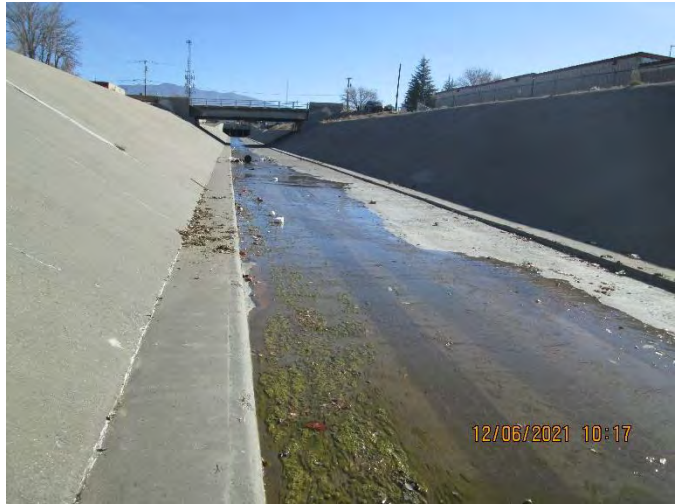
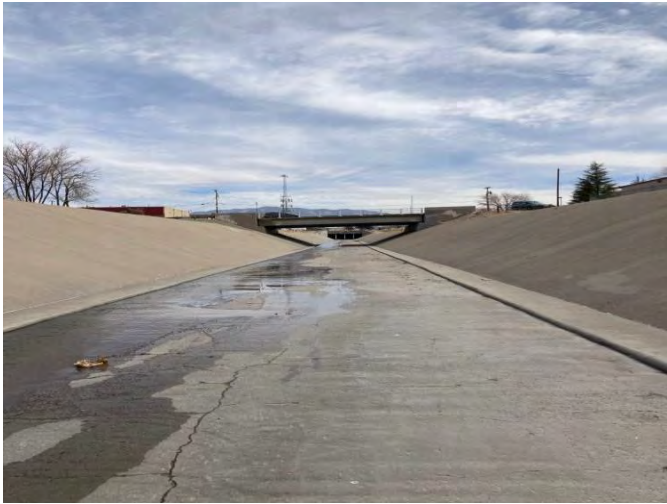
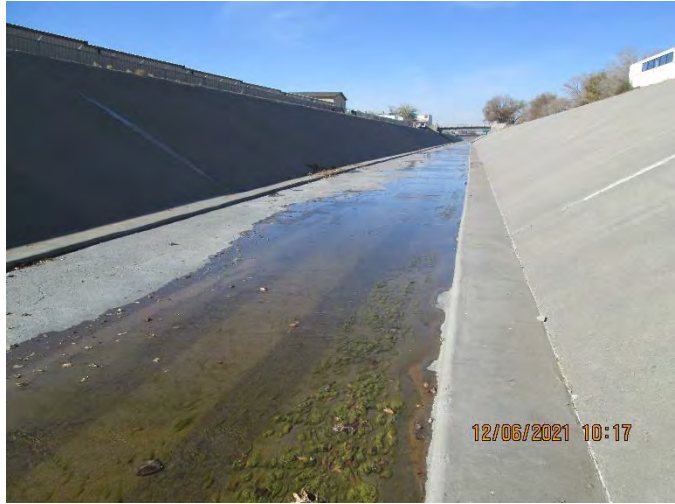
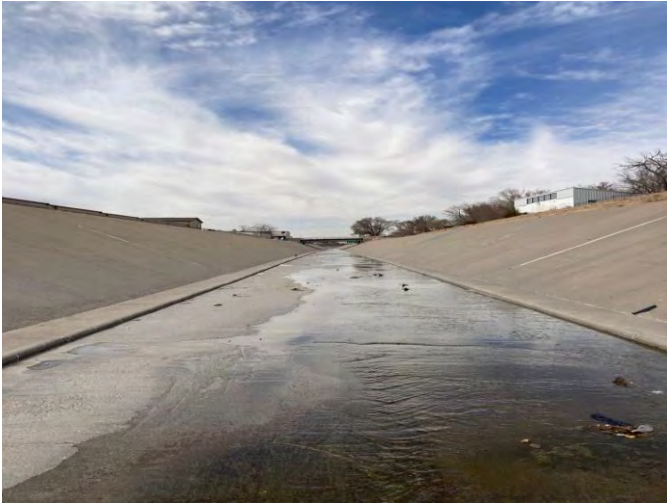
Embudo Arroyo	December 6, 2021	March 3, 2022

Photo 41: Embudo Arroyo – Looking Upstream	Photo 42: Embudo Arroyo – Looking Upstream

Photo 43: Embudo Arroyo – Looking Downstream	Photo 44: Embudo Arroyo – Looking Downstream

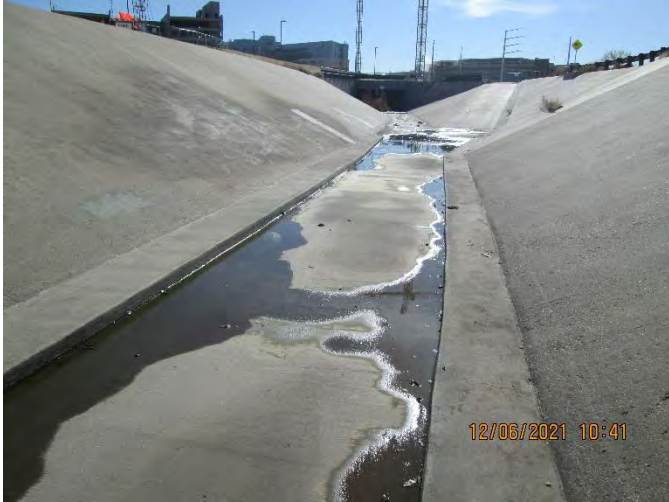
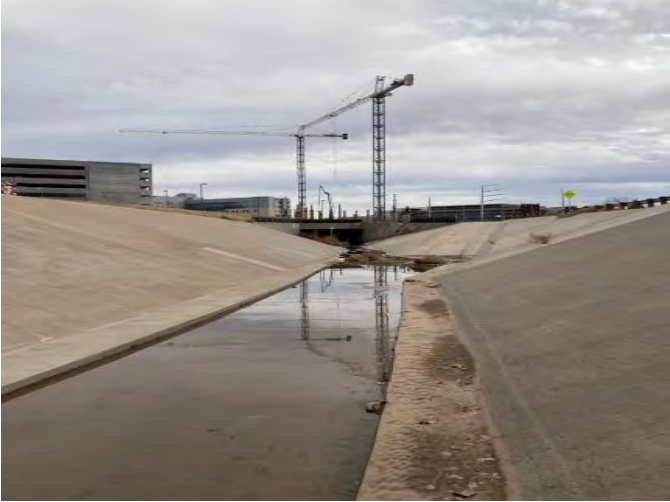
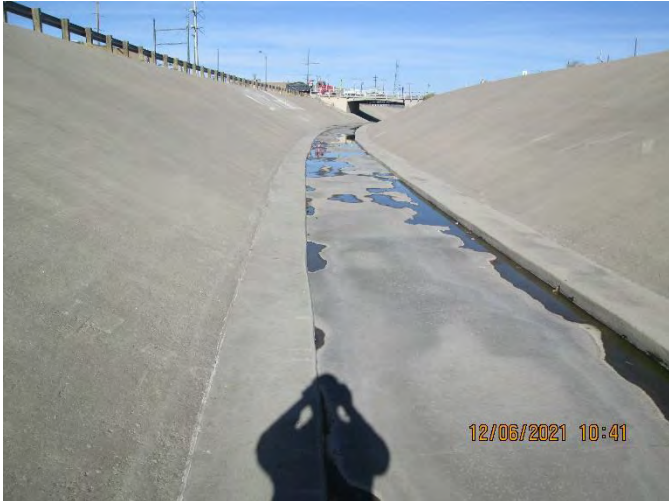
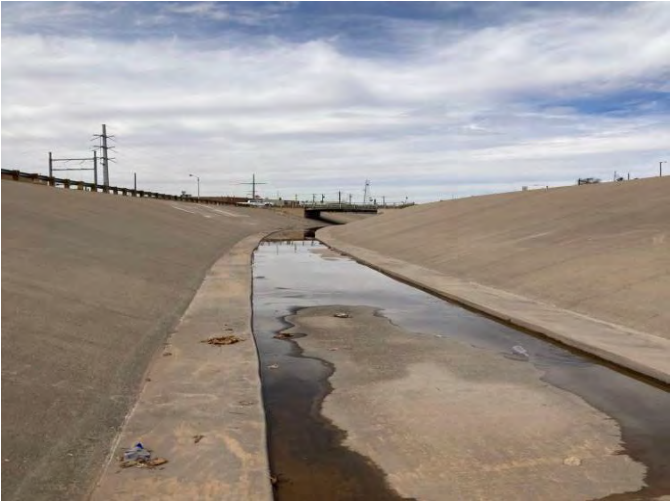
Campus Wash	December 6, 2021	March 3, 2022

Photo 45: Campus Wash – Looking Upstream	Photo 46: Campus Wash – Looking Upstream

Photo 47: Campus Wash – Looking Downstream	Photo 48: Campus Wash – Looking Downstream

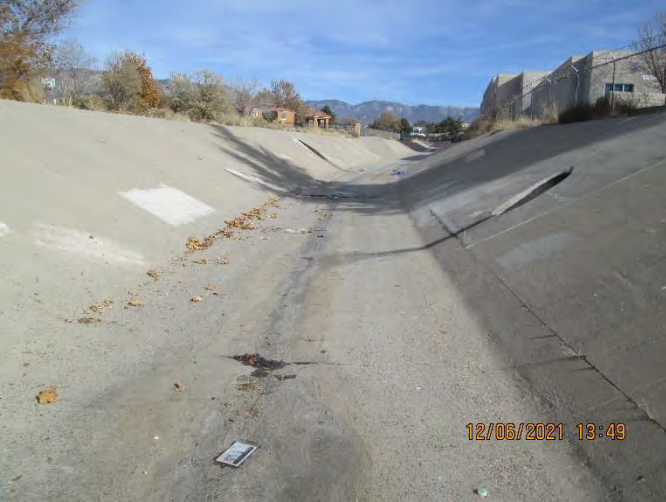
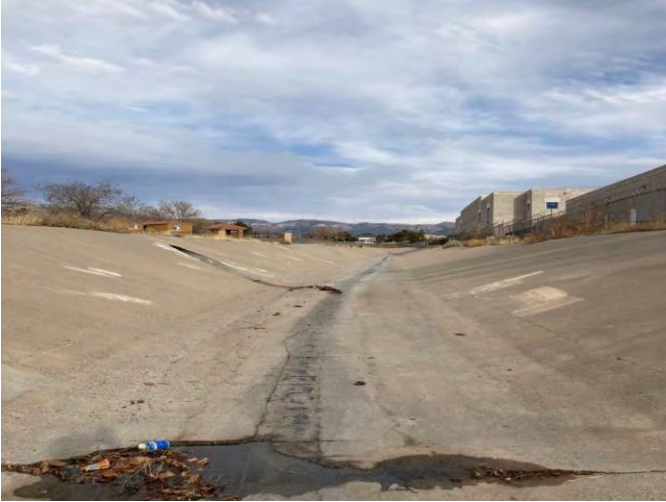
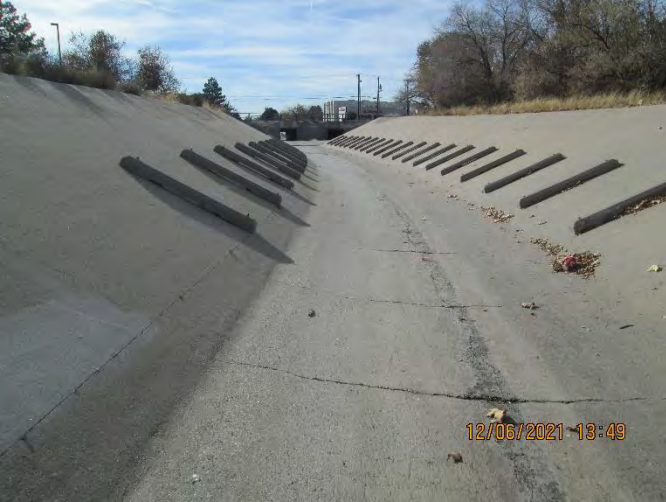
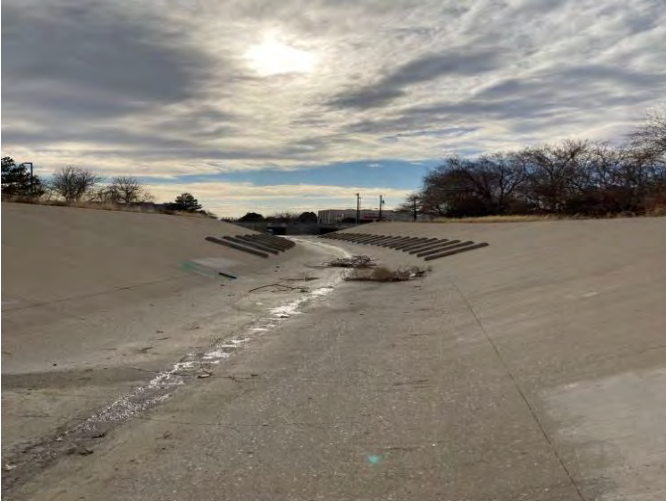
Lower Bear – Wyoming (Upstream)	December 6, 2021	March 3, 2022

Photo 49: Lower Bear (Wyoming) – Looking Upstream	Photo 50: Lower Bear (Wyoming) – Looking Upstream

Photo 51: Lower Bear (Wyoming) – Looking Downstream	Photo 52: Lower Bear (Wyoming) – Looking Downstream

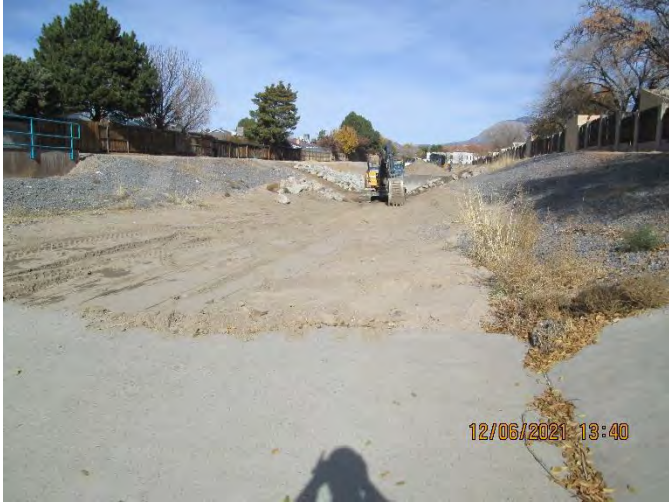
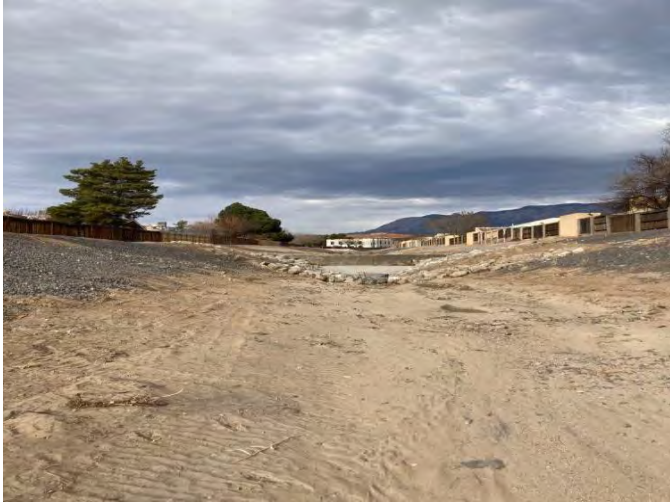
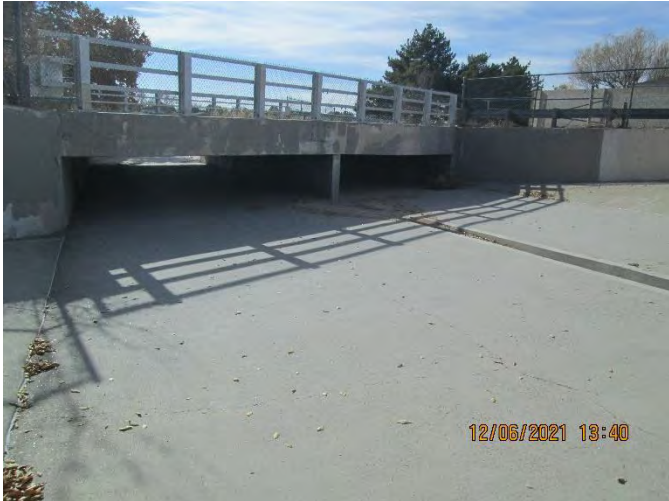
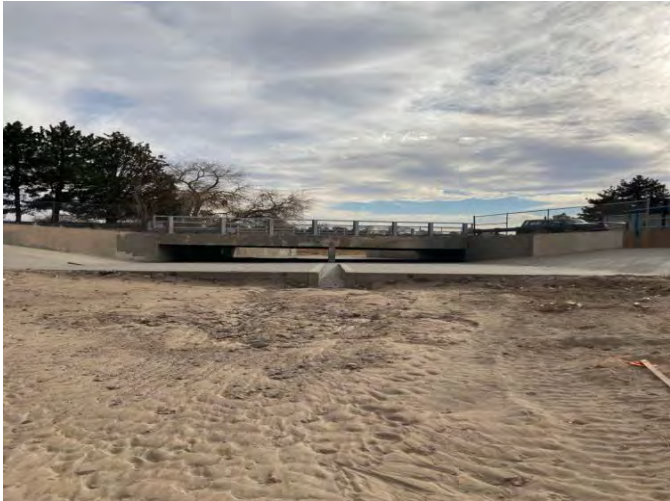
Lower Bear – Spain (Downstream)	December 6, 2021	March 3, 2022

Photo 53: Lower Bear (Spain) – Looking Upstream	Photo 54: Lower Bear (Spain) – Looking Upstream

Photo 55: Lower Bear (Spain) – Looking Downstream	Photo 56: Lower Bear (Spain) – Looking Downstream

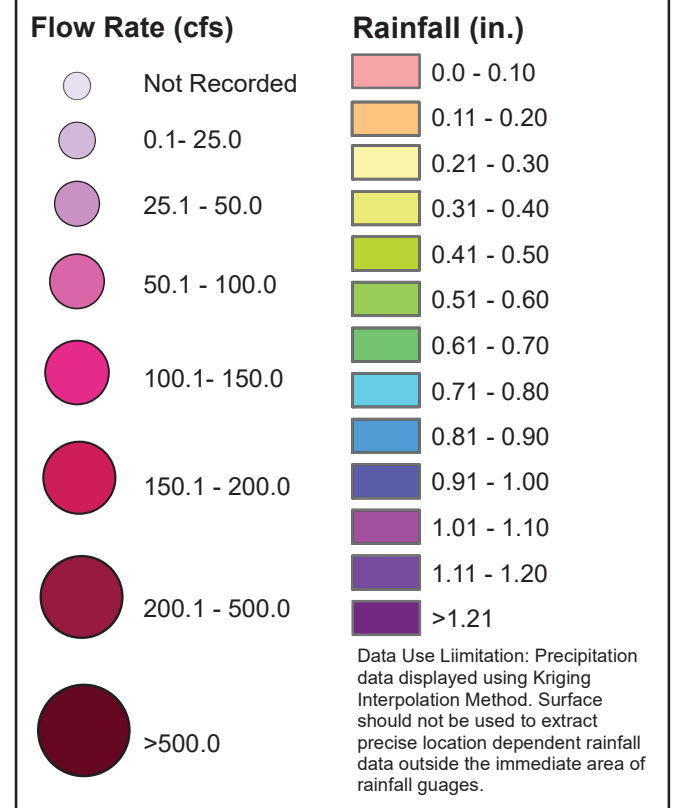
Figure 11

AMAFCA Levellogger Runoff and CoCoRaHS Rainfall November 24, 2021 Storm Event

On November 24, 2021, a storm event occurred. Table 2 presents the daily CoCoRaHS data for this storm event for all the NDC watersheds with Levellogger sites. The bar chart in Figure 10 graphically shows the recorded Levellogger peak flow rates and runoff volume data for the Levellogger locations. The CoCoRaHS data for this storm event was added into ArcGIS; the data is presented spatially related to the underlying watersheds in Figure 11.

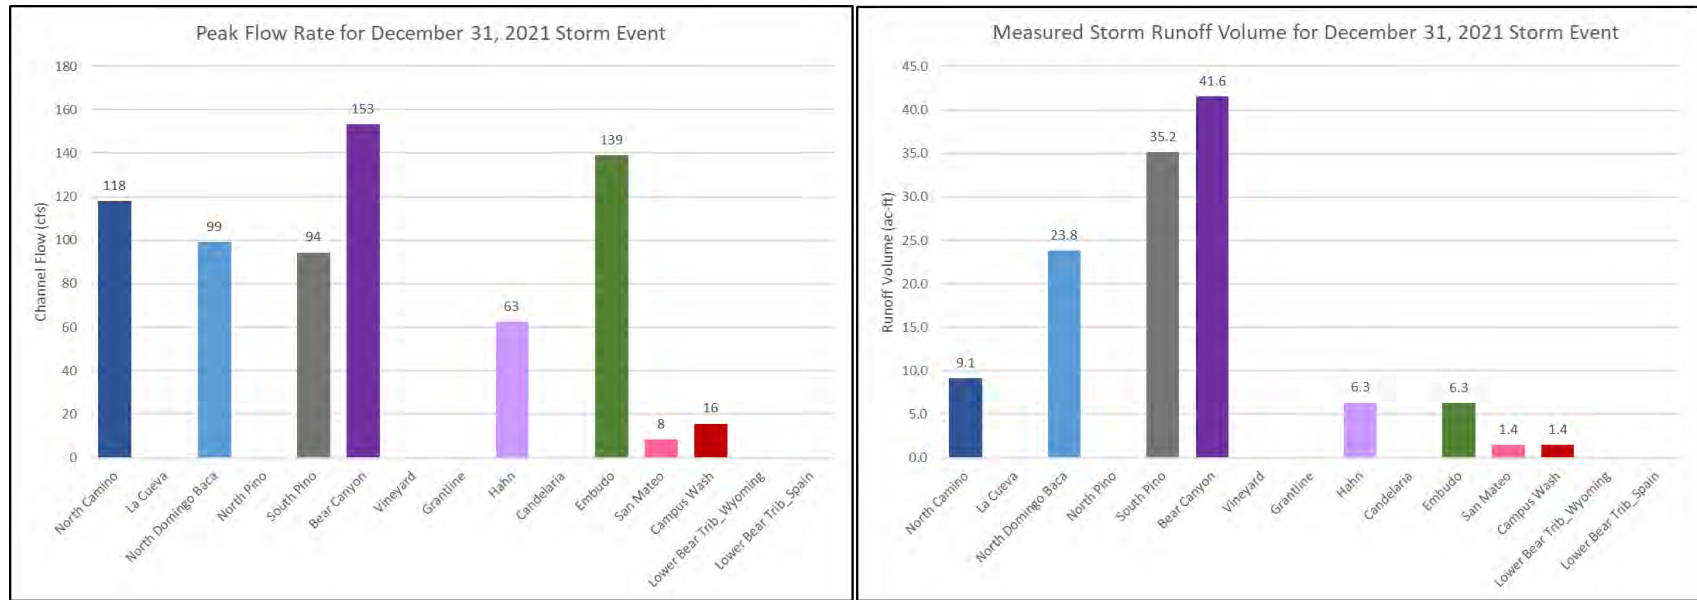
Figure 13: December 31, 2021 Storm Event, Peak Flow Rates and Runoff Volume

On December 31, 2021, a storm event occurred. Table 4 presents the daily CoCoRaHS data for this storm event for all the NDC watersheds with Levellogger sites. The bar chart in Figure 13 graphically shows the recorded Levellogger peak flow rates and runoff volume data for the Levellogger locations. The CoCoRaHS data for this storm event was added into ArcGIS; the data is presented spatially related to the underlying watersheds in Figure 14.
