LEVELLOGGER REPORT FOR MARCH – JUNE 2022

**AMAFCA
2600 Prospect Avenue NE
Albuquerque, NM 87107**

BOHANNAN HUSTON, INC.

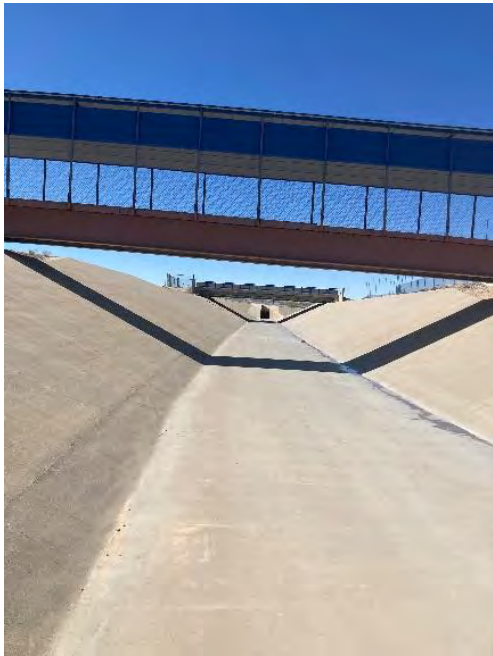
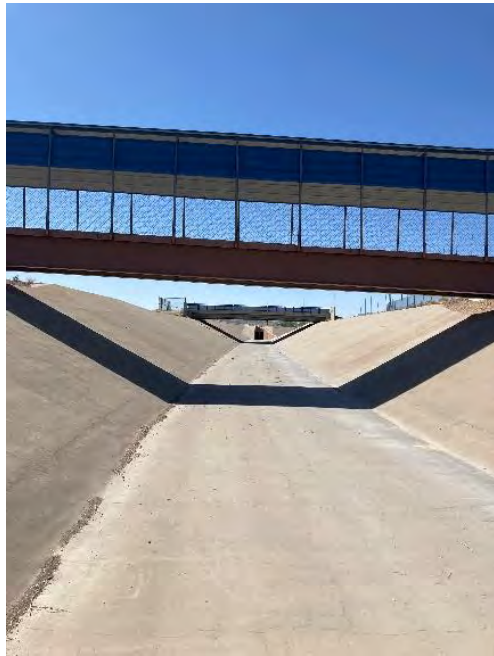
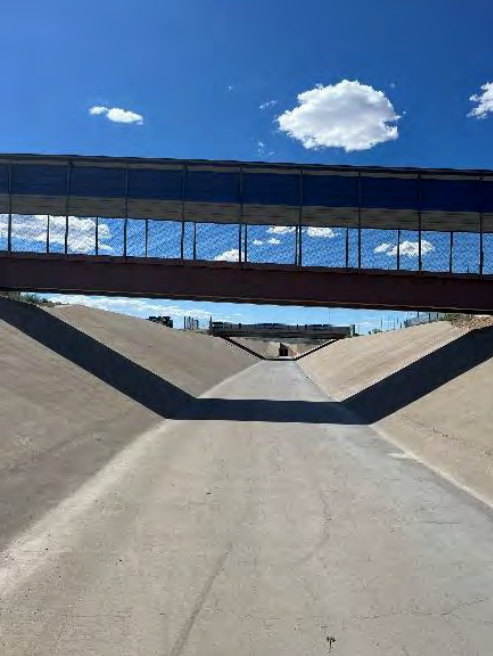
<p>Photo 13: La Cueva Arroyo – Looking Downstream</p>	<p>Photo 14: La Cueva Arroyo – Looking Downstream</p>	<p>Photo 15: La Cueva Arroyo – Looking Downstream</p>	<p>Photo 16: La Cueva Arroyo – Looking Downstream</p>

No signs of illicit discharge were observed during the March to June 2022 Levellogger collection period site visits. AMAFCA obtained and provided site photos looking upstream and downstream of each Levellogger to document the visual screening and appearance of the channels. All acquired photos are provided by month, see pages 5 – 18, for each Levellogger location covered in this report.

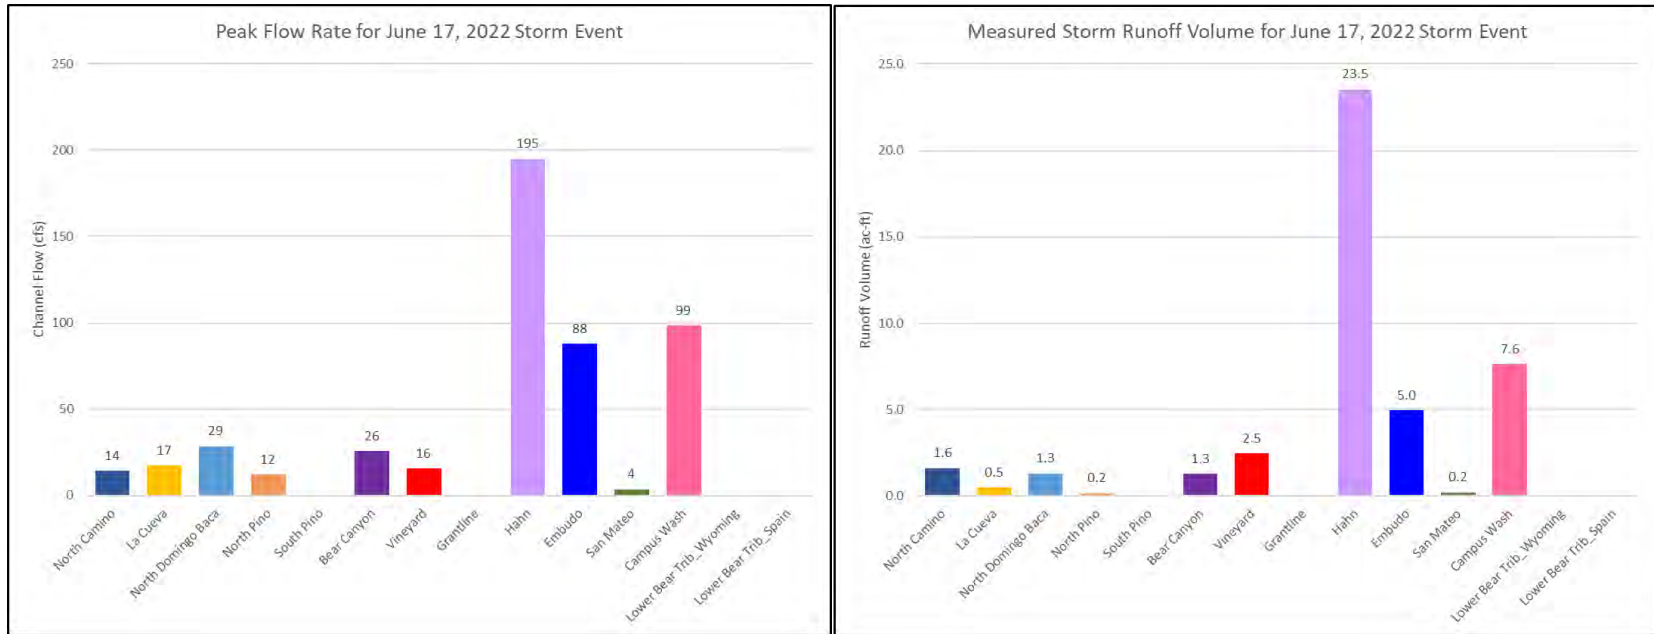
Figure 15: June 17, 2022 Storm Event, Peak Flow Rates and Runoff Volume

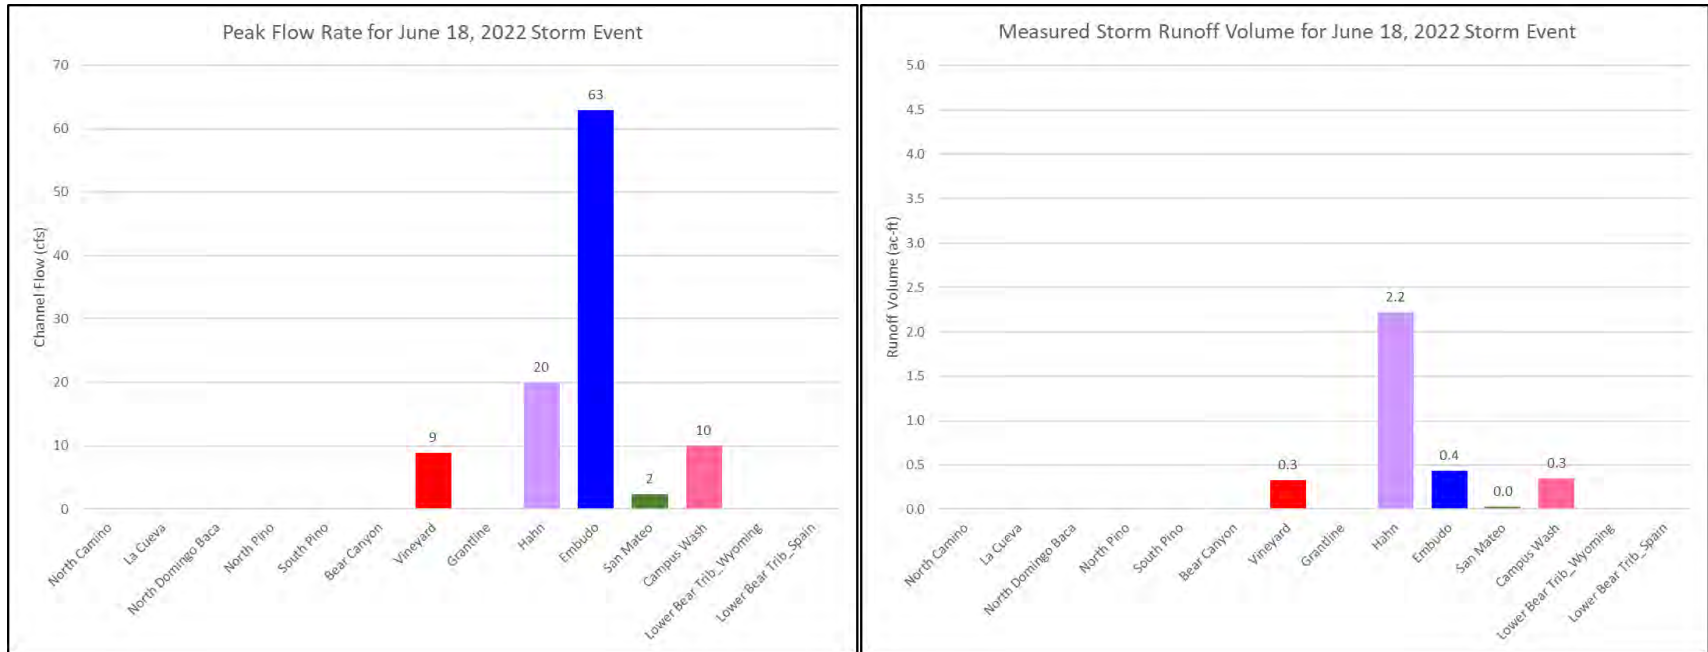
Figure 17: June 18, 2022 Storm Event, Peak Flow Rates and Runoff Volume

On June 18, 2022 rainfall was occurring most of the day and some of the Levelloggers reported two runoff peaks. Both runoff peaks were reported as one storm event for the day because the CoCoRaHS rainfall data reports one value for the entire day and does not provide storm event timing information. Table 6 presents the daily CoCoRaHS data for this storm event for all the NDC watersheds with Levellogger sites. The bar chart in Figure 17 graphically shows the recorded Levellogger peak flow rates and runoff volume data for the Levellogger locations. The CoCoRaHS data for this storm event was added into ArcGIS; the data is presented spatially related to the underlying watersheds in Figure 18.

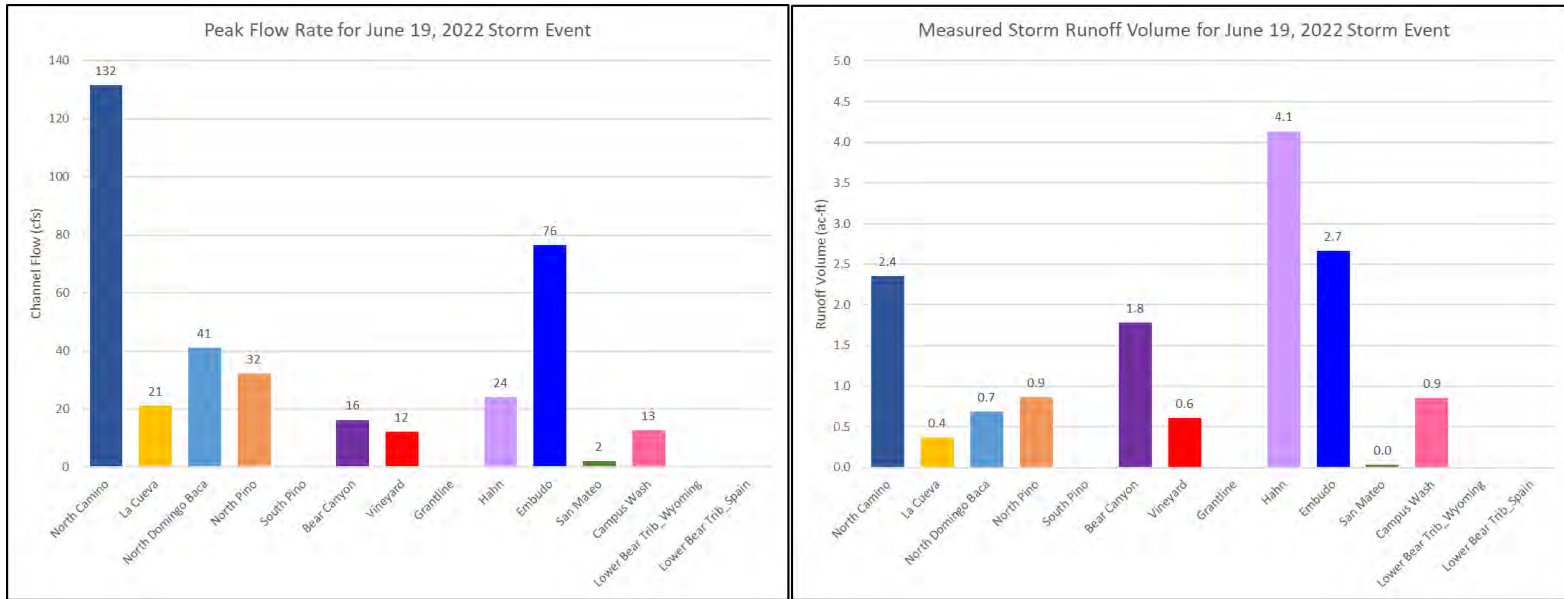
Figure 19: June 19, 2022 Storm Event, Peak Flow Rates and Runoff Volume

On June 19, 2022, rainfall was occurring most of the day and the Levelloggers reported two different runoff peaks. Both runoff peaks were reported as one storm event for the day because the CoCoRaHS rainfall data reports one value for the entire day and does not provide storm event timing information. Table 7 presents the daily CoCoRaHS data for this storm event for all the NDC watersheds with Levellogger sites. The bar chart in Figure 19 graphically shows the recorded Levellogger peak flow rates and runoff volume data for the Levellogger locations. The CoCoRaHS data for this storm event was added into ArcGIS; the data is presented spatially related to the underlying watersheds in Figure 20.

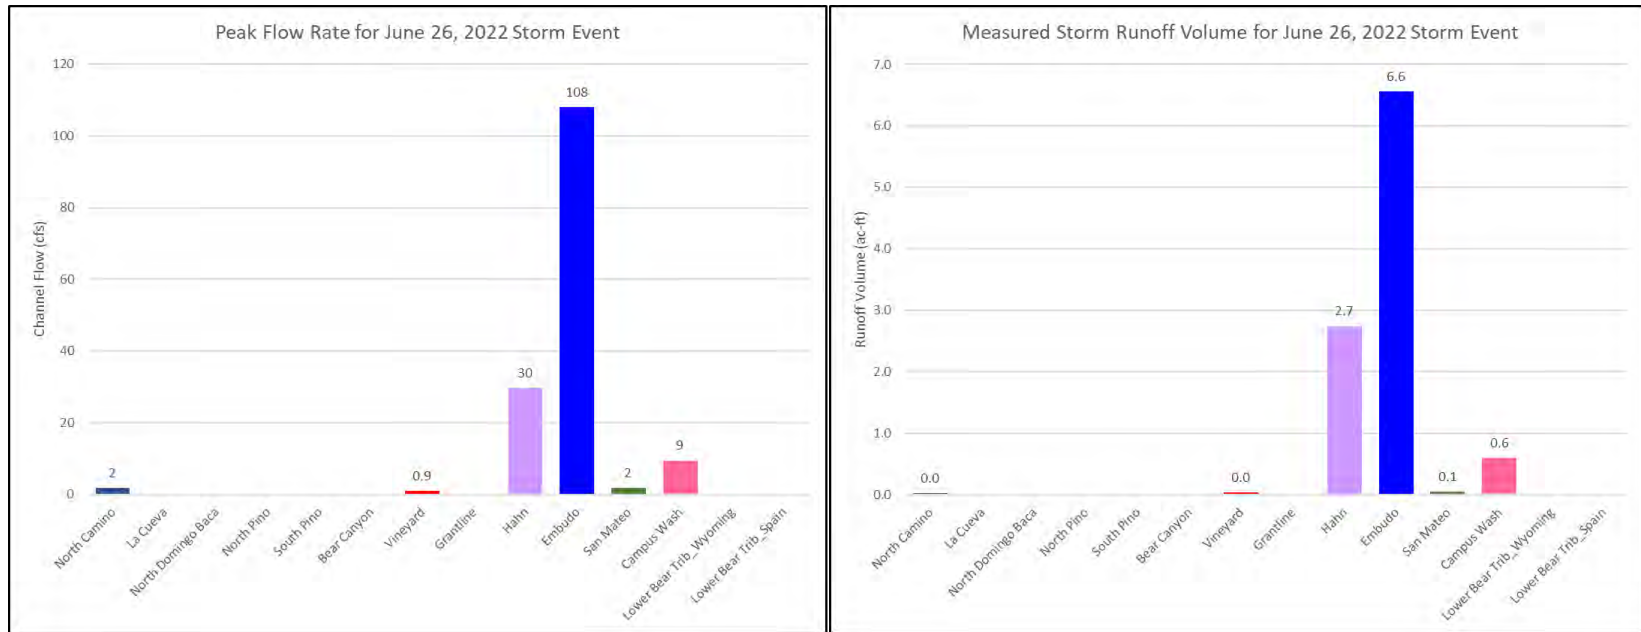
Figure 23: June 26, 2022 Storm Event, Peak Flow Rates and Runoff Volume
