**Re: First Quarter (January – March) 2022 In-Stream Water Quality Monitoring Memo**

## 1 Background

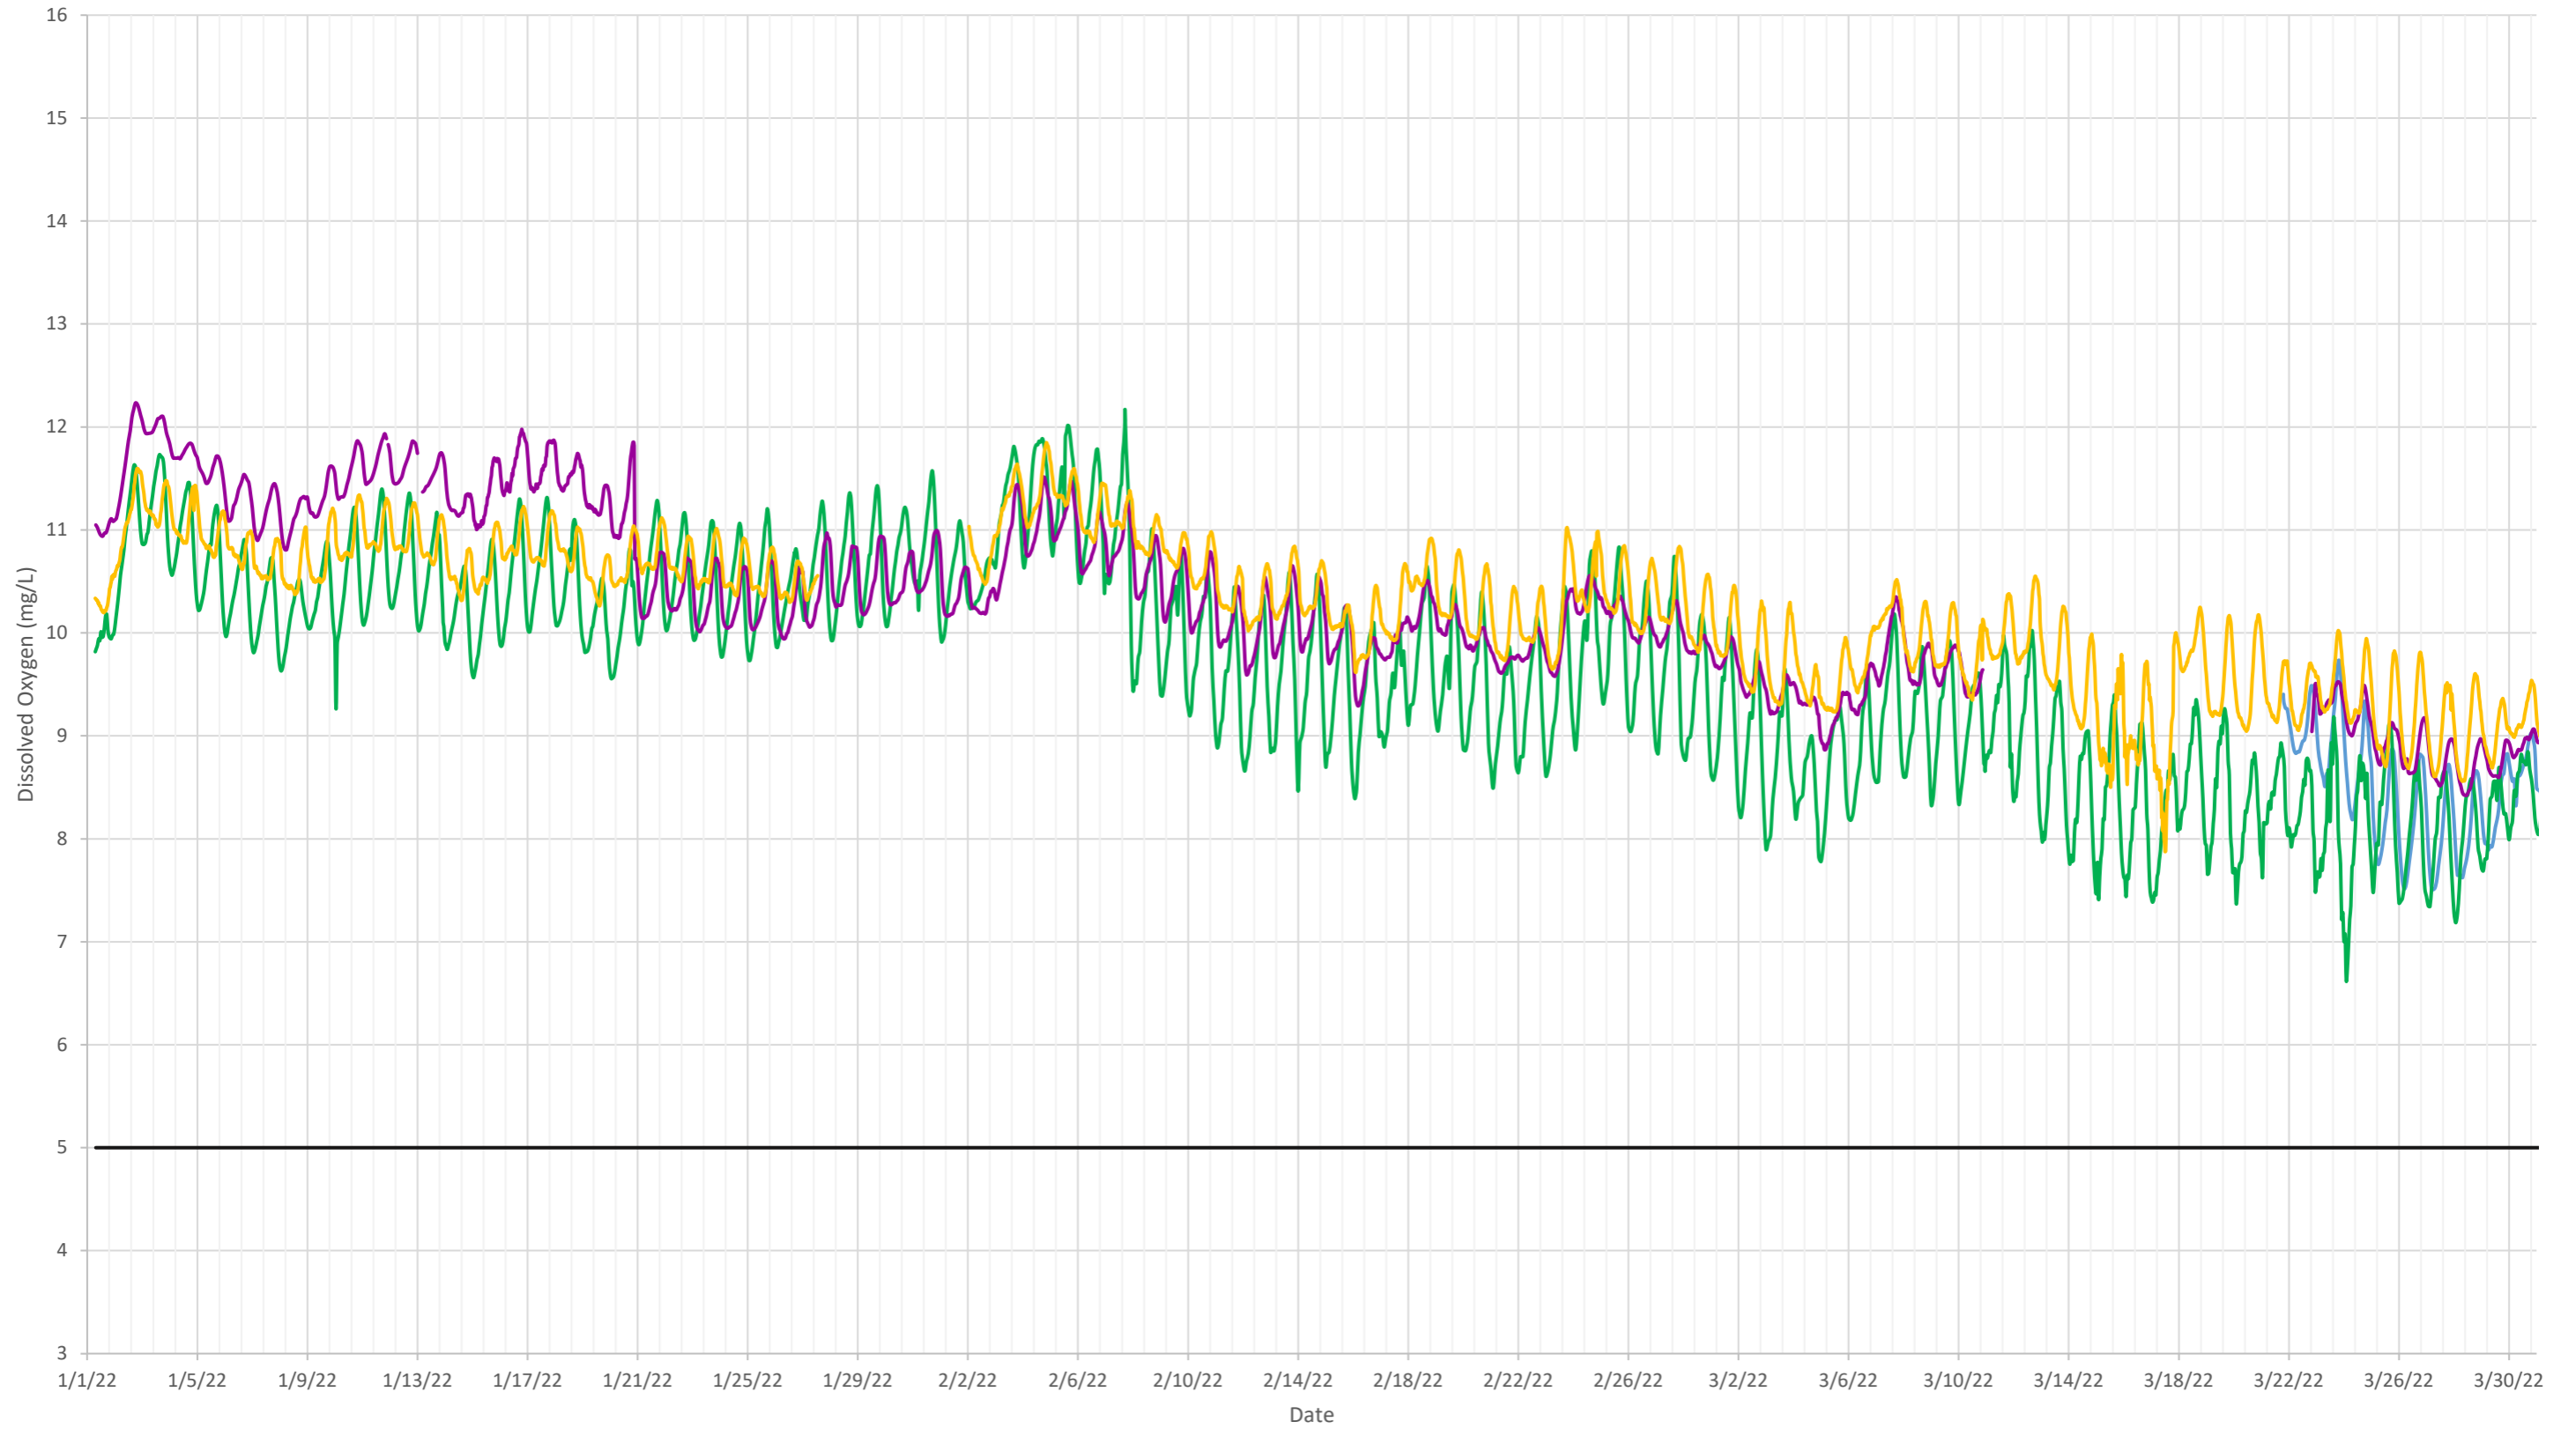
Dissolved Oxygen - All Sondes - Quarter 1, 2021

Isleta Central Sandia 550 DO Exceedance (5 mg/L)

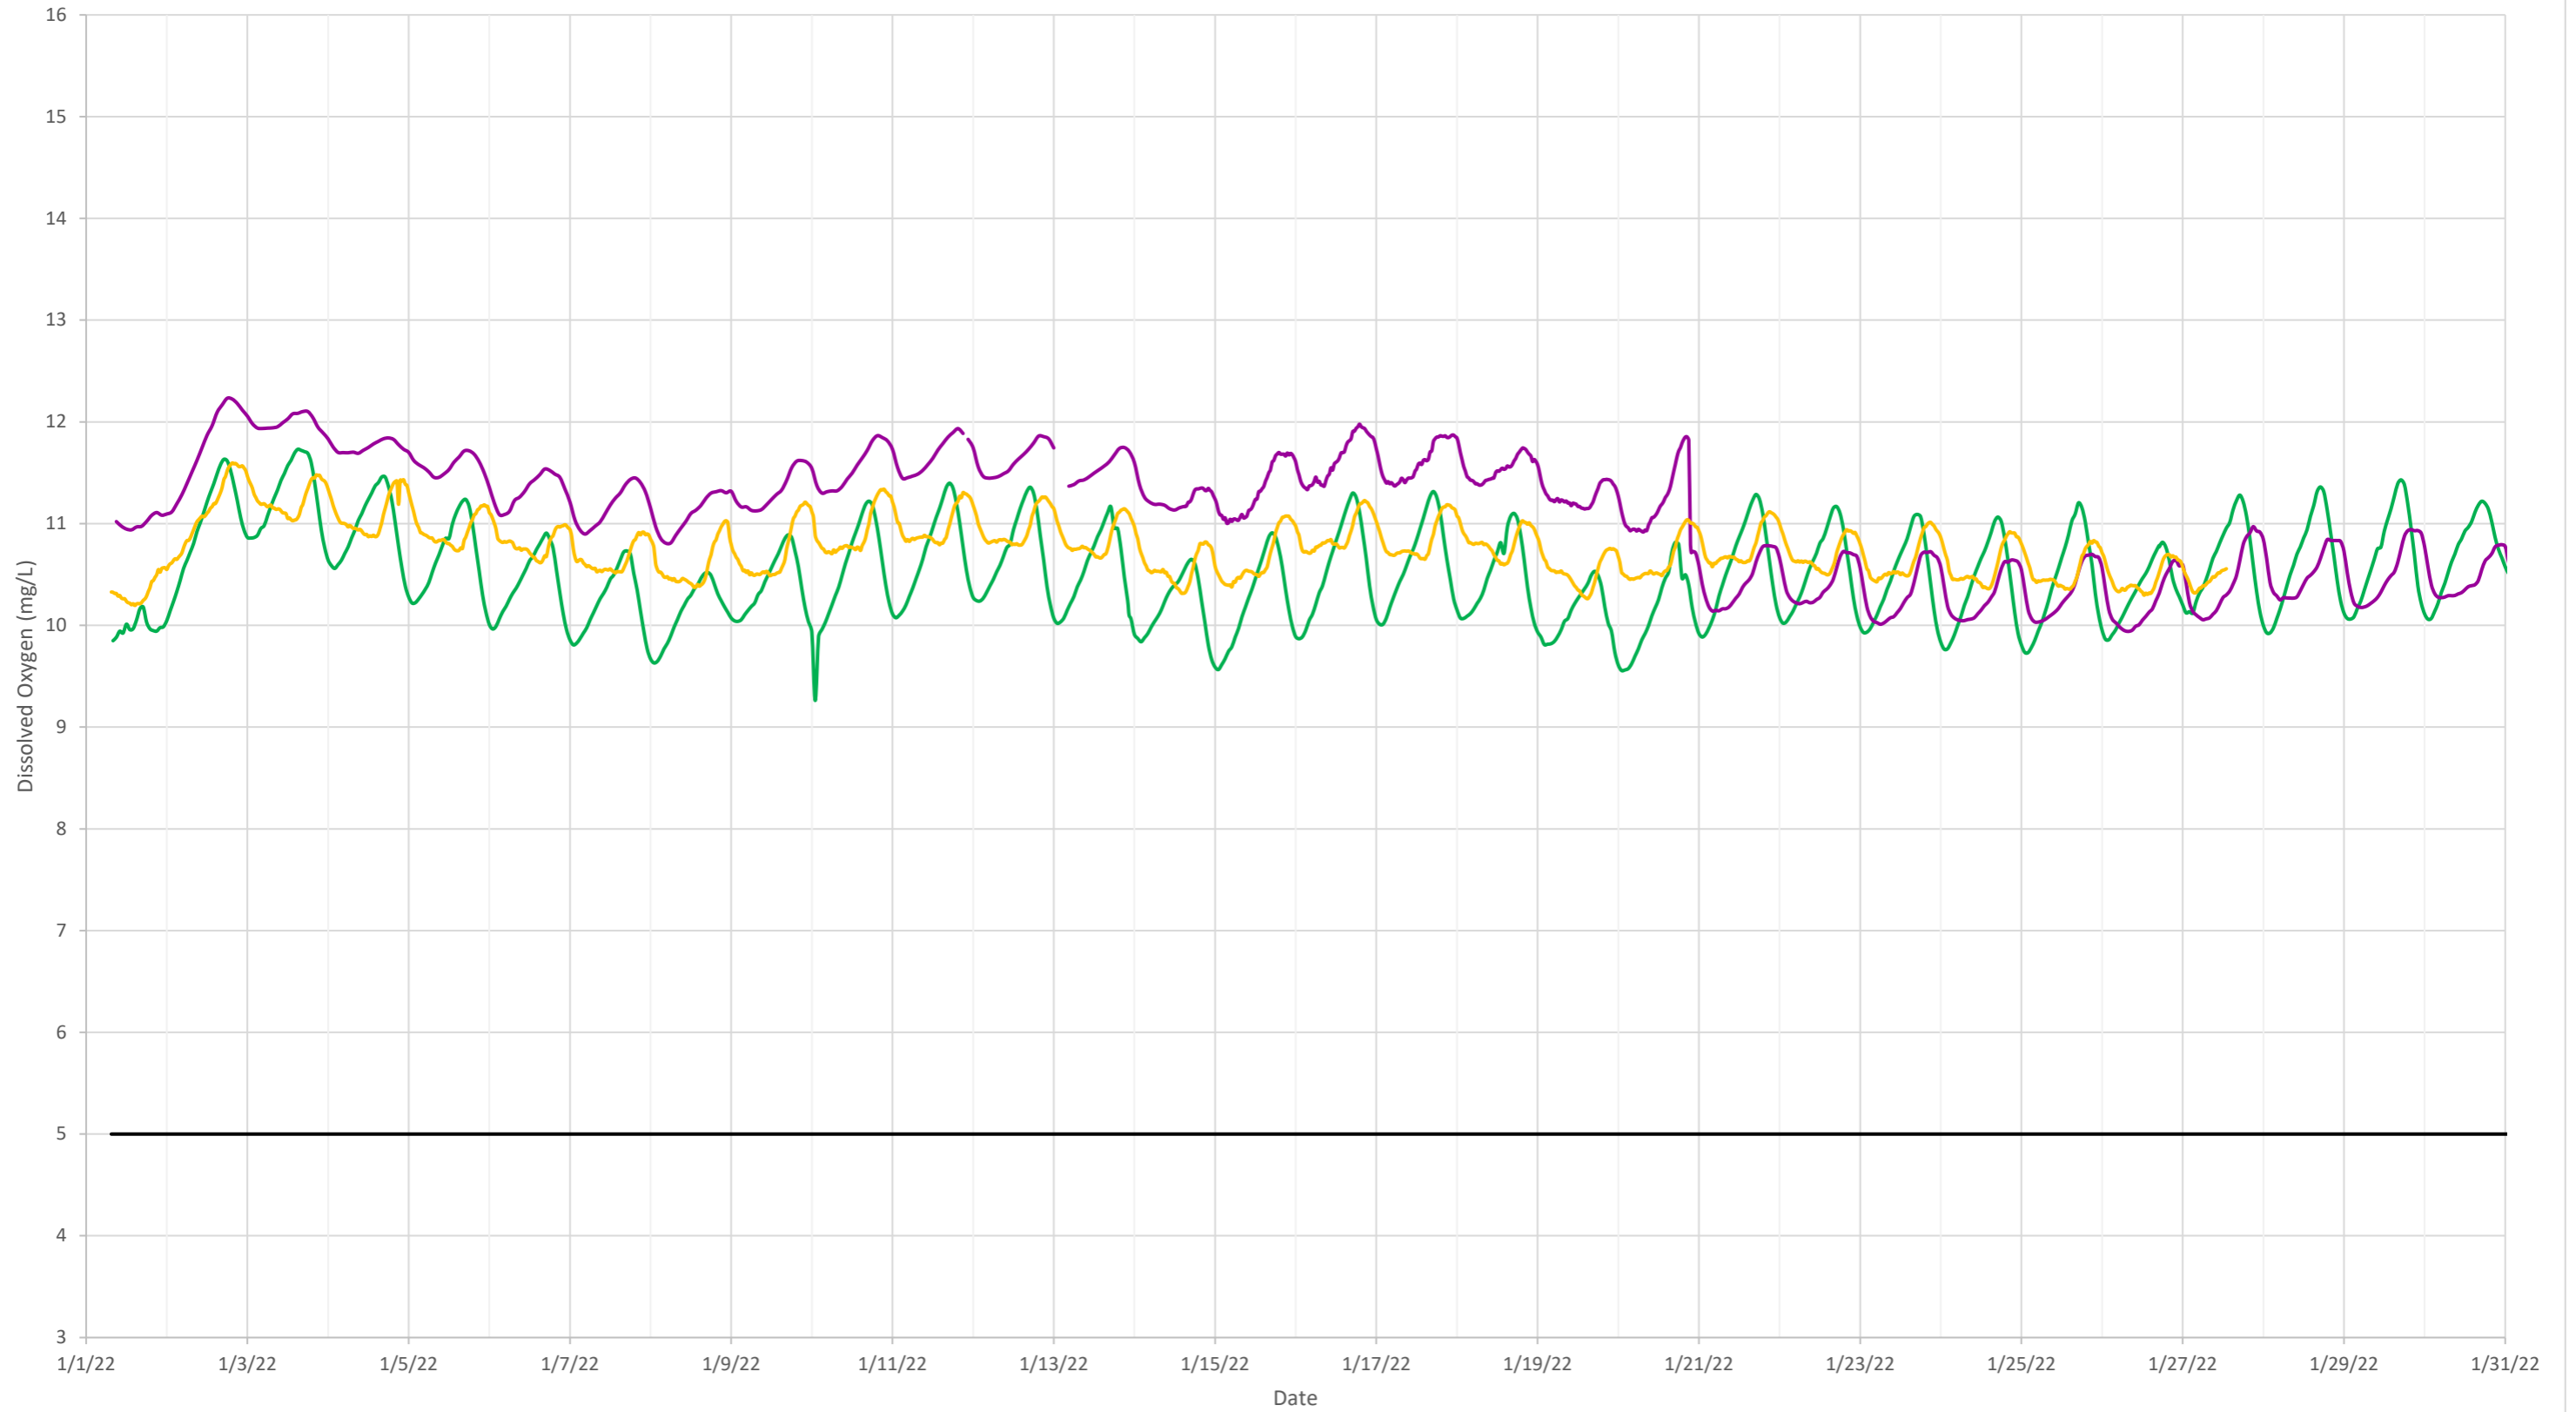
### Dissolved Oxygen - All Sondes - January 2021

— Isleta — Central — Sandia — 550 — DO Exceedance (5 mg/L)

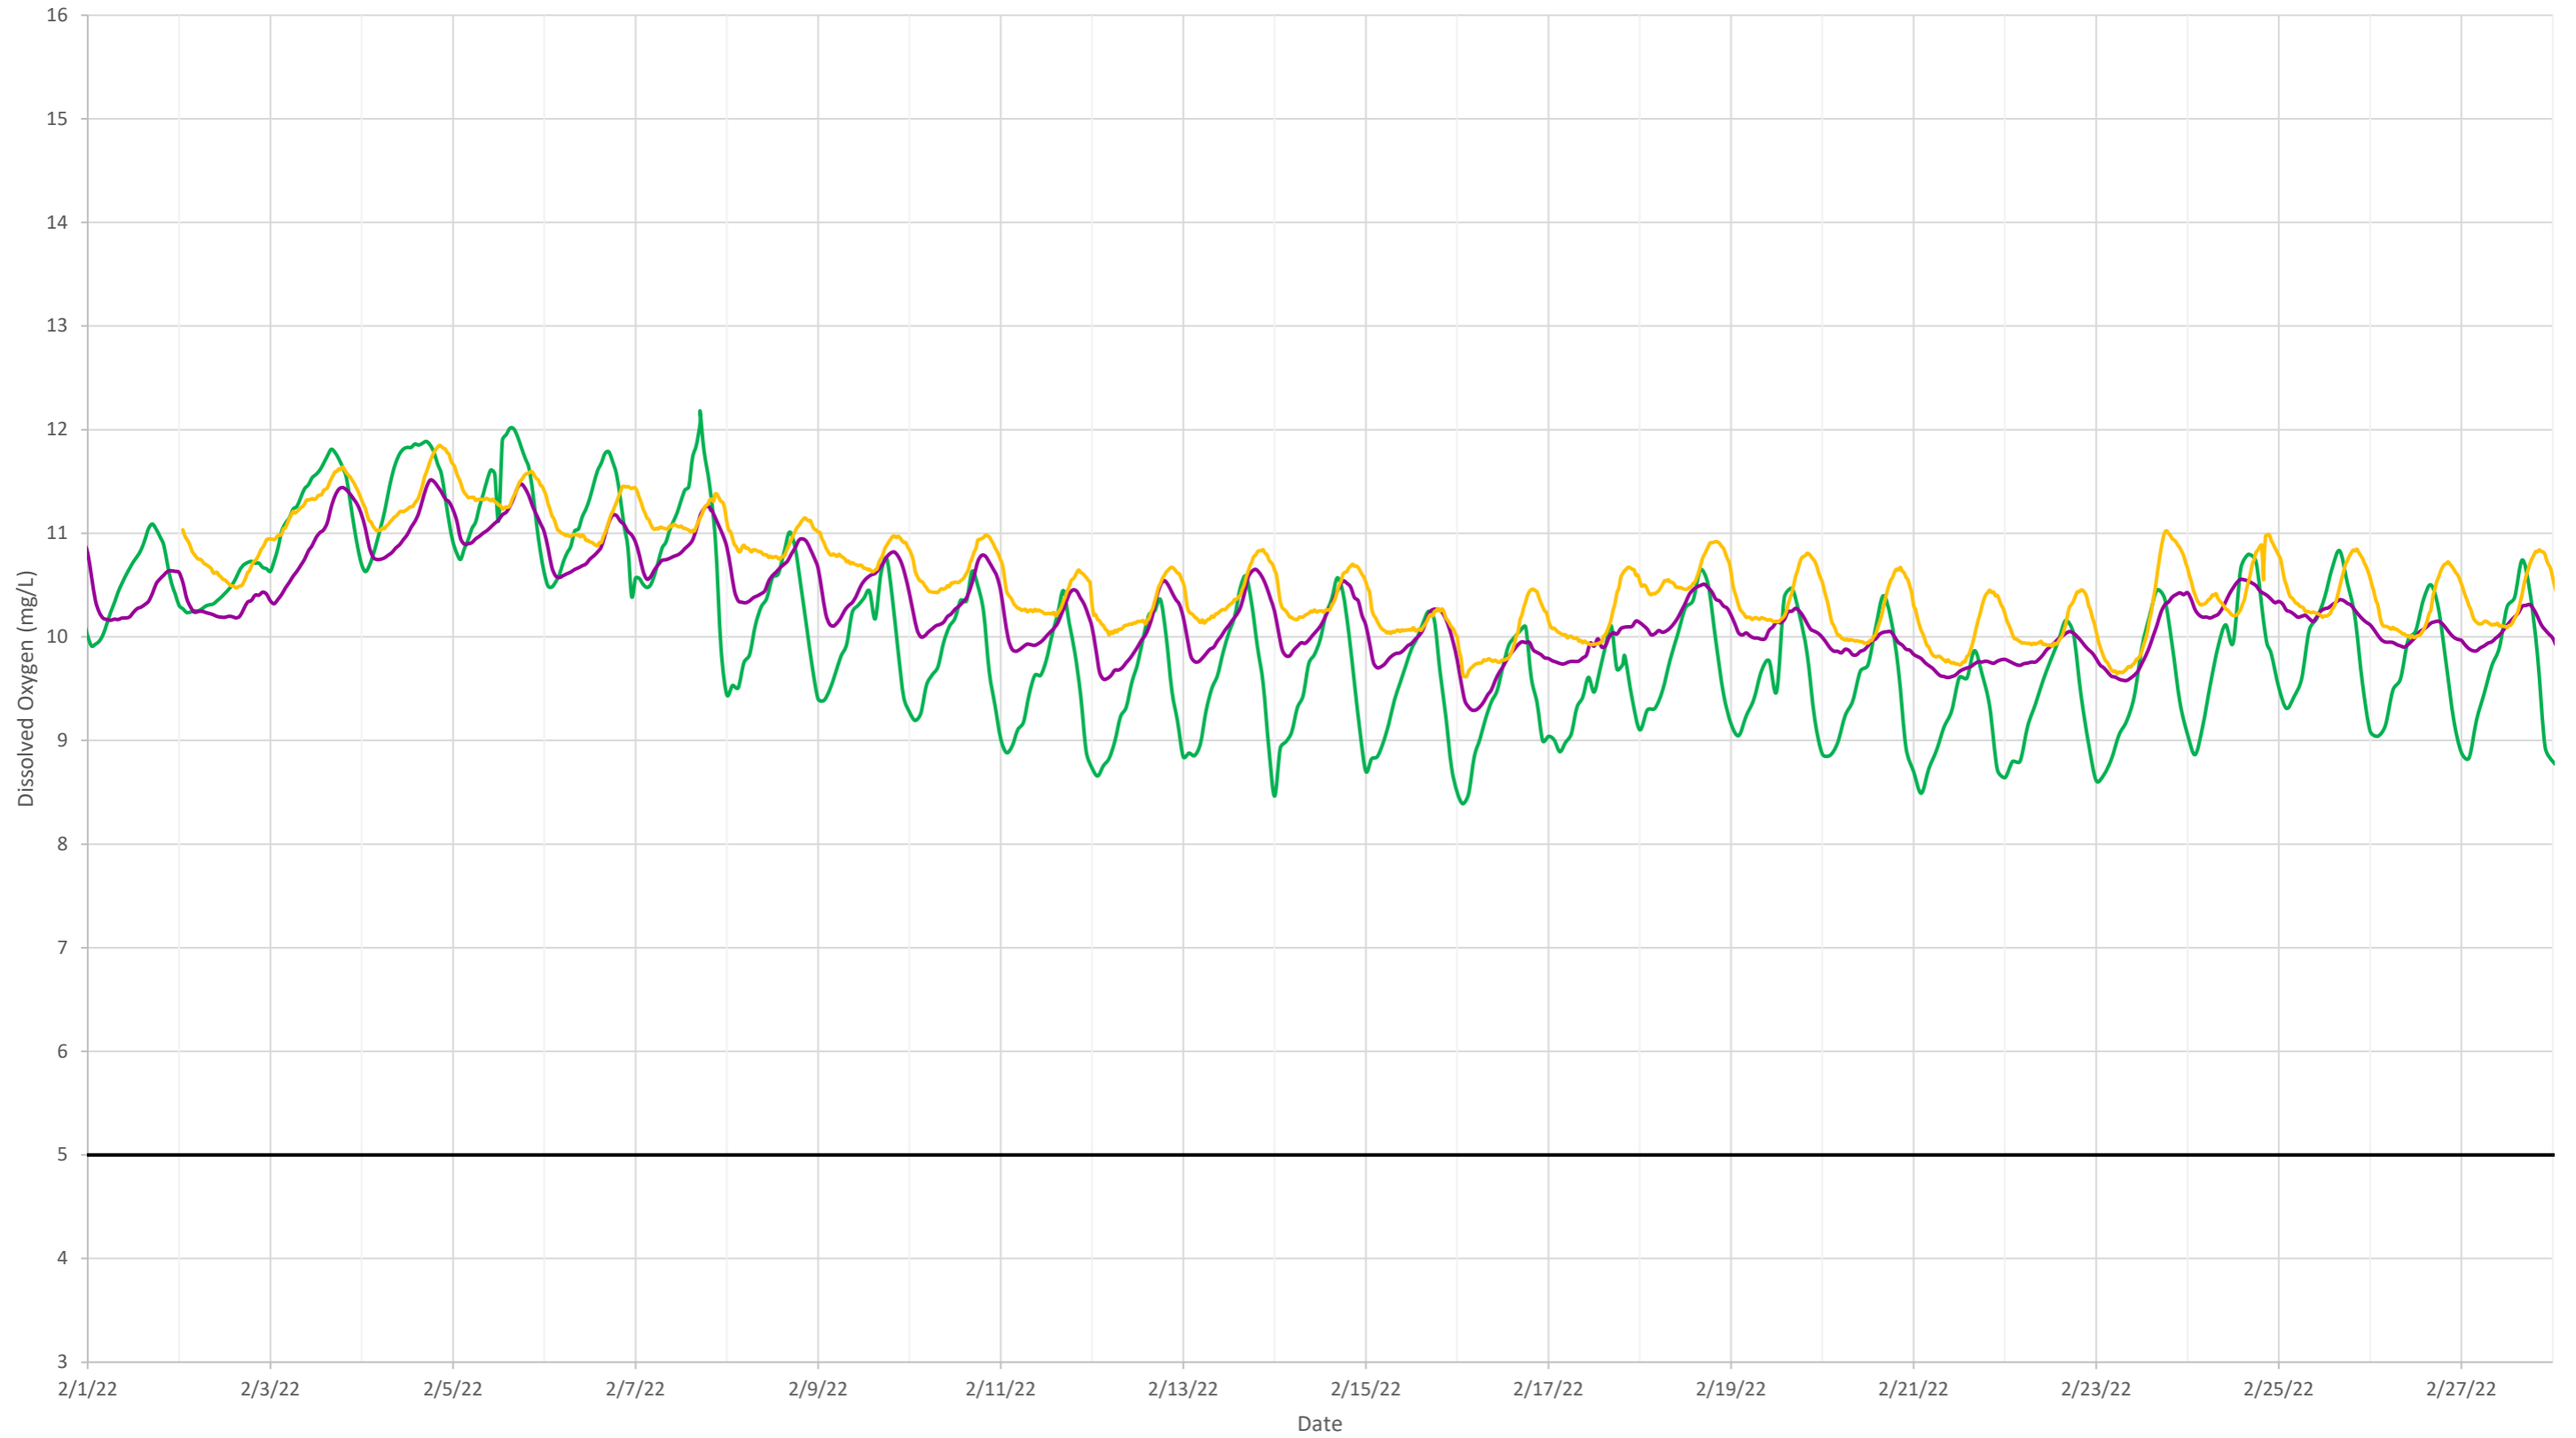
### Dissolved Oxygen - All Sondes - February 2021

— Isleta — Central — Sandia — 550 — DO Exceedance (5 mg/L)

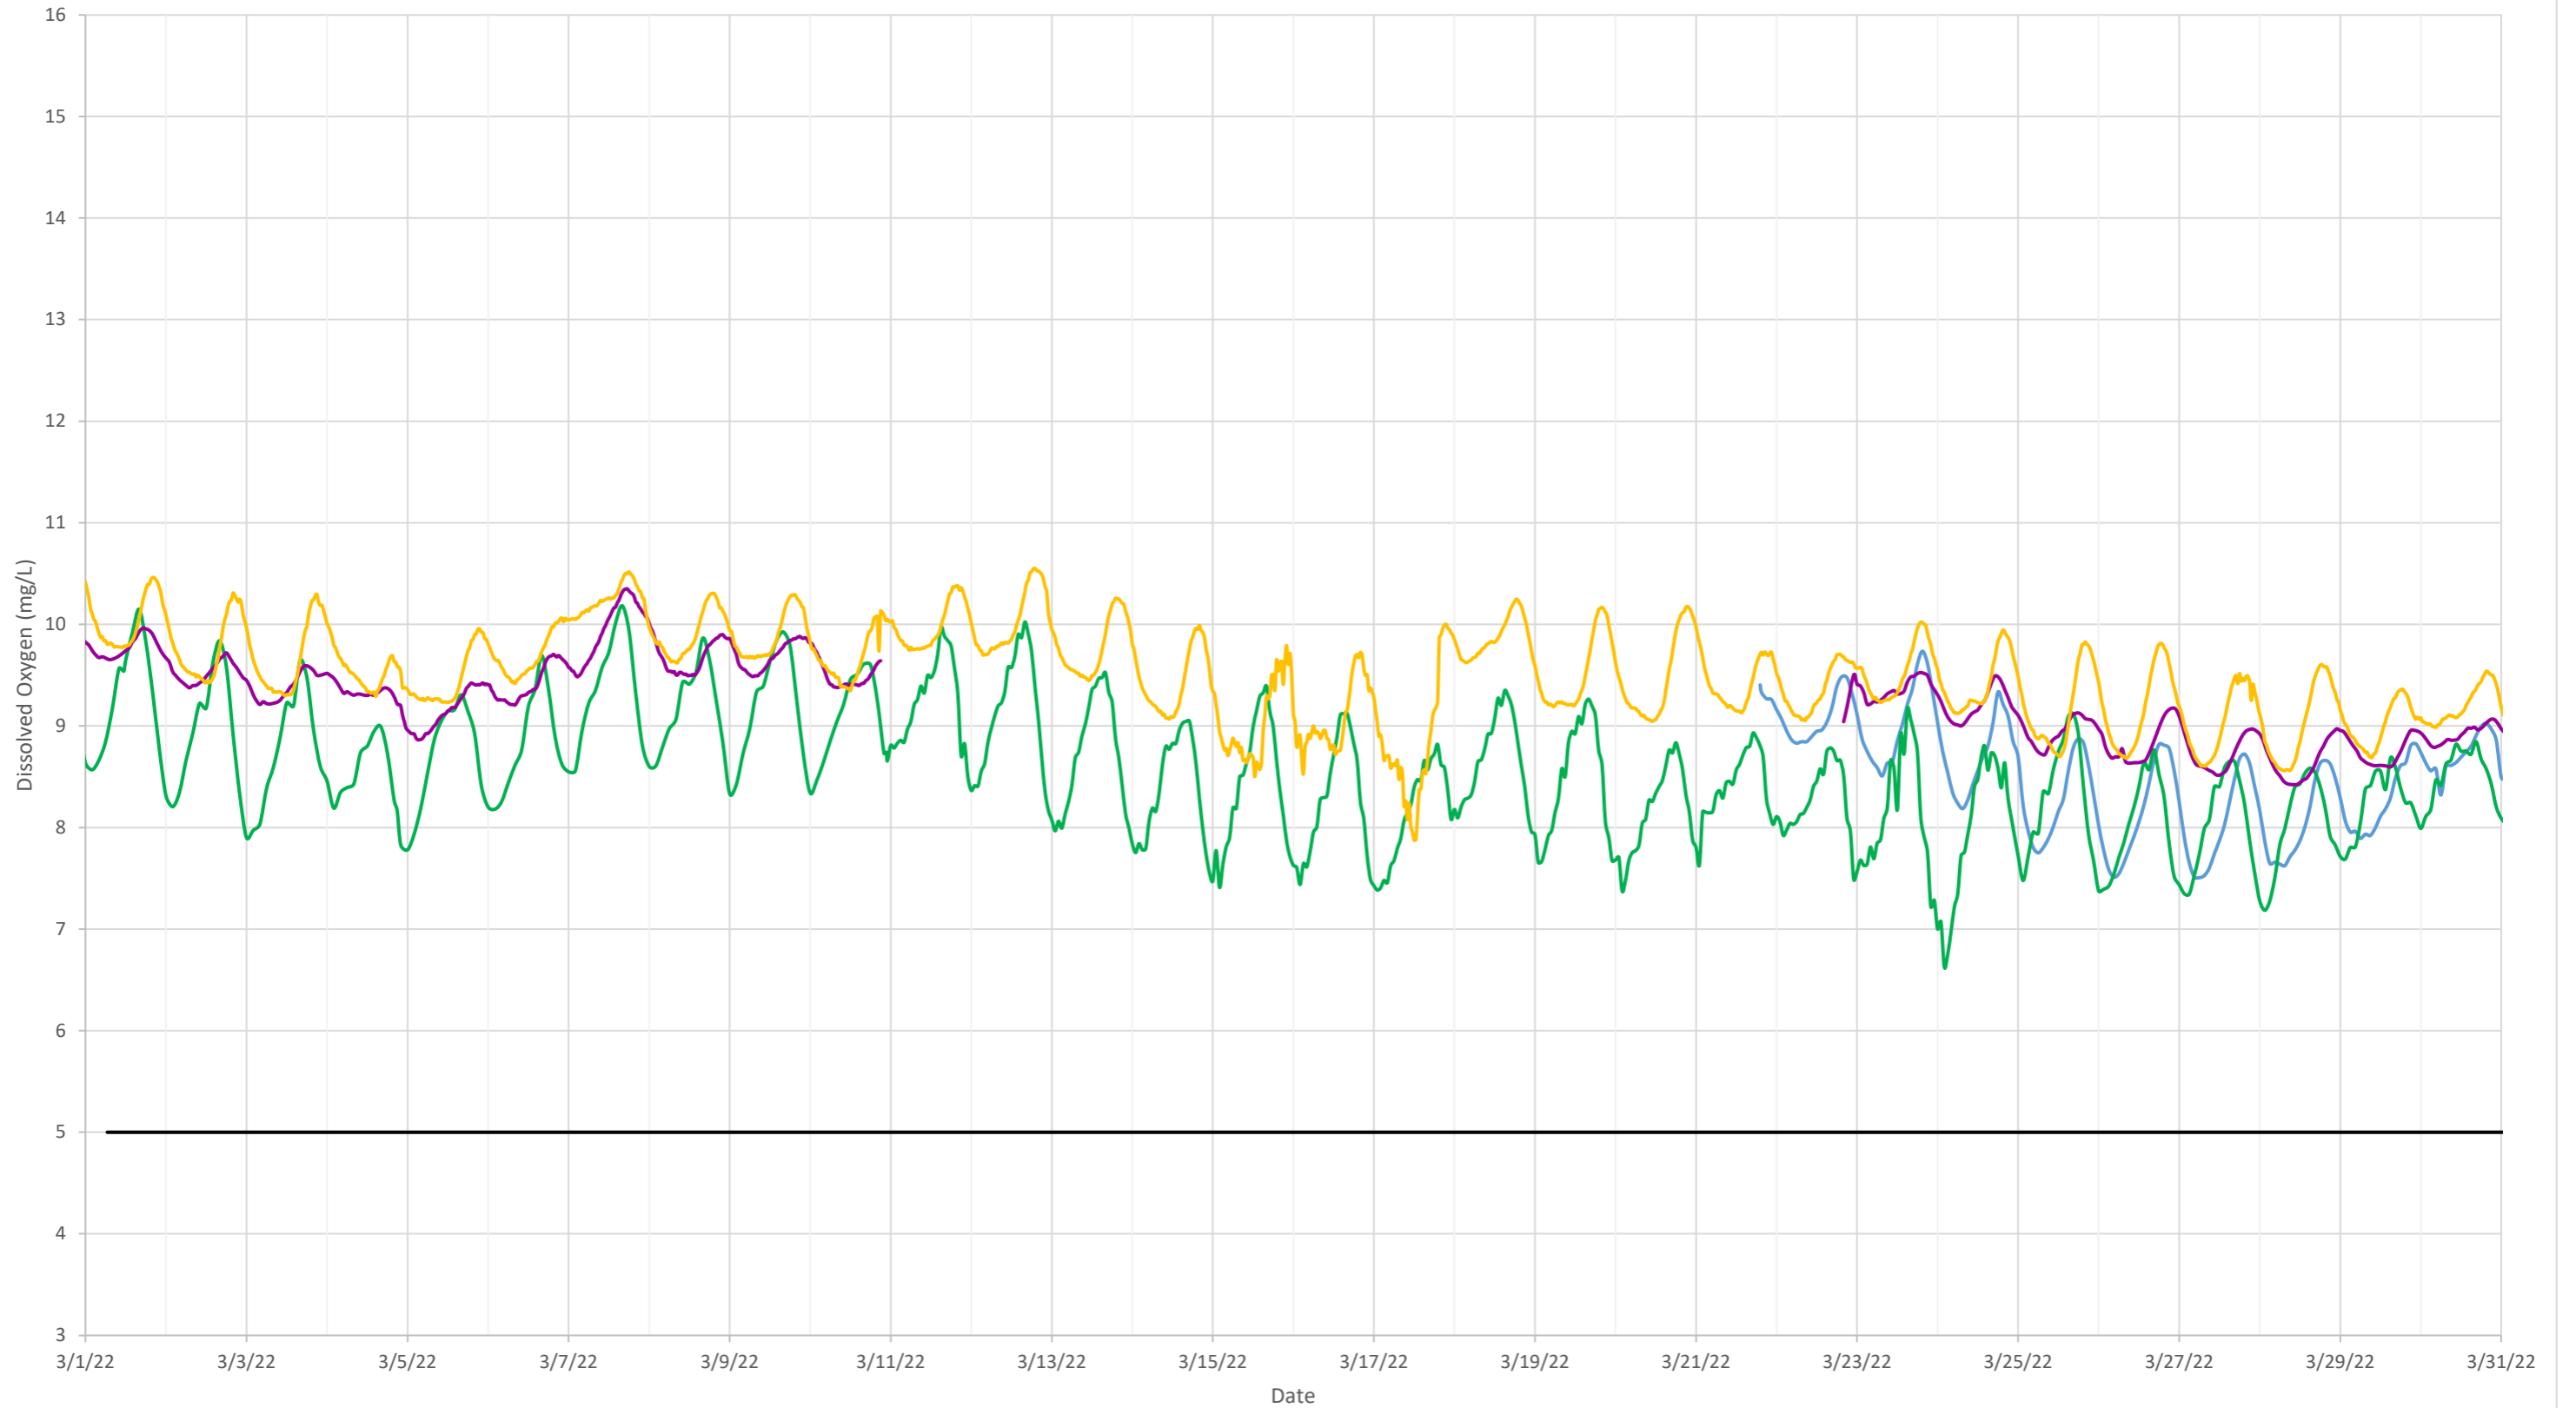
### Dissolved Oxygen - All Sondes - March 2021

— Isleta — Central — Sandia — 550 — DO Exceedance (5 mg/L)

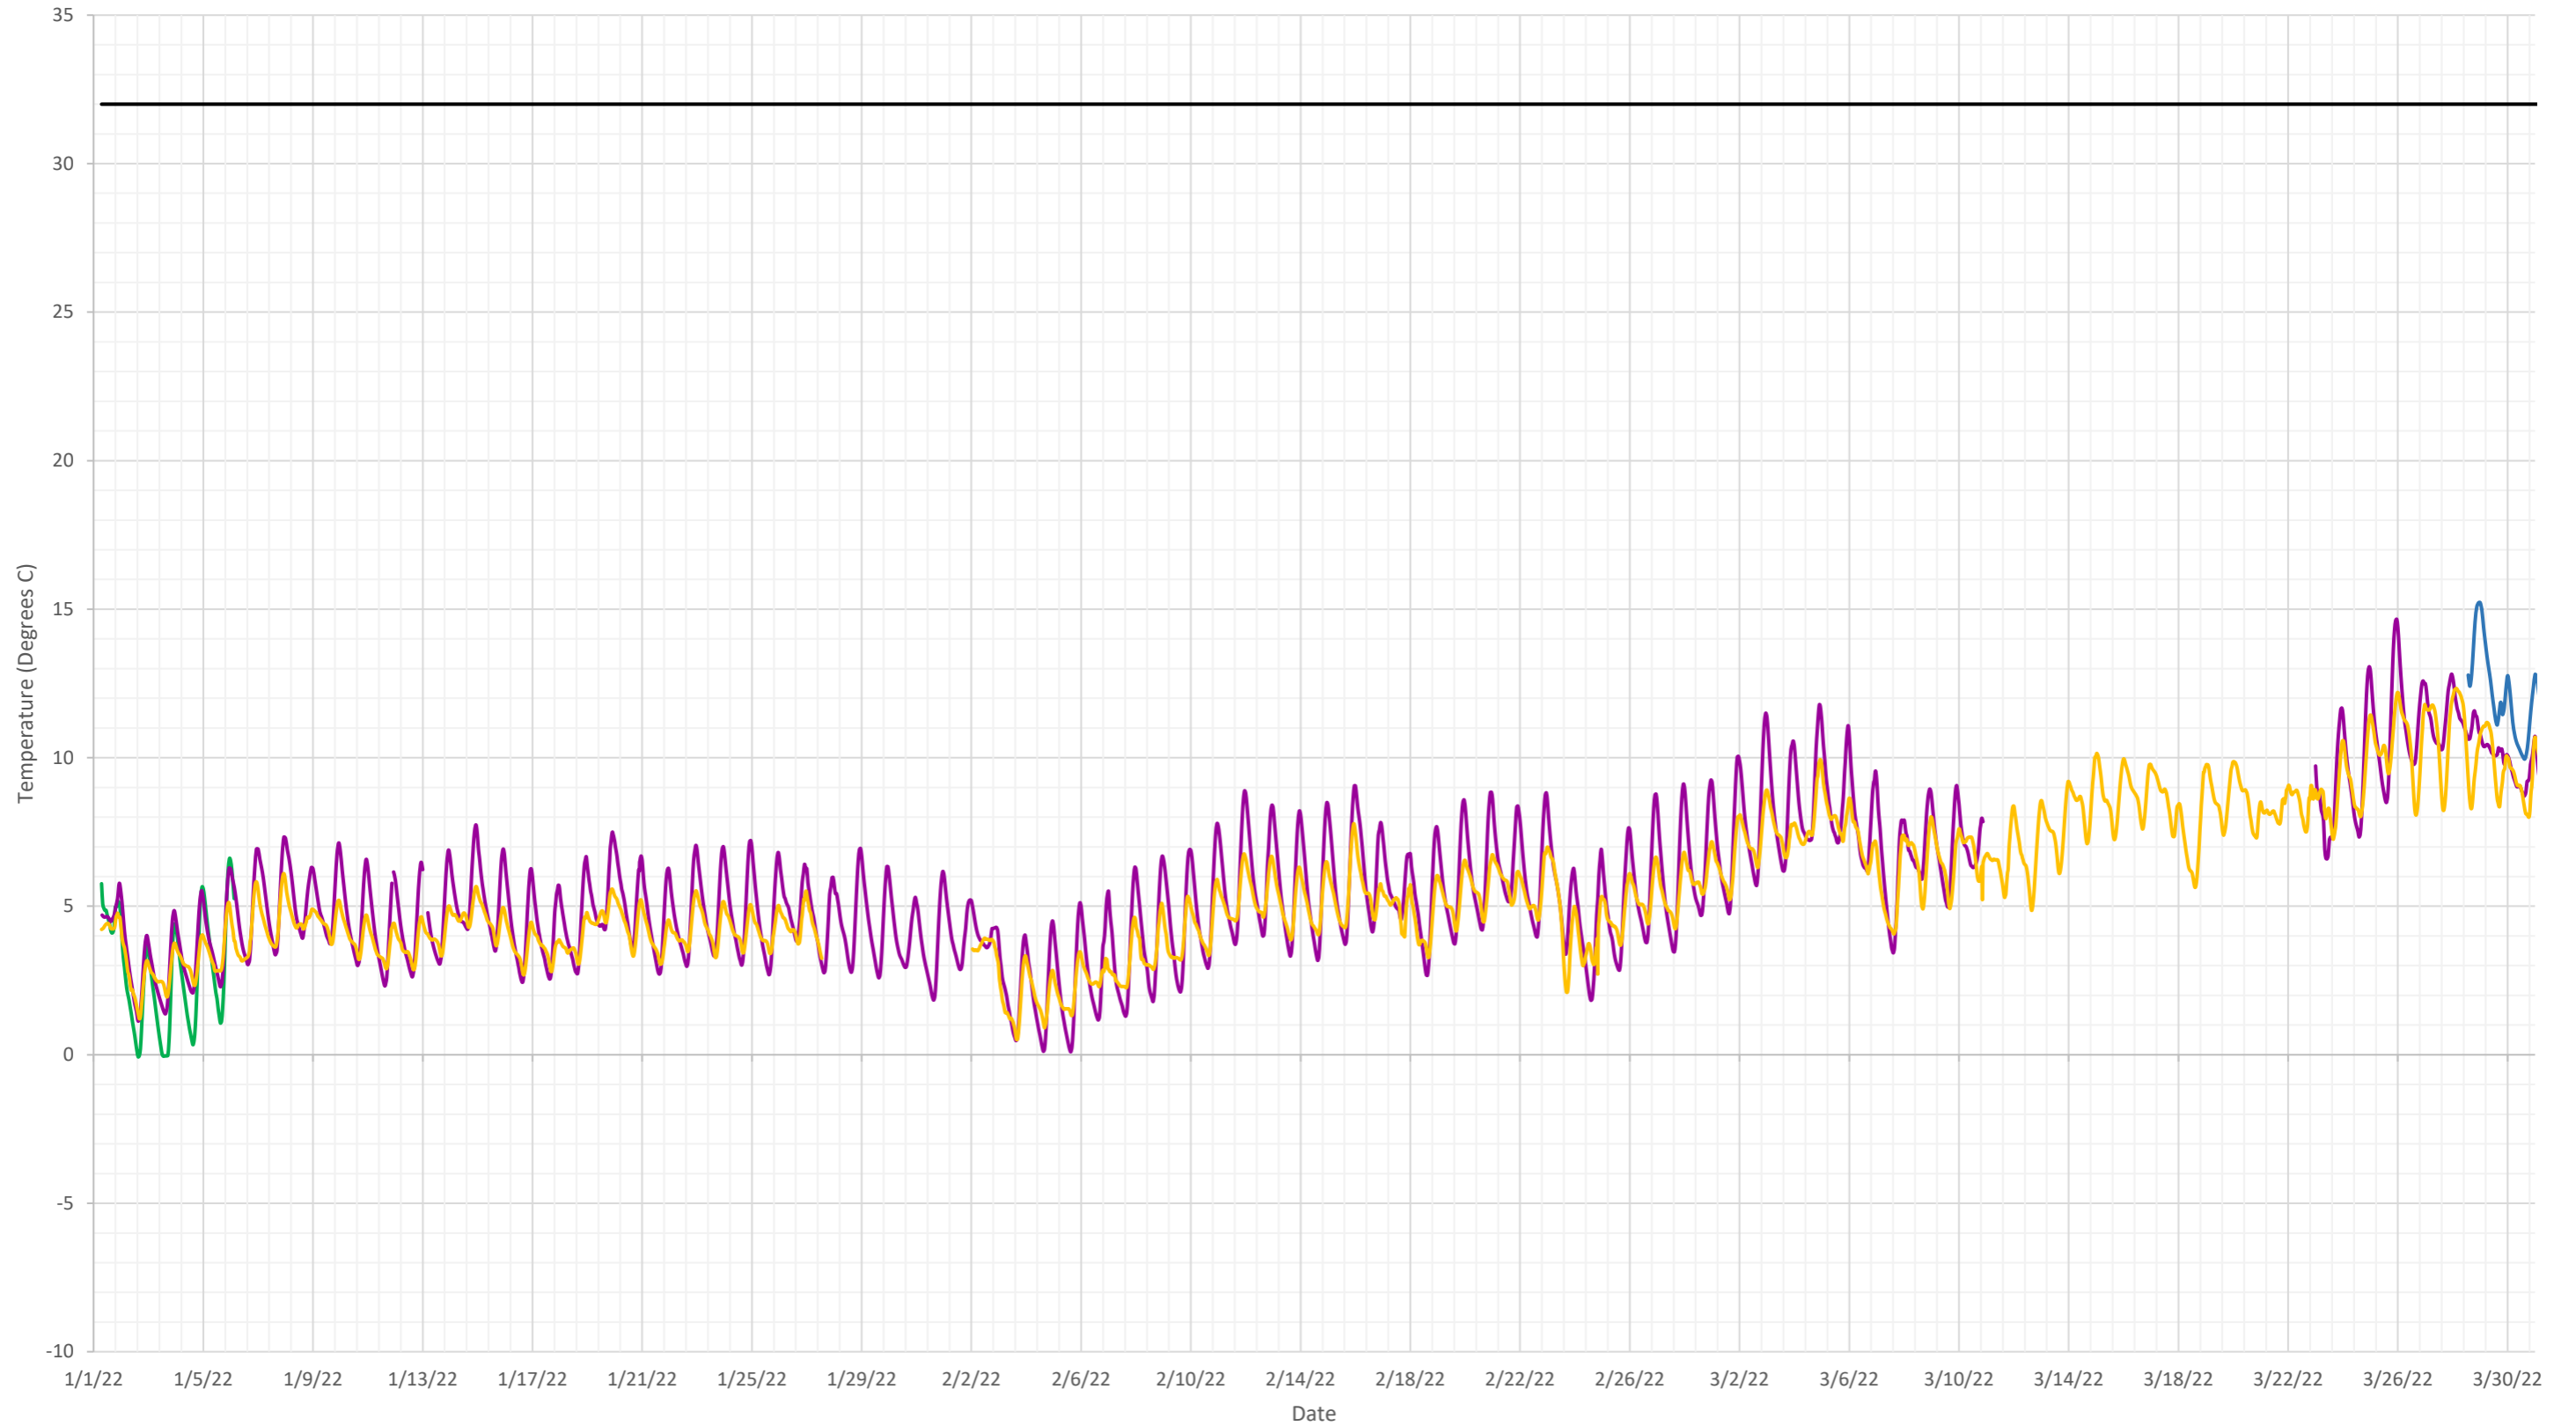
Temperature - All Sondes - Quarter 1, 2021

Isleta Central Sandia 550 Temperature Exceedance (32F)

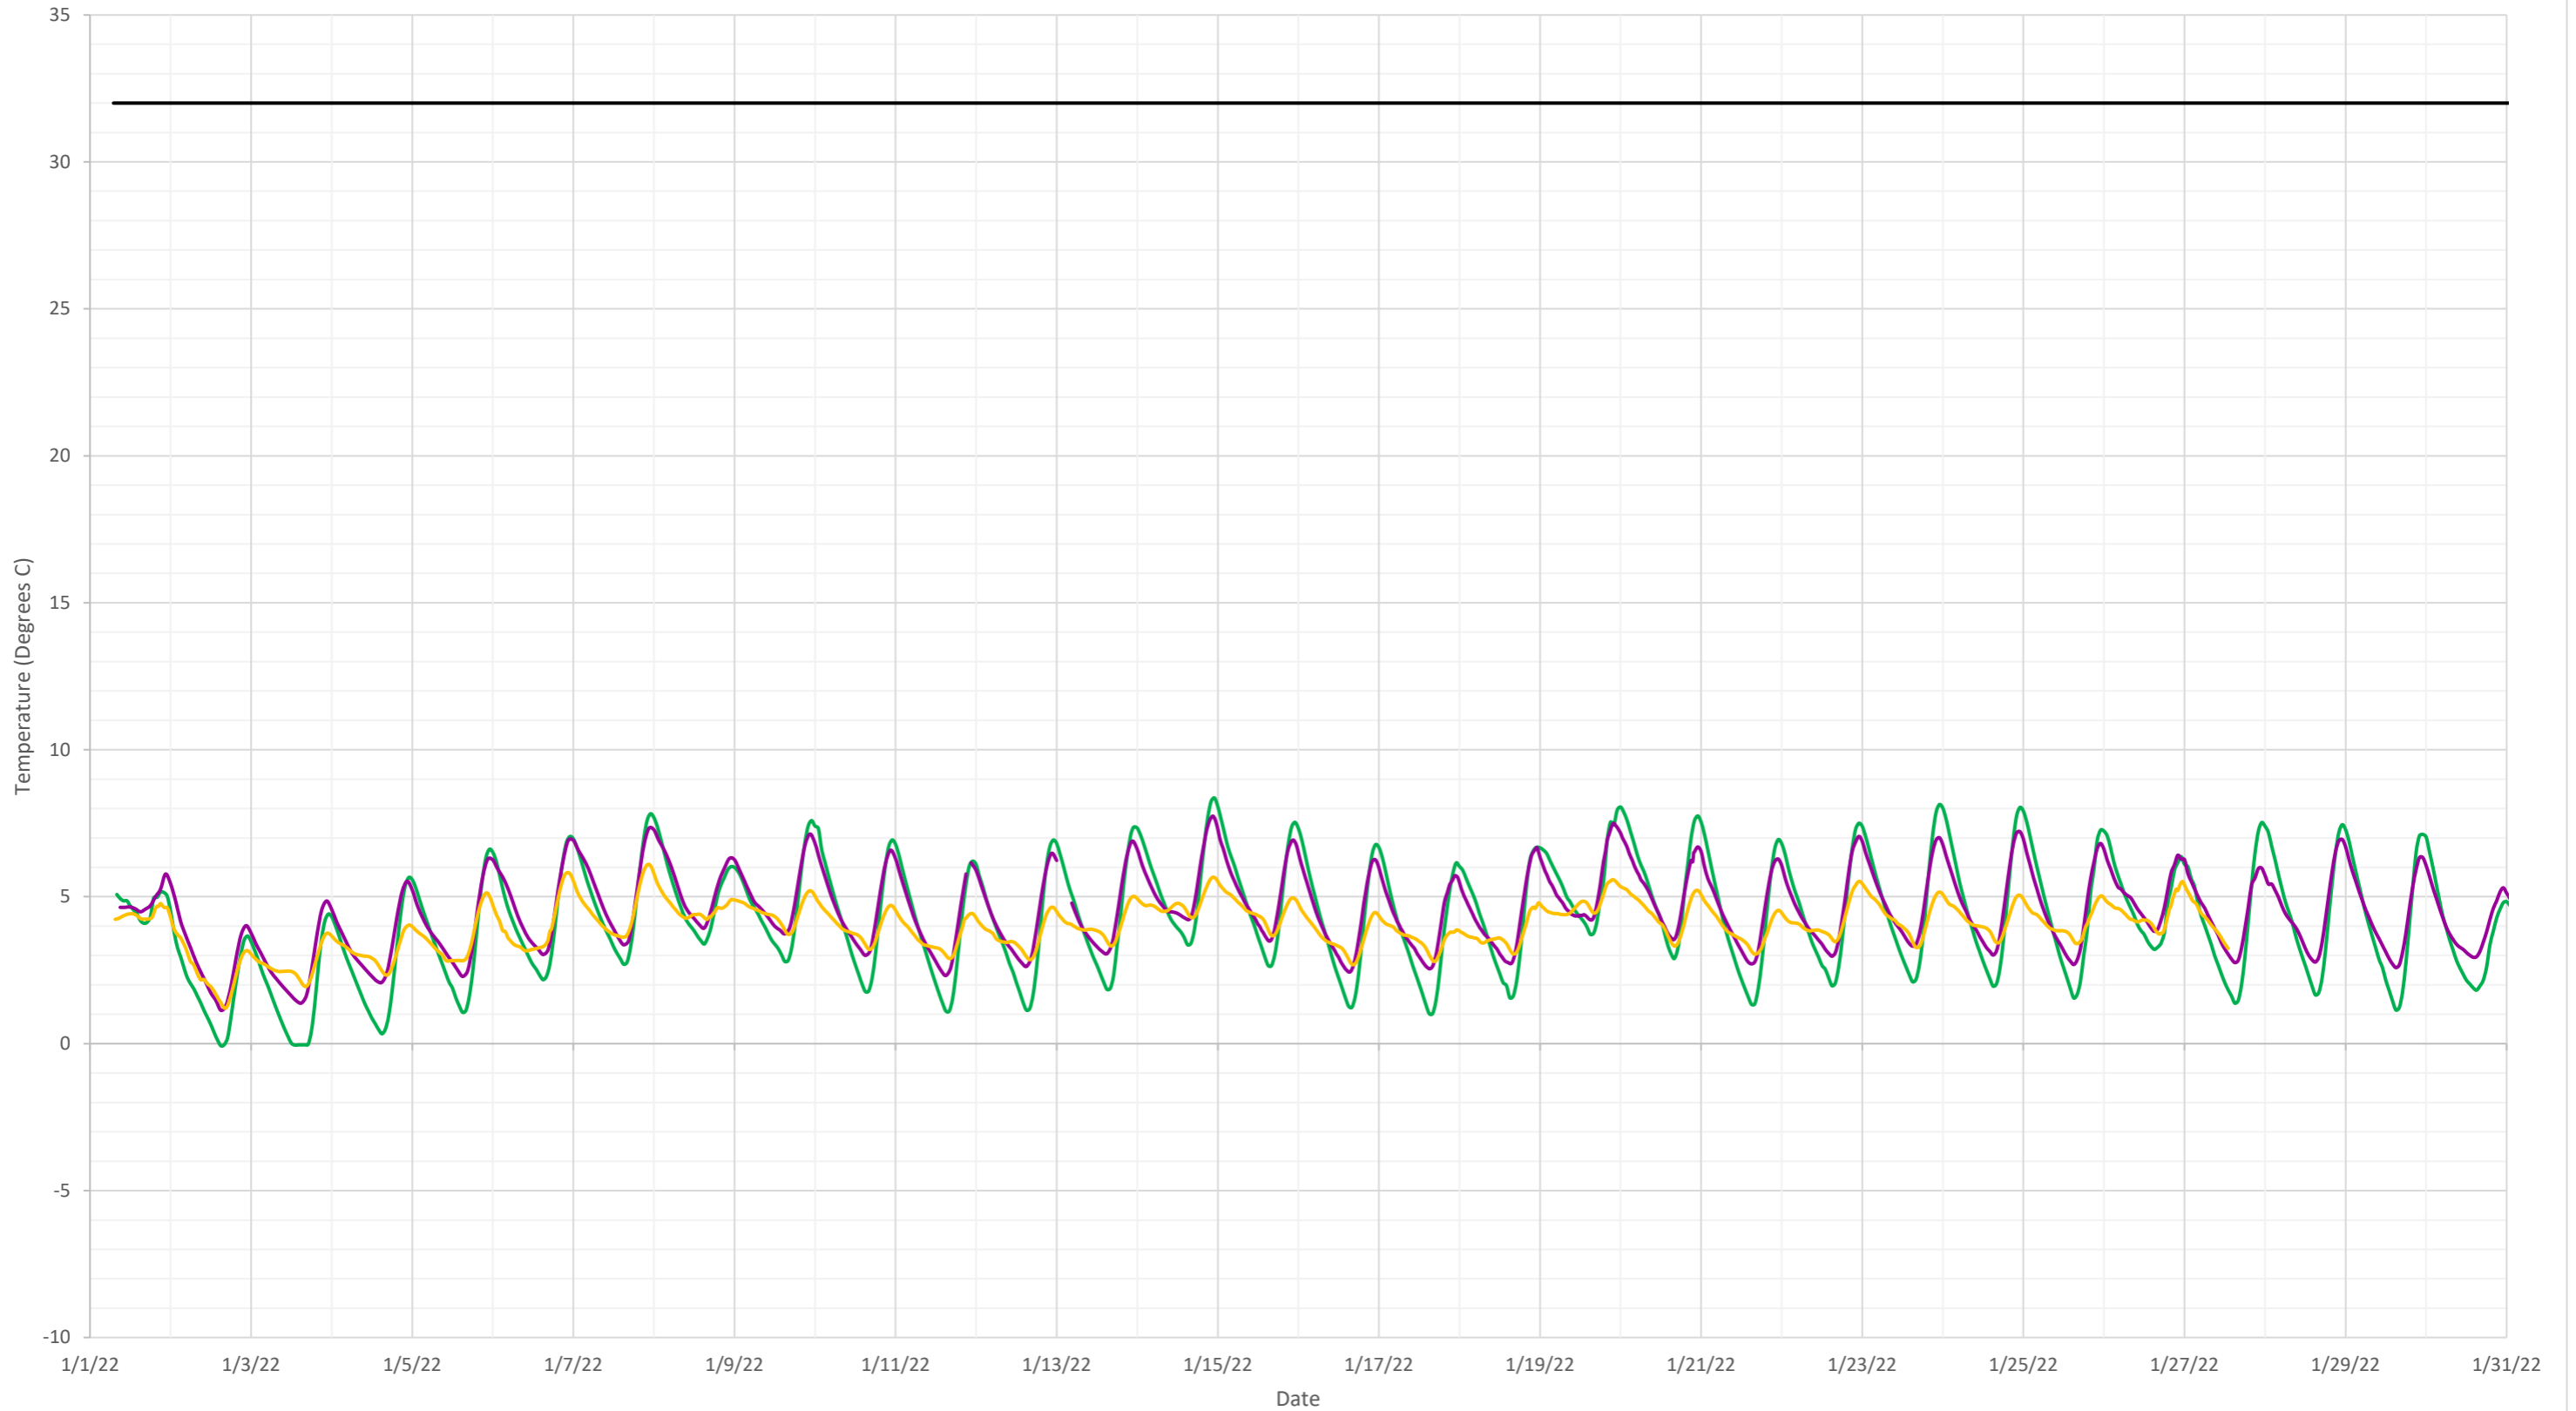
### Temperature - All Sondes - January 2021

Isleta Central Sandia 550 Temperature Exceedance (32F)
