**Re: First Quarter (January – March) 2022 In-Stream Water Quality Monitoring Memo**

## 1 Background

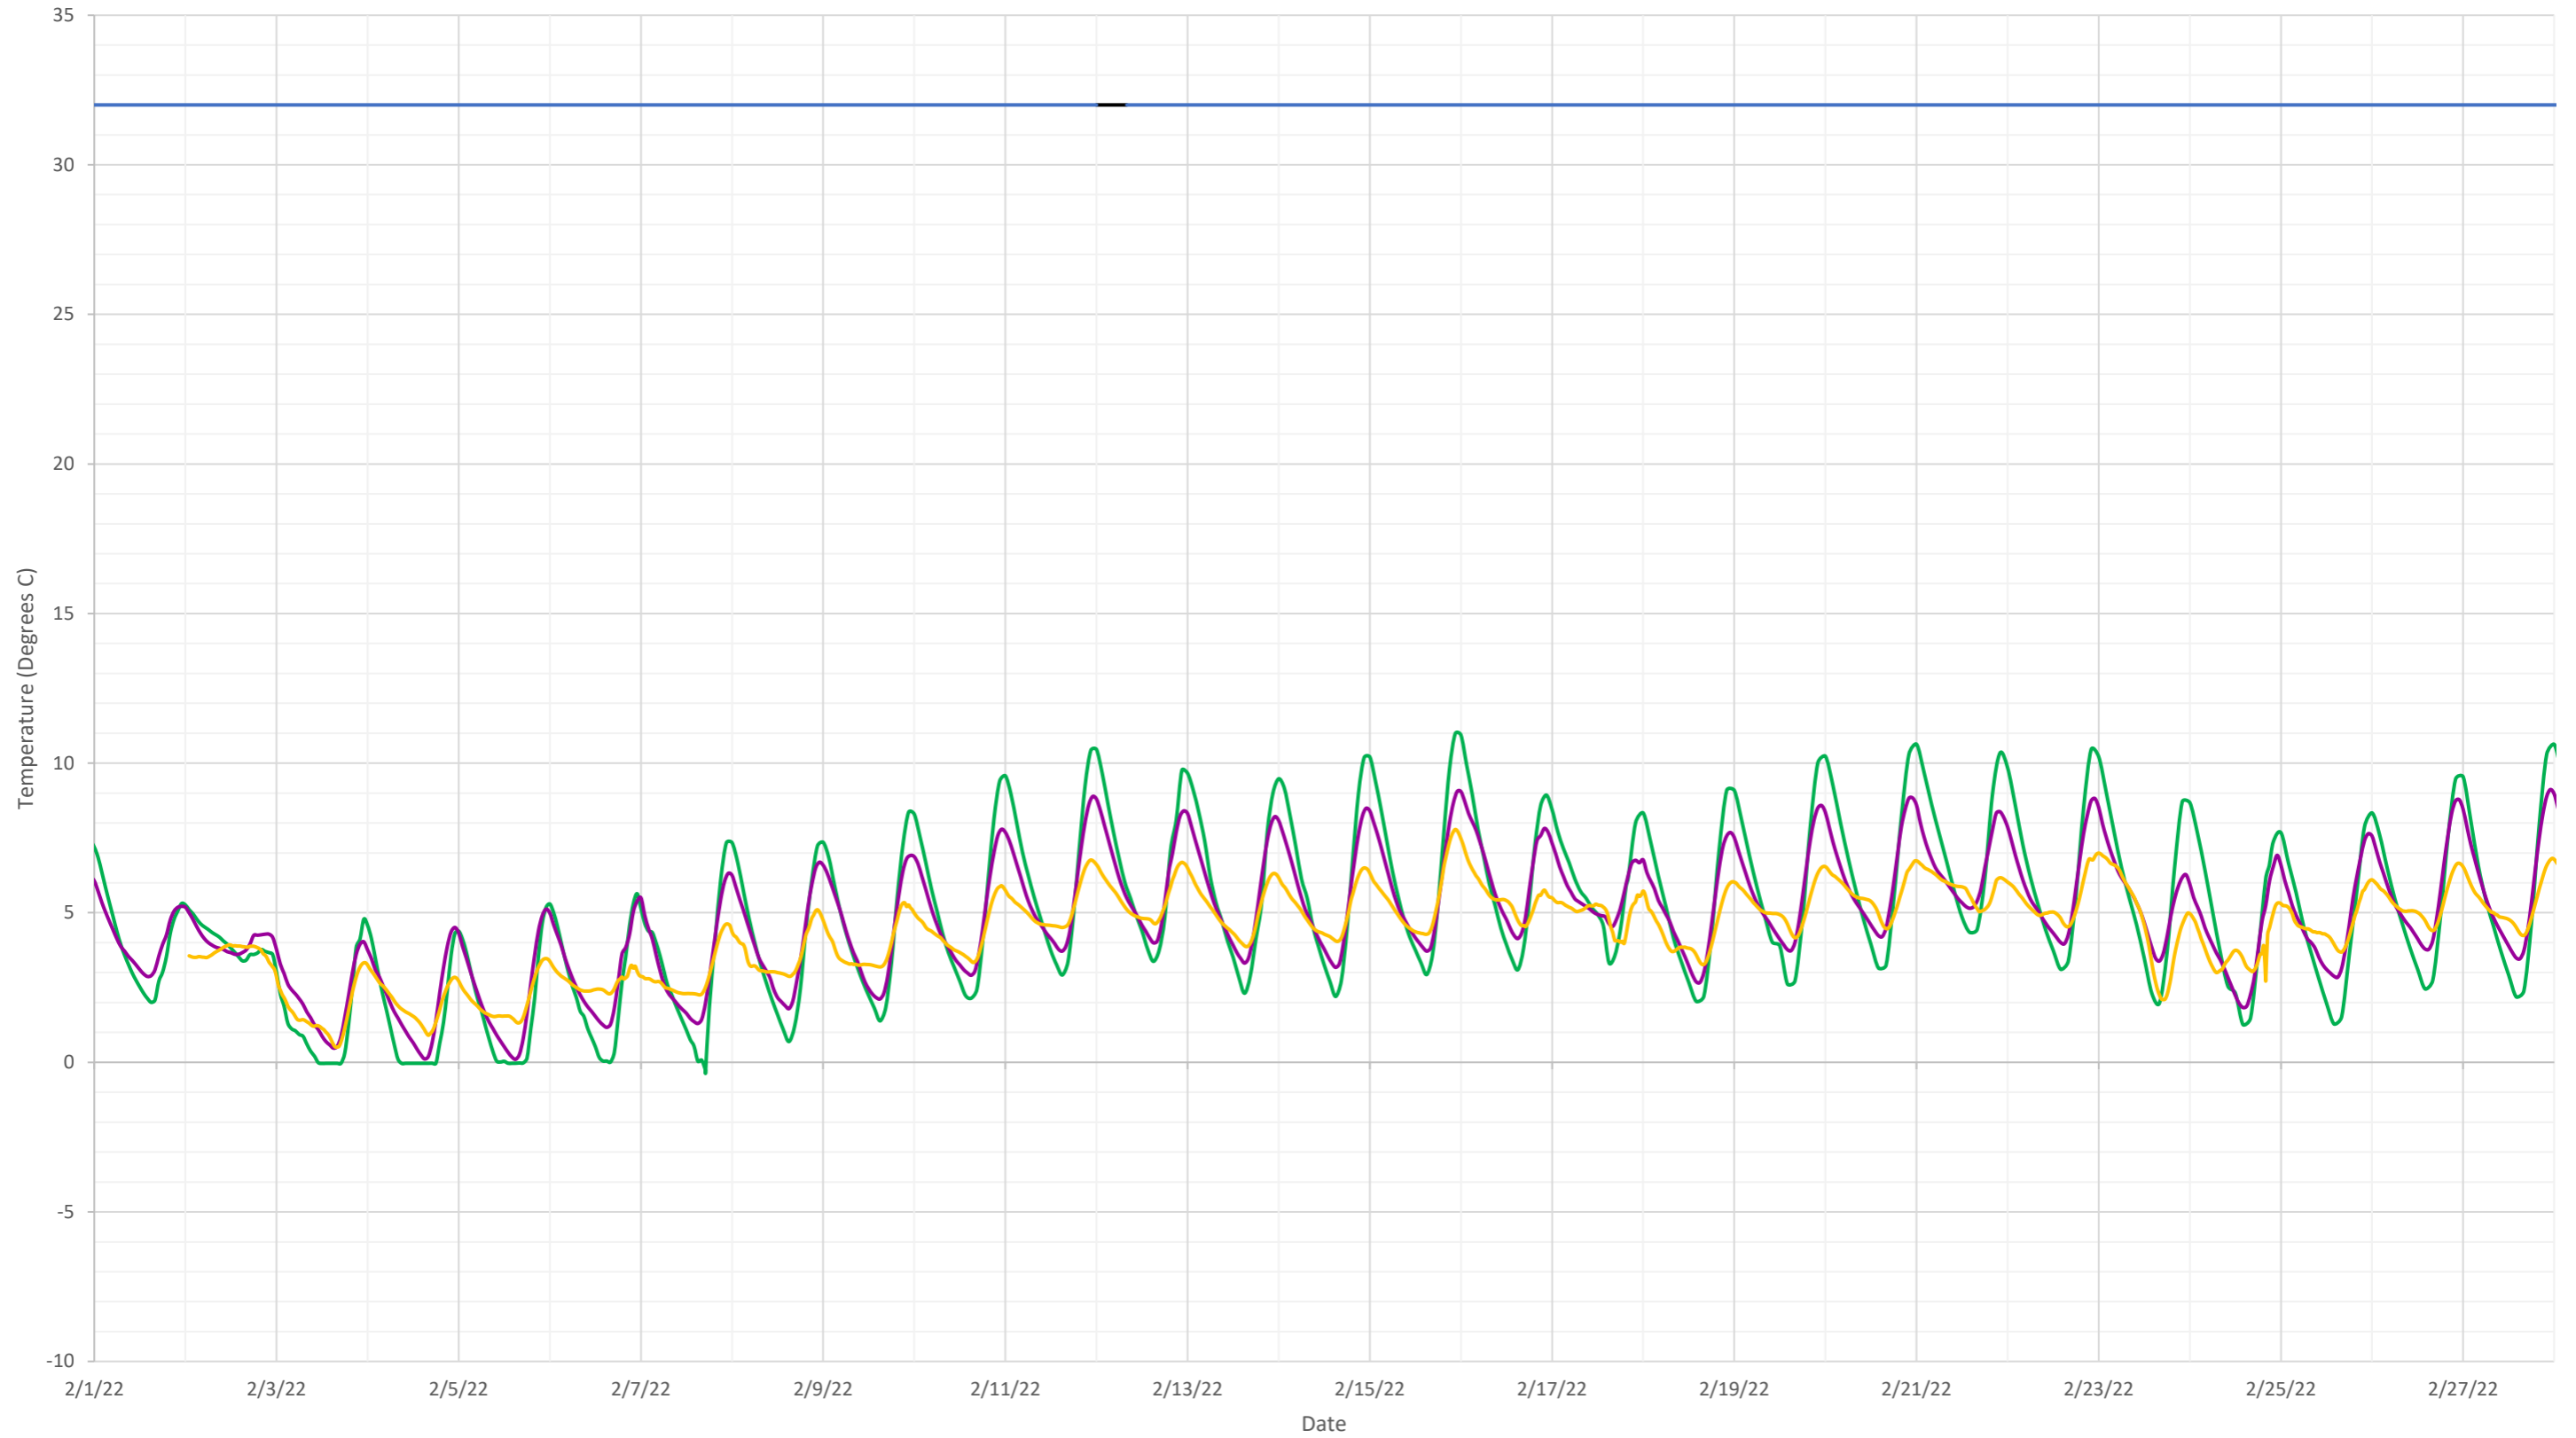
### Temperature - All Sondes - February 2021

Isleta Central Sandia 550 Temperature Exceedance (32F)

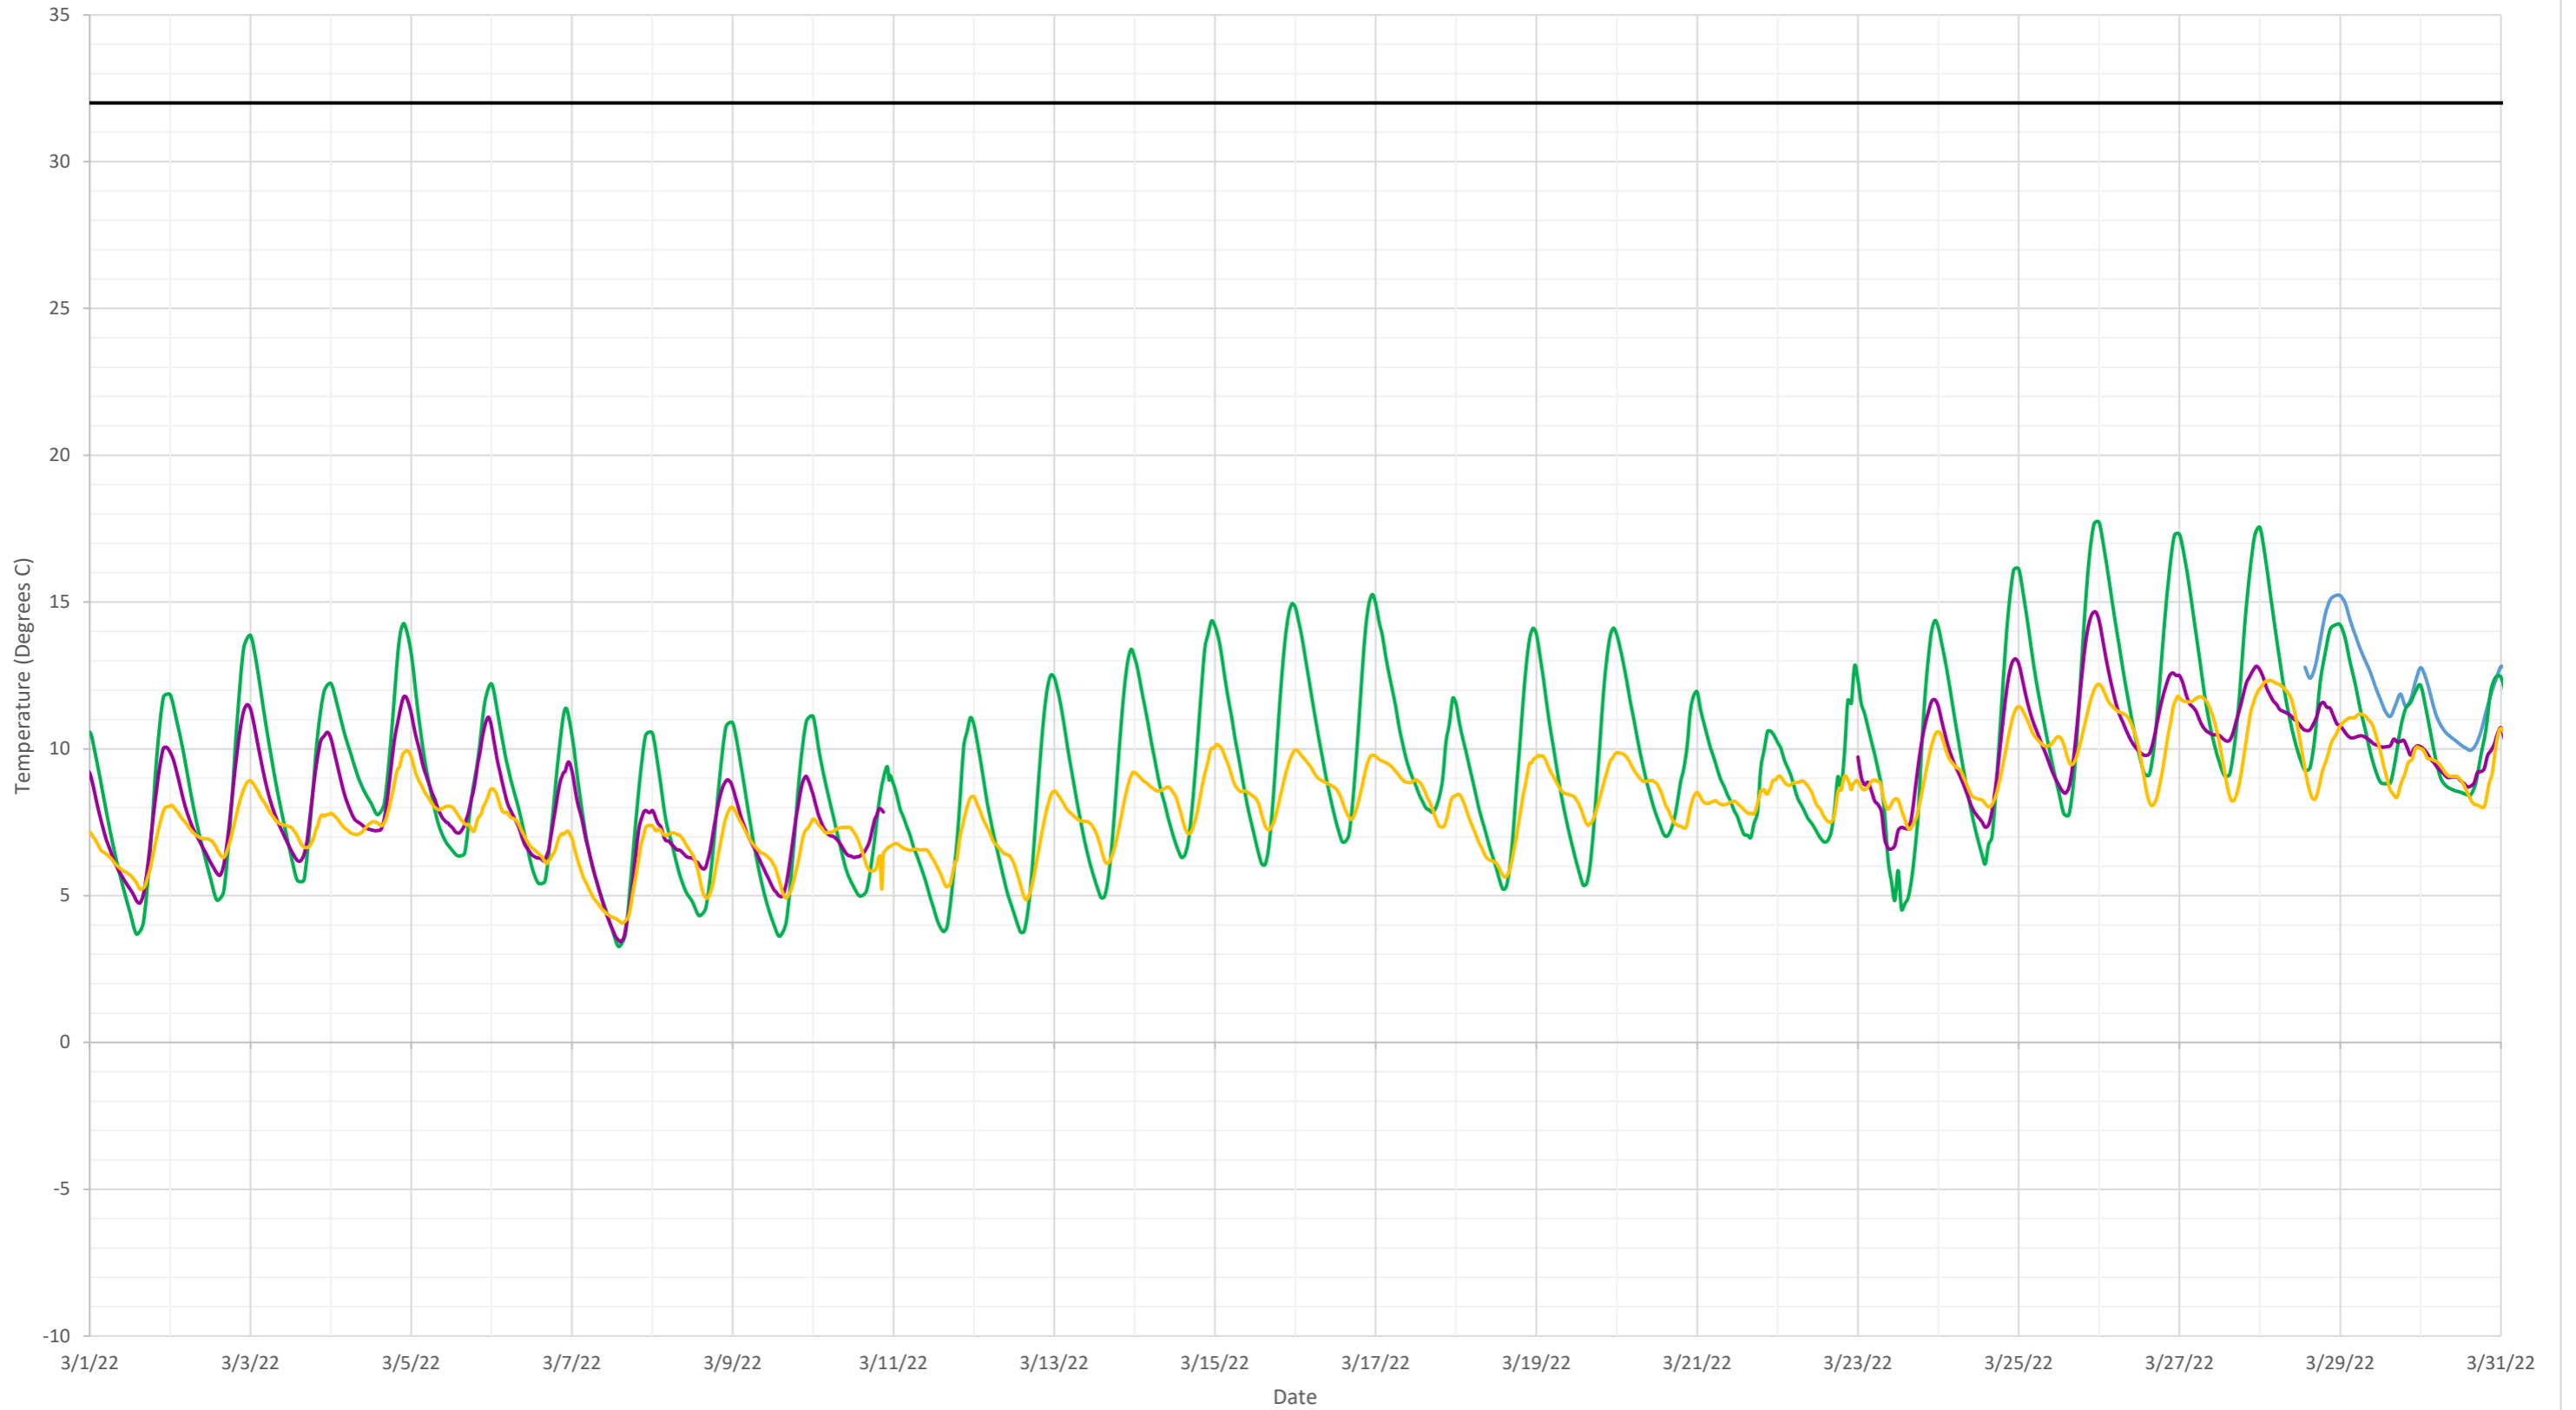
### Temperature - All Sondes - March 2021

Isleta Central Sandia 550 Temperature Exceedance (32F)

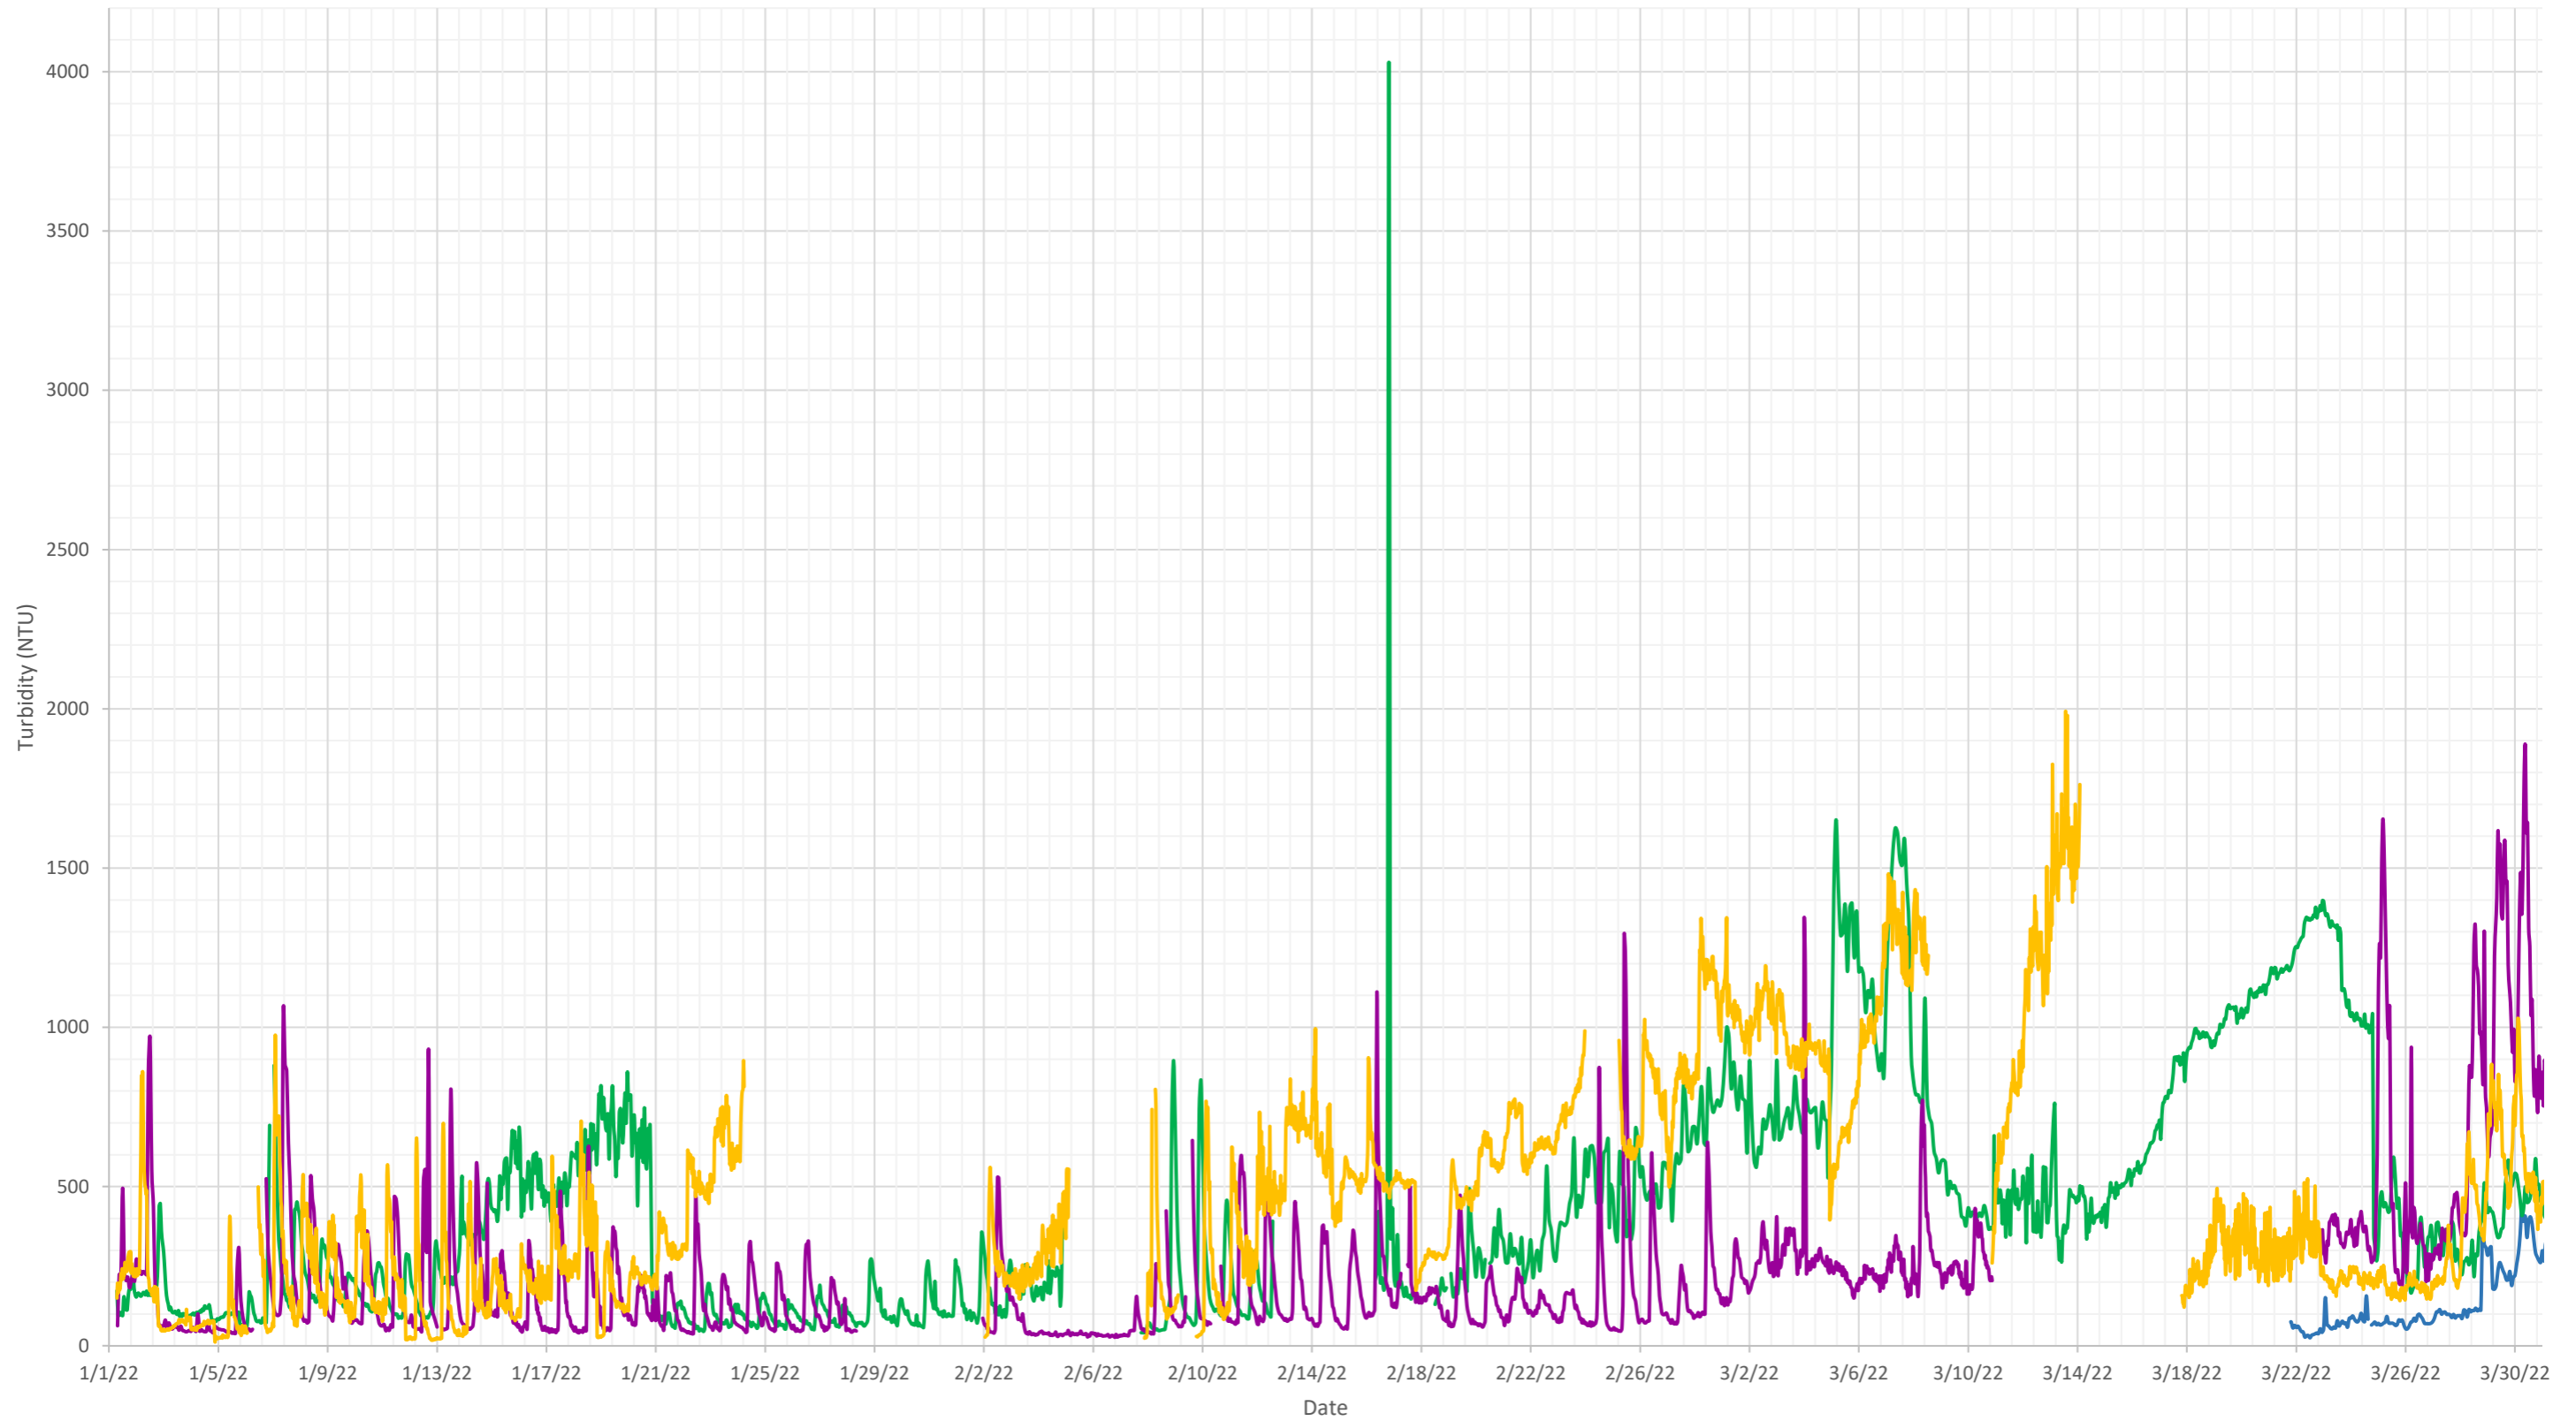
Turbidity - All Sondes - Quarter 1, 2021

Isleta Central Sandia 550

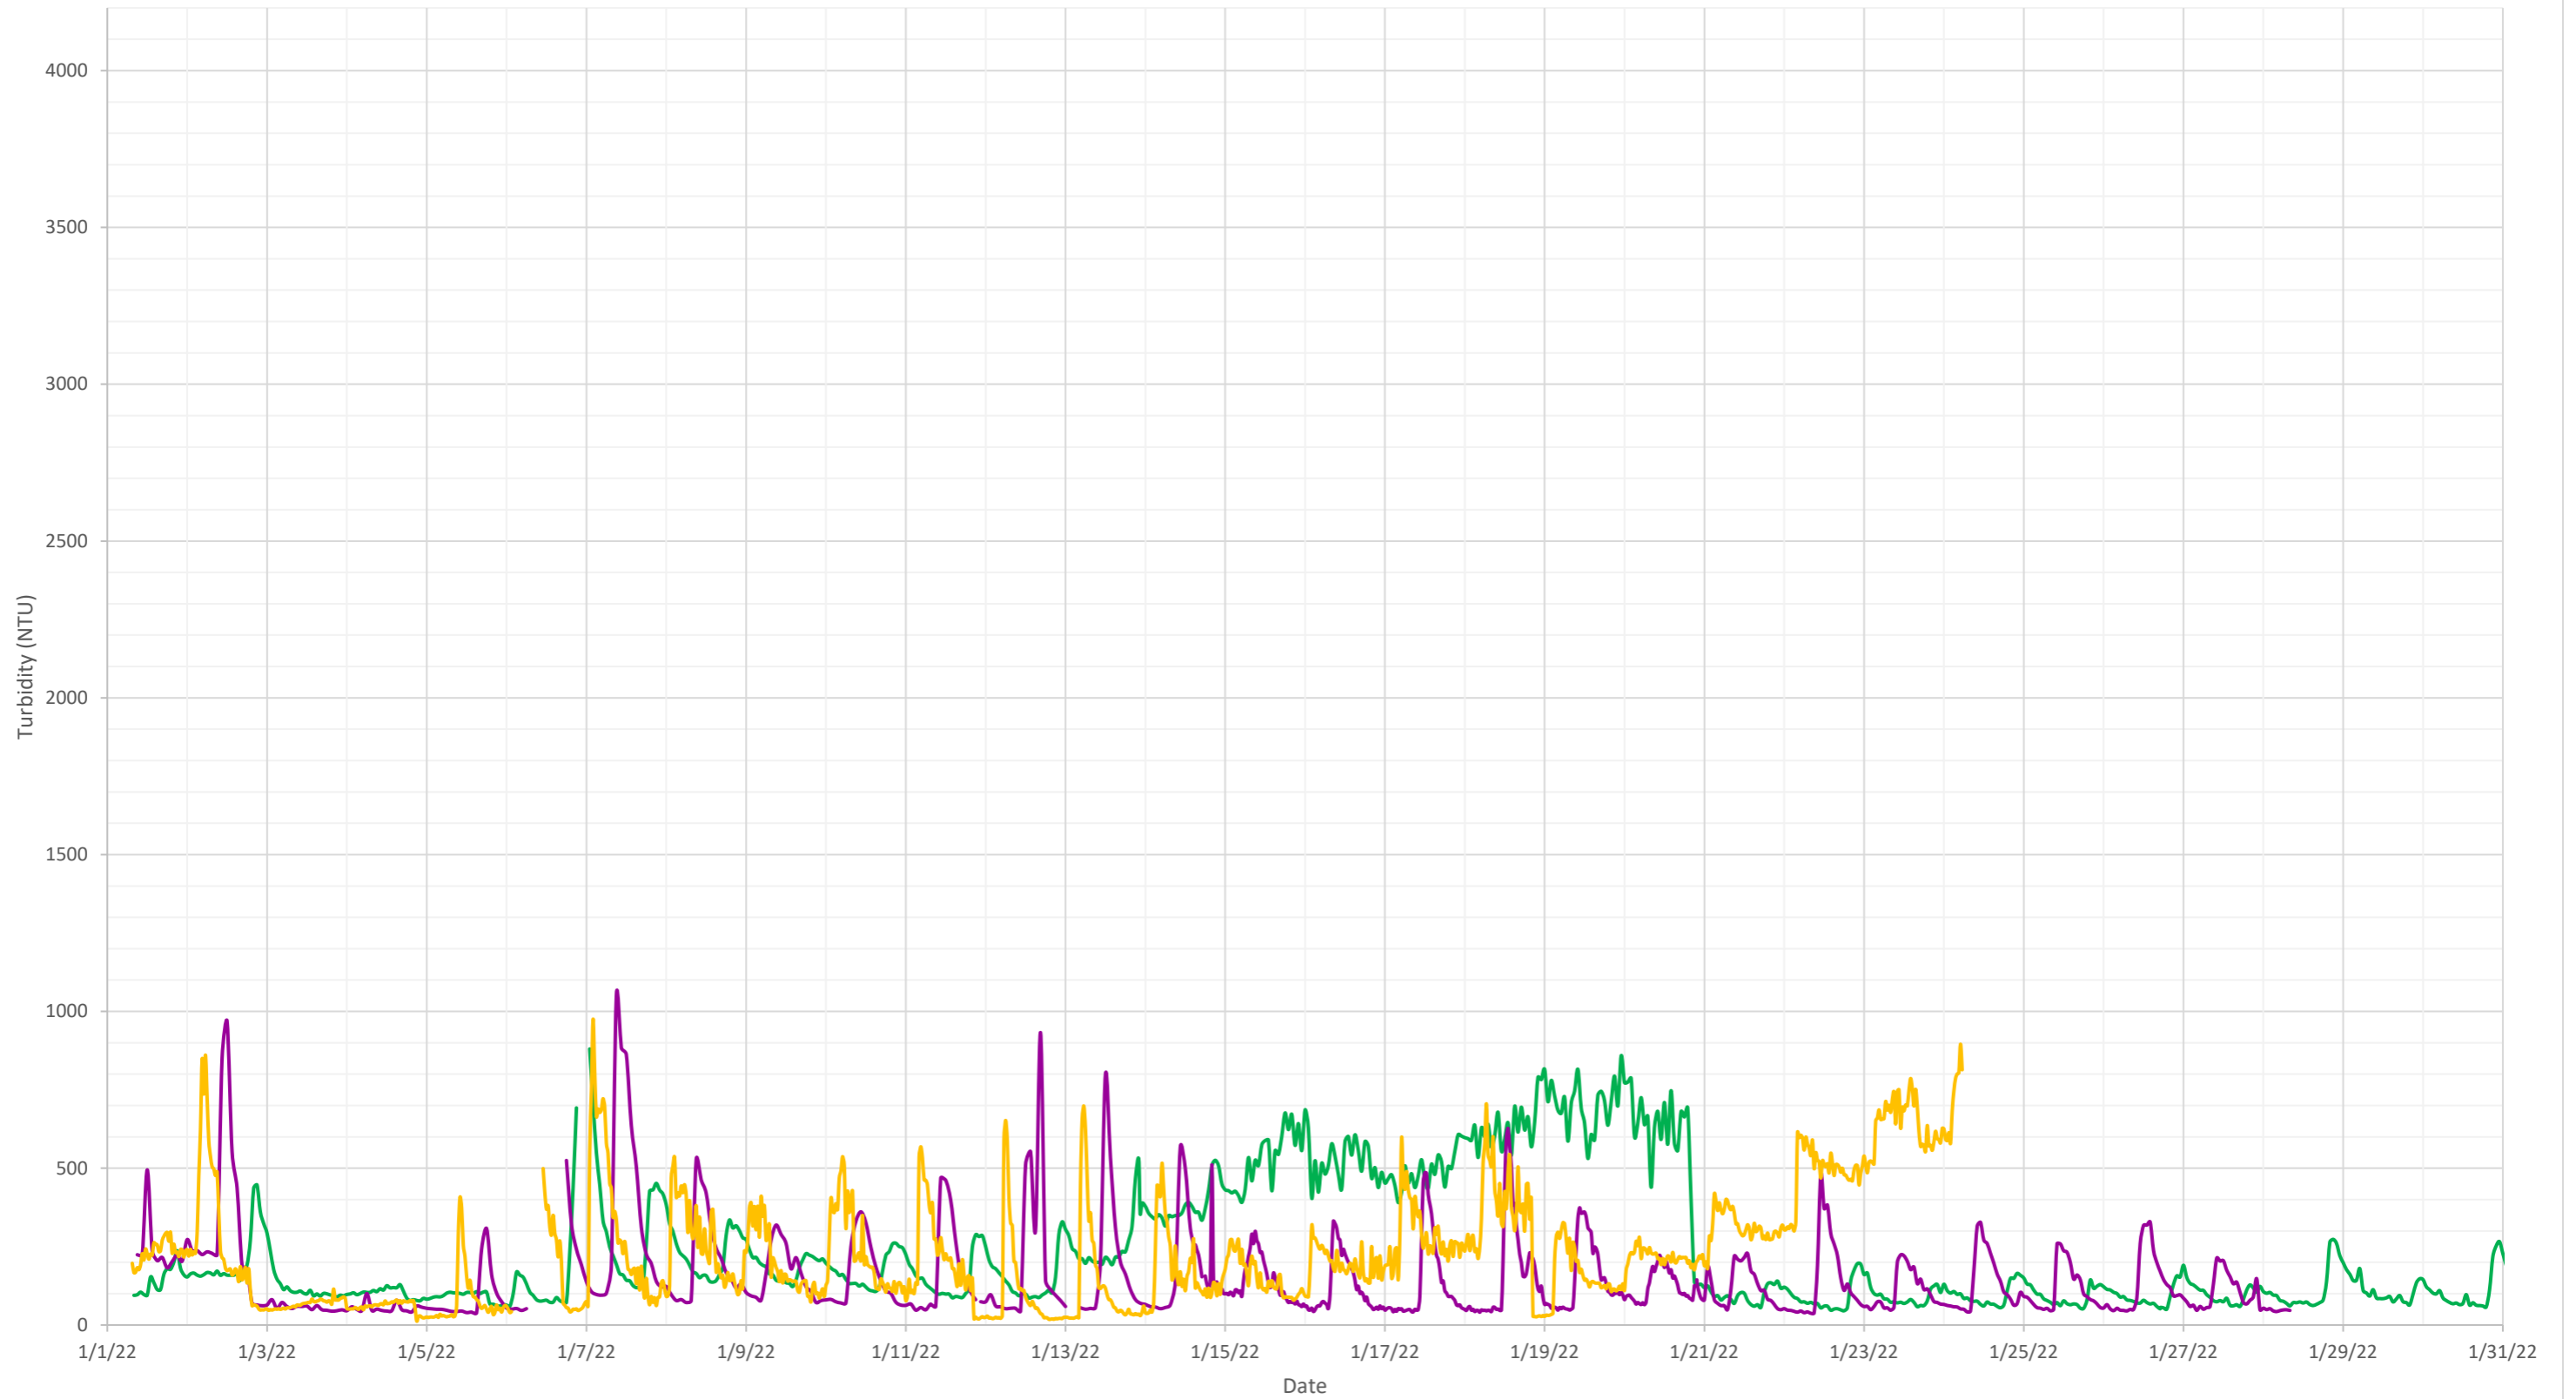
Turbidity - All Sondes - January 2021

Isleta Central Sandia 550

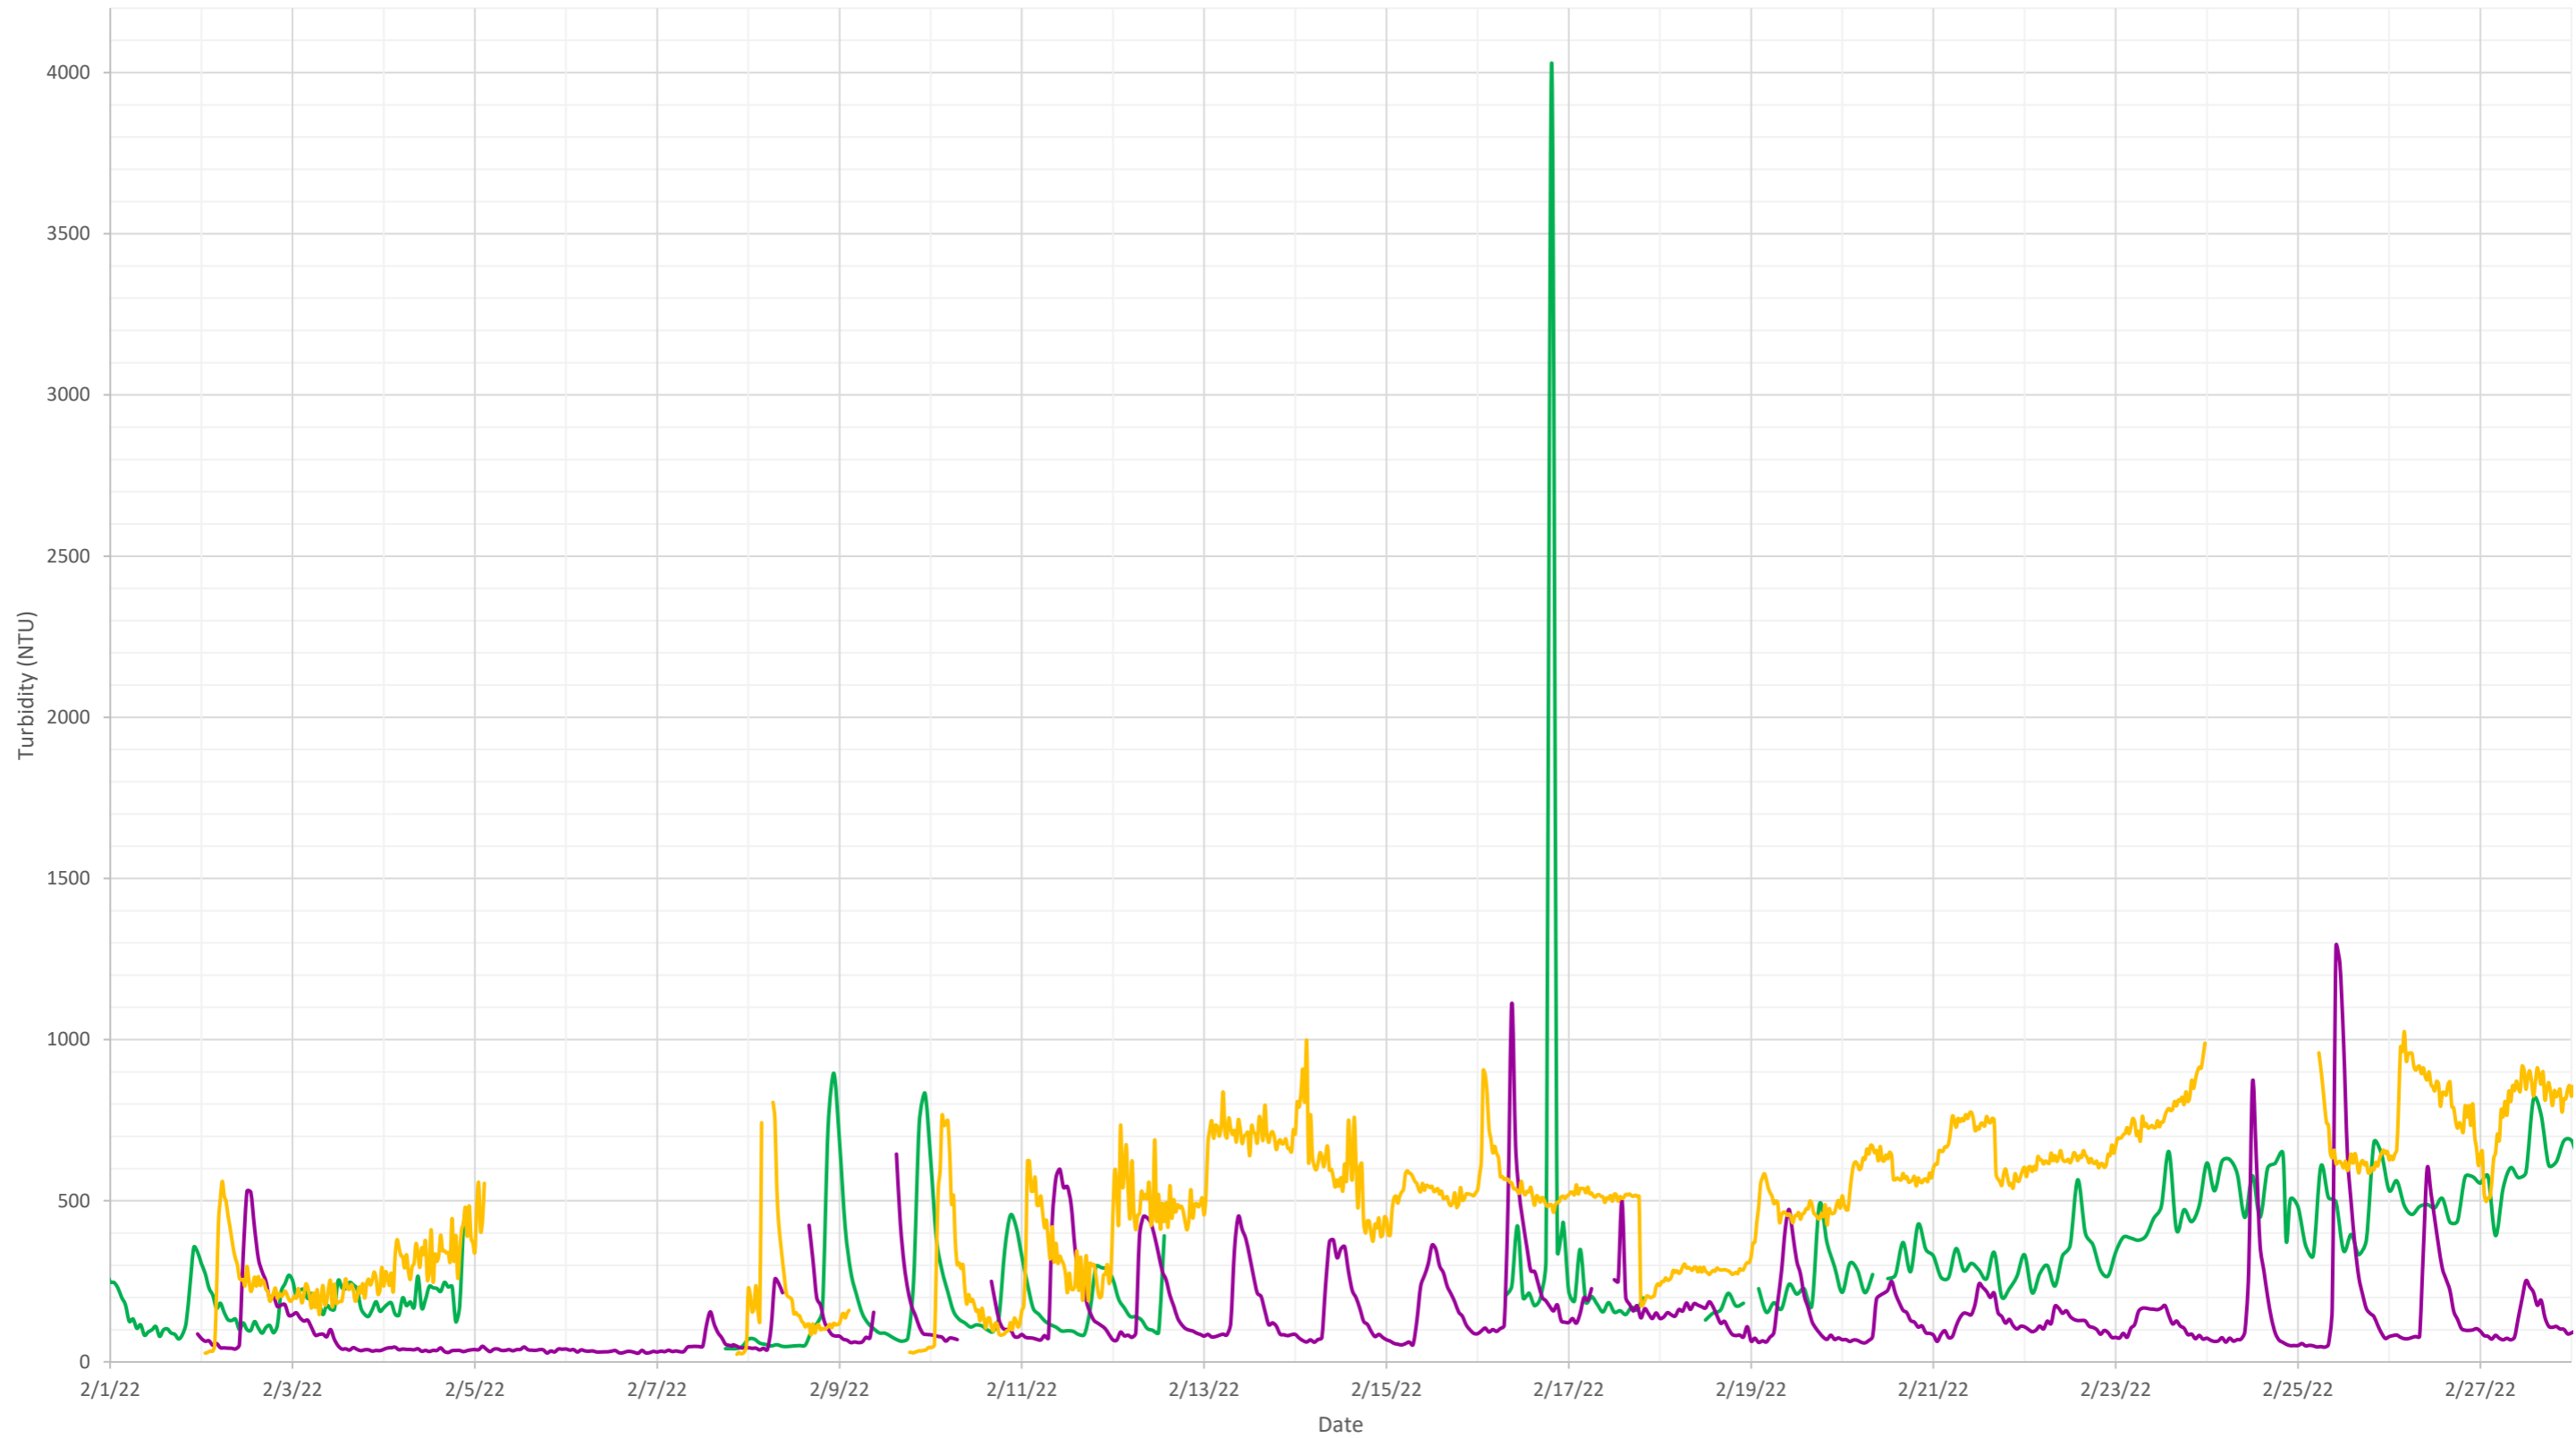
Turbidity - All Sondes - February 2021

Isleta Central Sandia 550

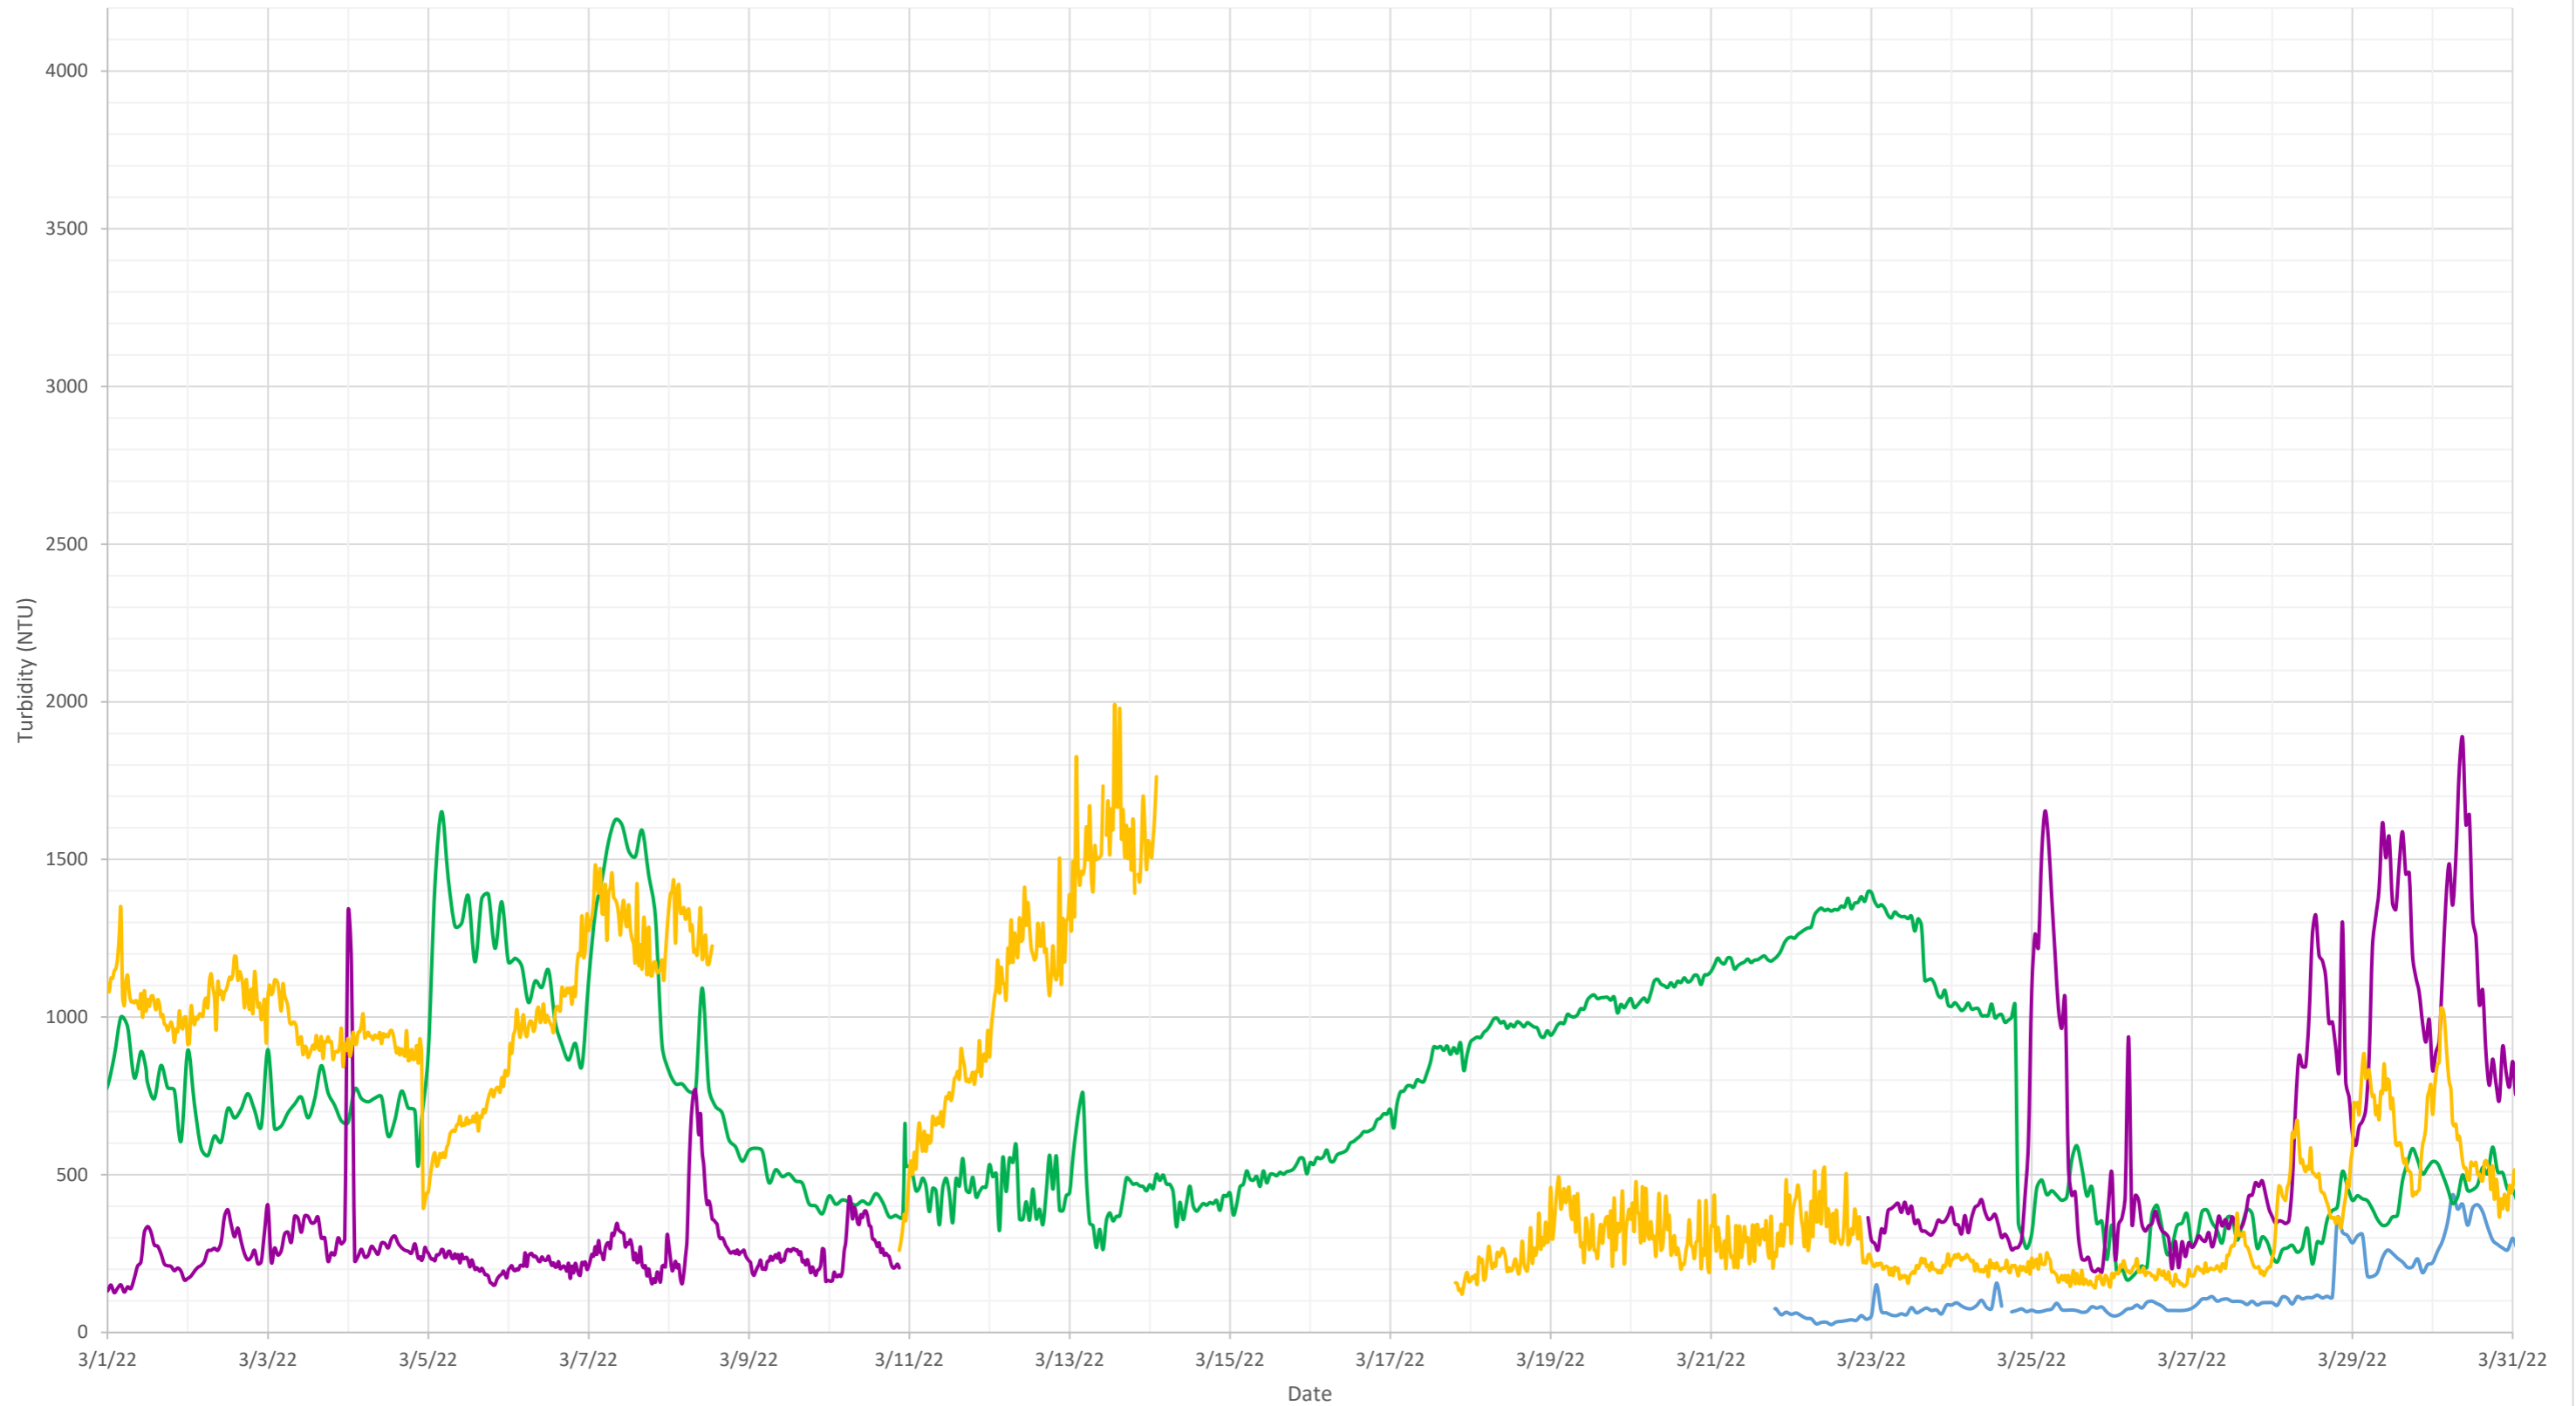
Turbidity - All Sondes -March 2021

Isleta Central Sandia 550
