Weston Solutions, Inc.
3840 Commons Ave., NE
Albuquerque, New Mexico 87109
505-883-6520 Fax 505-837-6595
www.westonsolutions.com

Re: Second Quarter (April – June) 2022 In-Stream Water Quality Monitoring Memo

1 Background

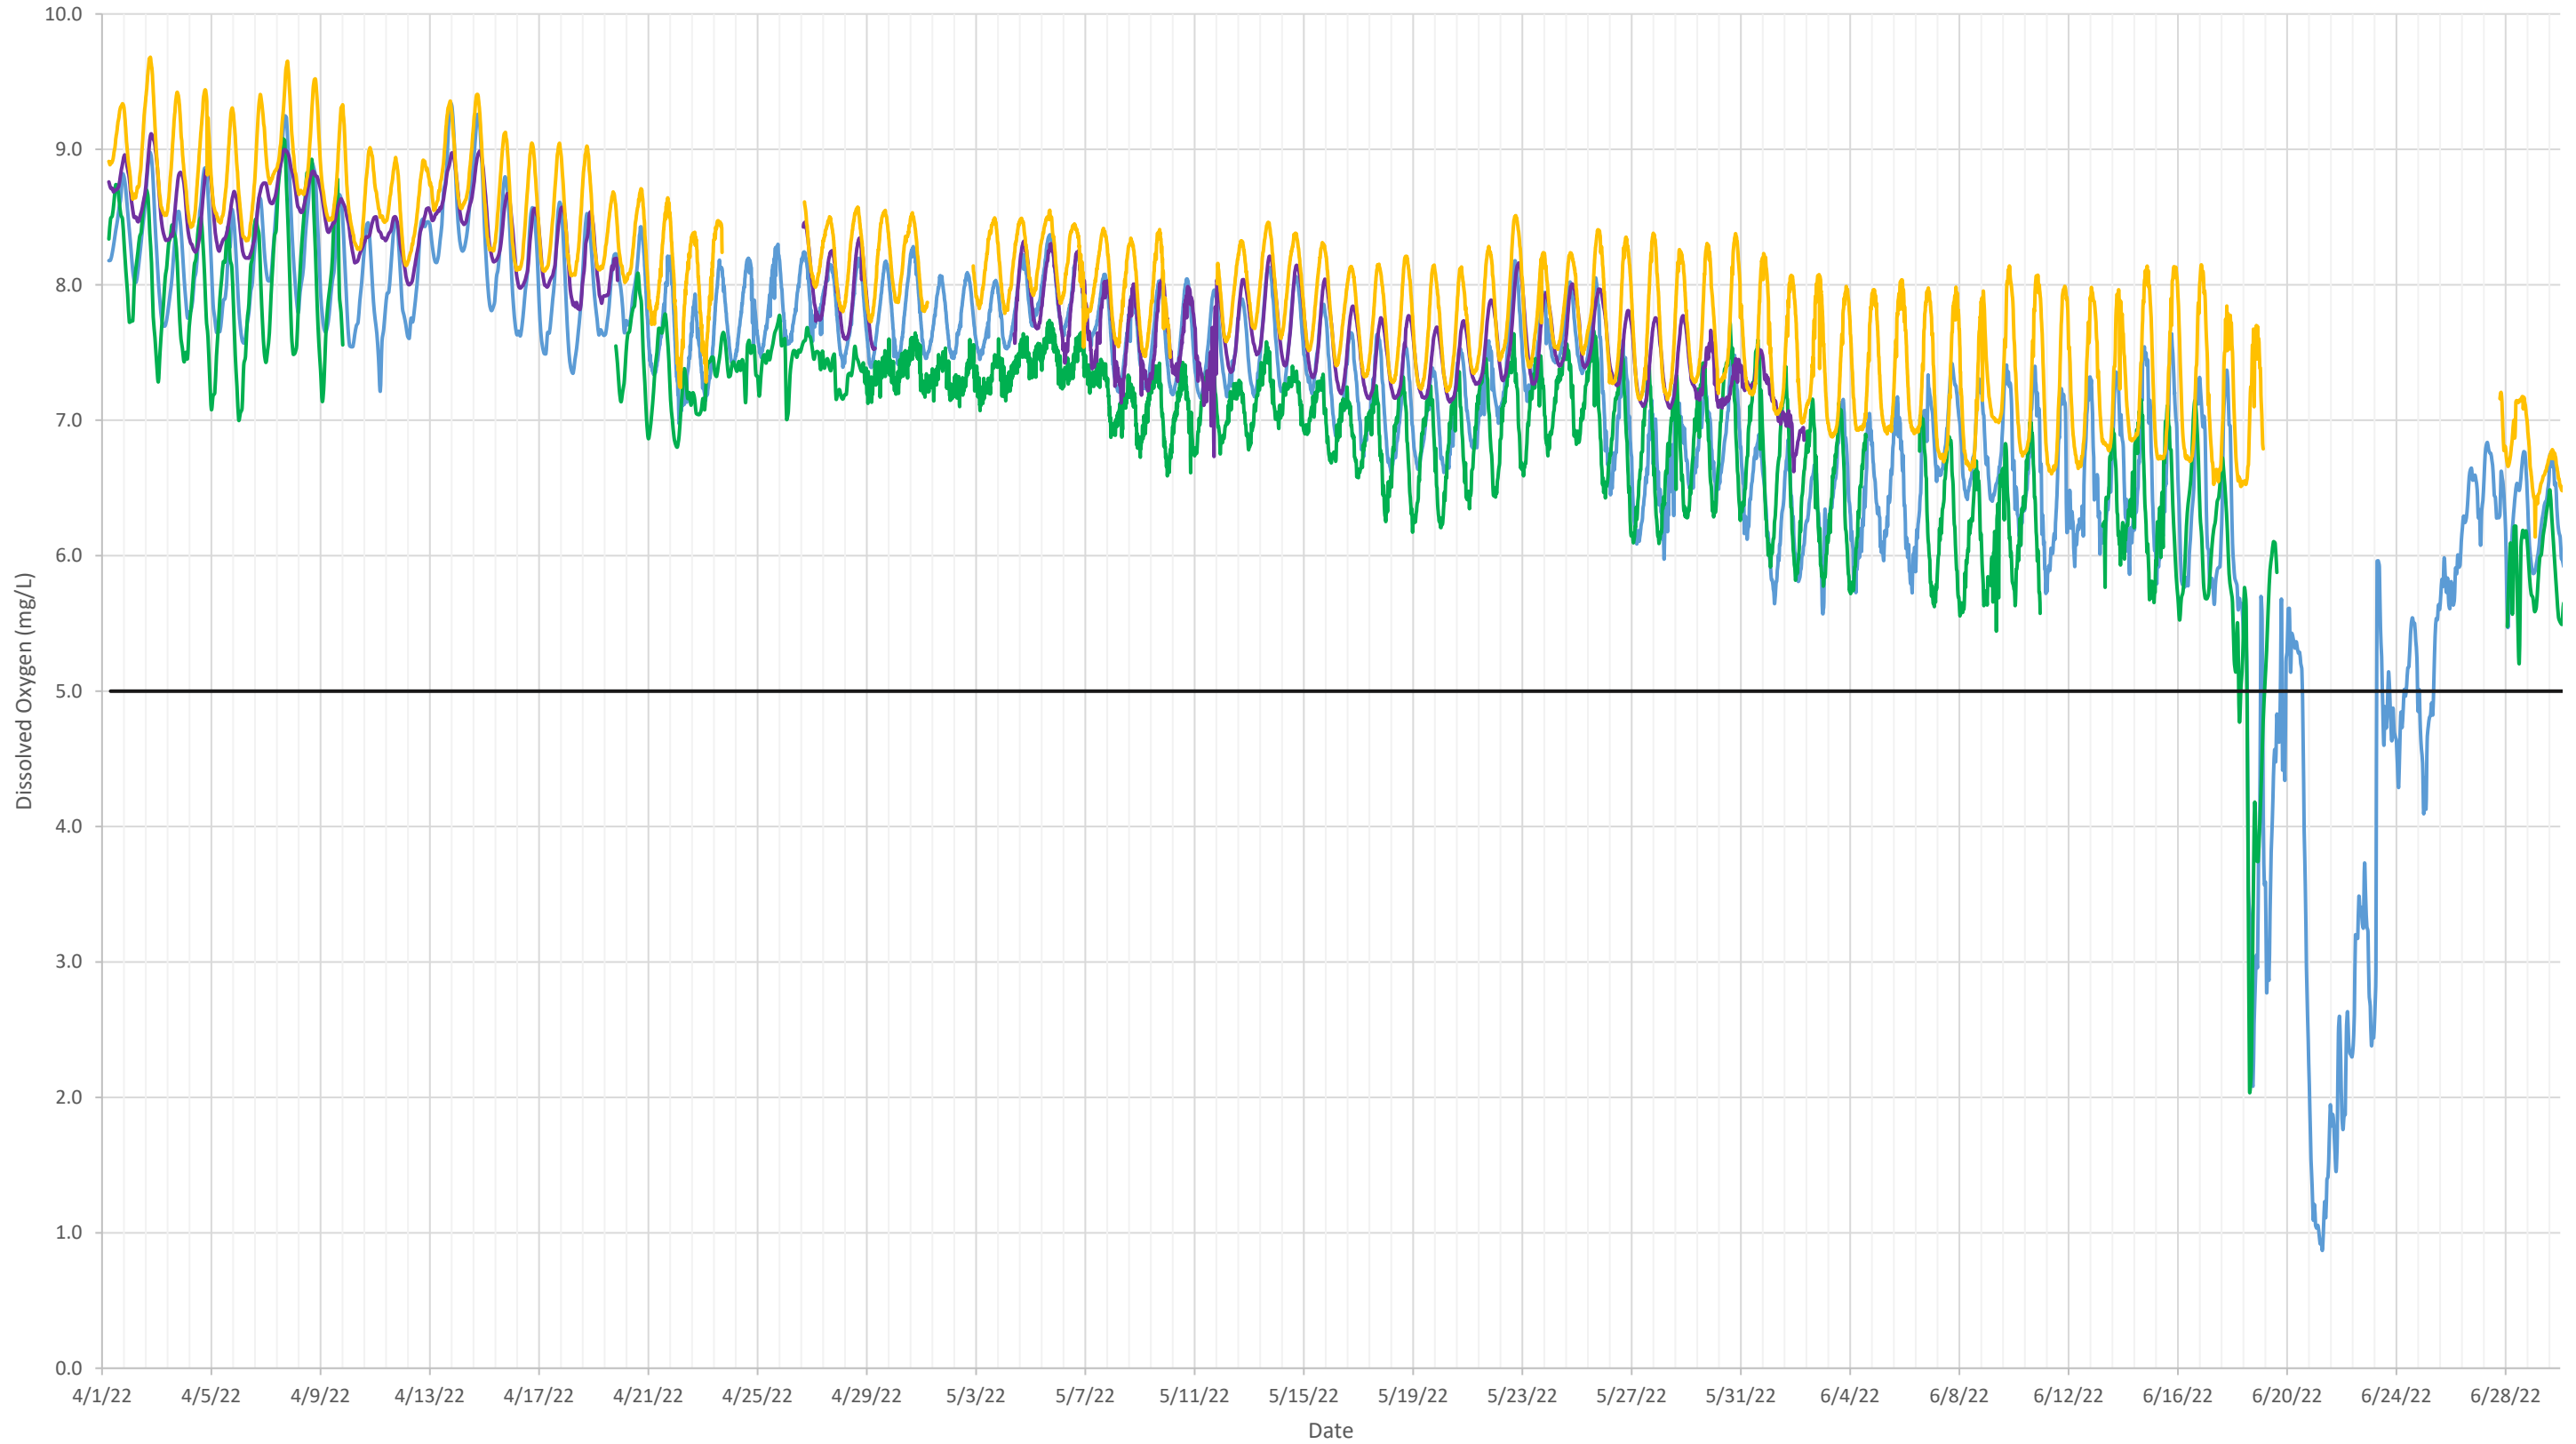
Dissolved Oxygen - All Sondes - Quarter 2, 2022

Isleta Central Sandia 550 DO Exceedance (5 mg/L)

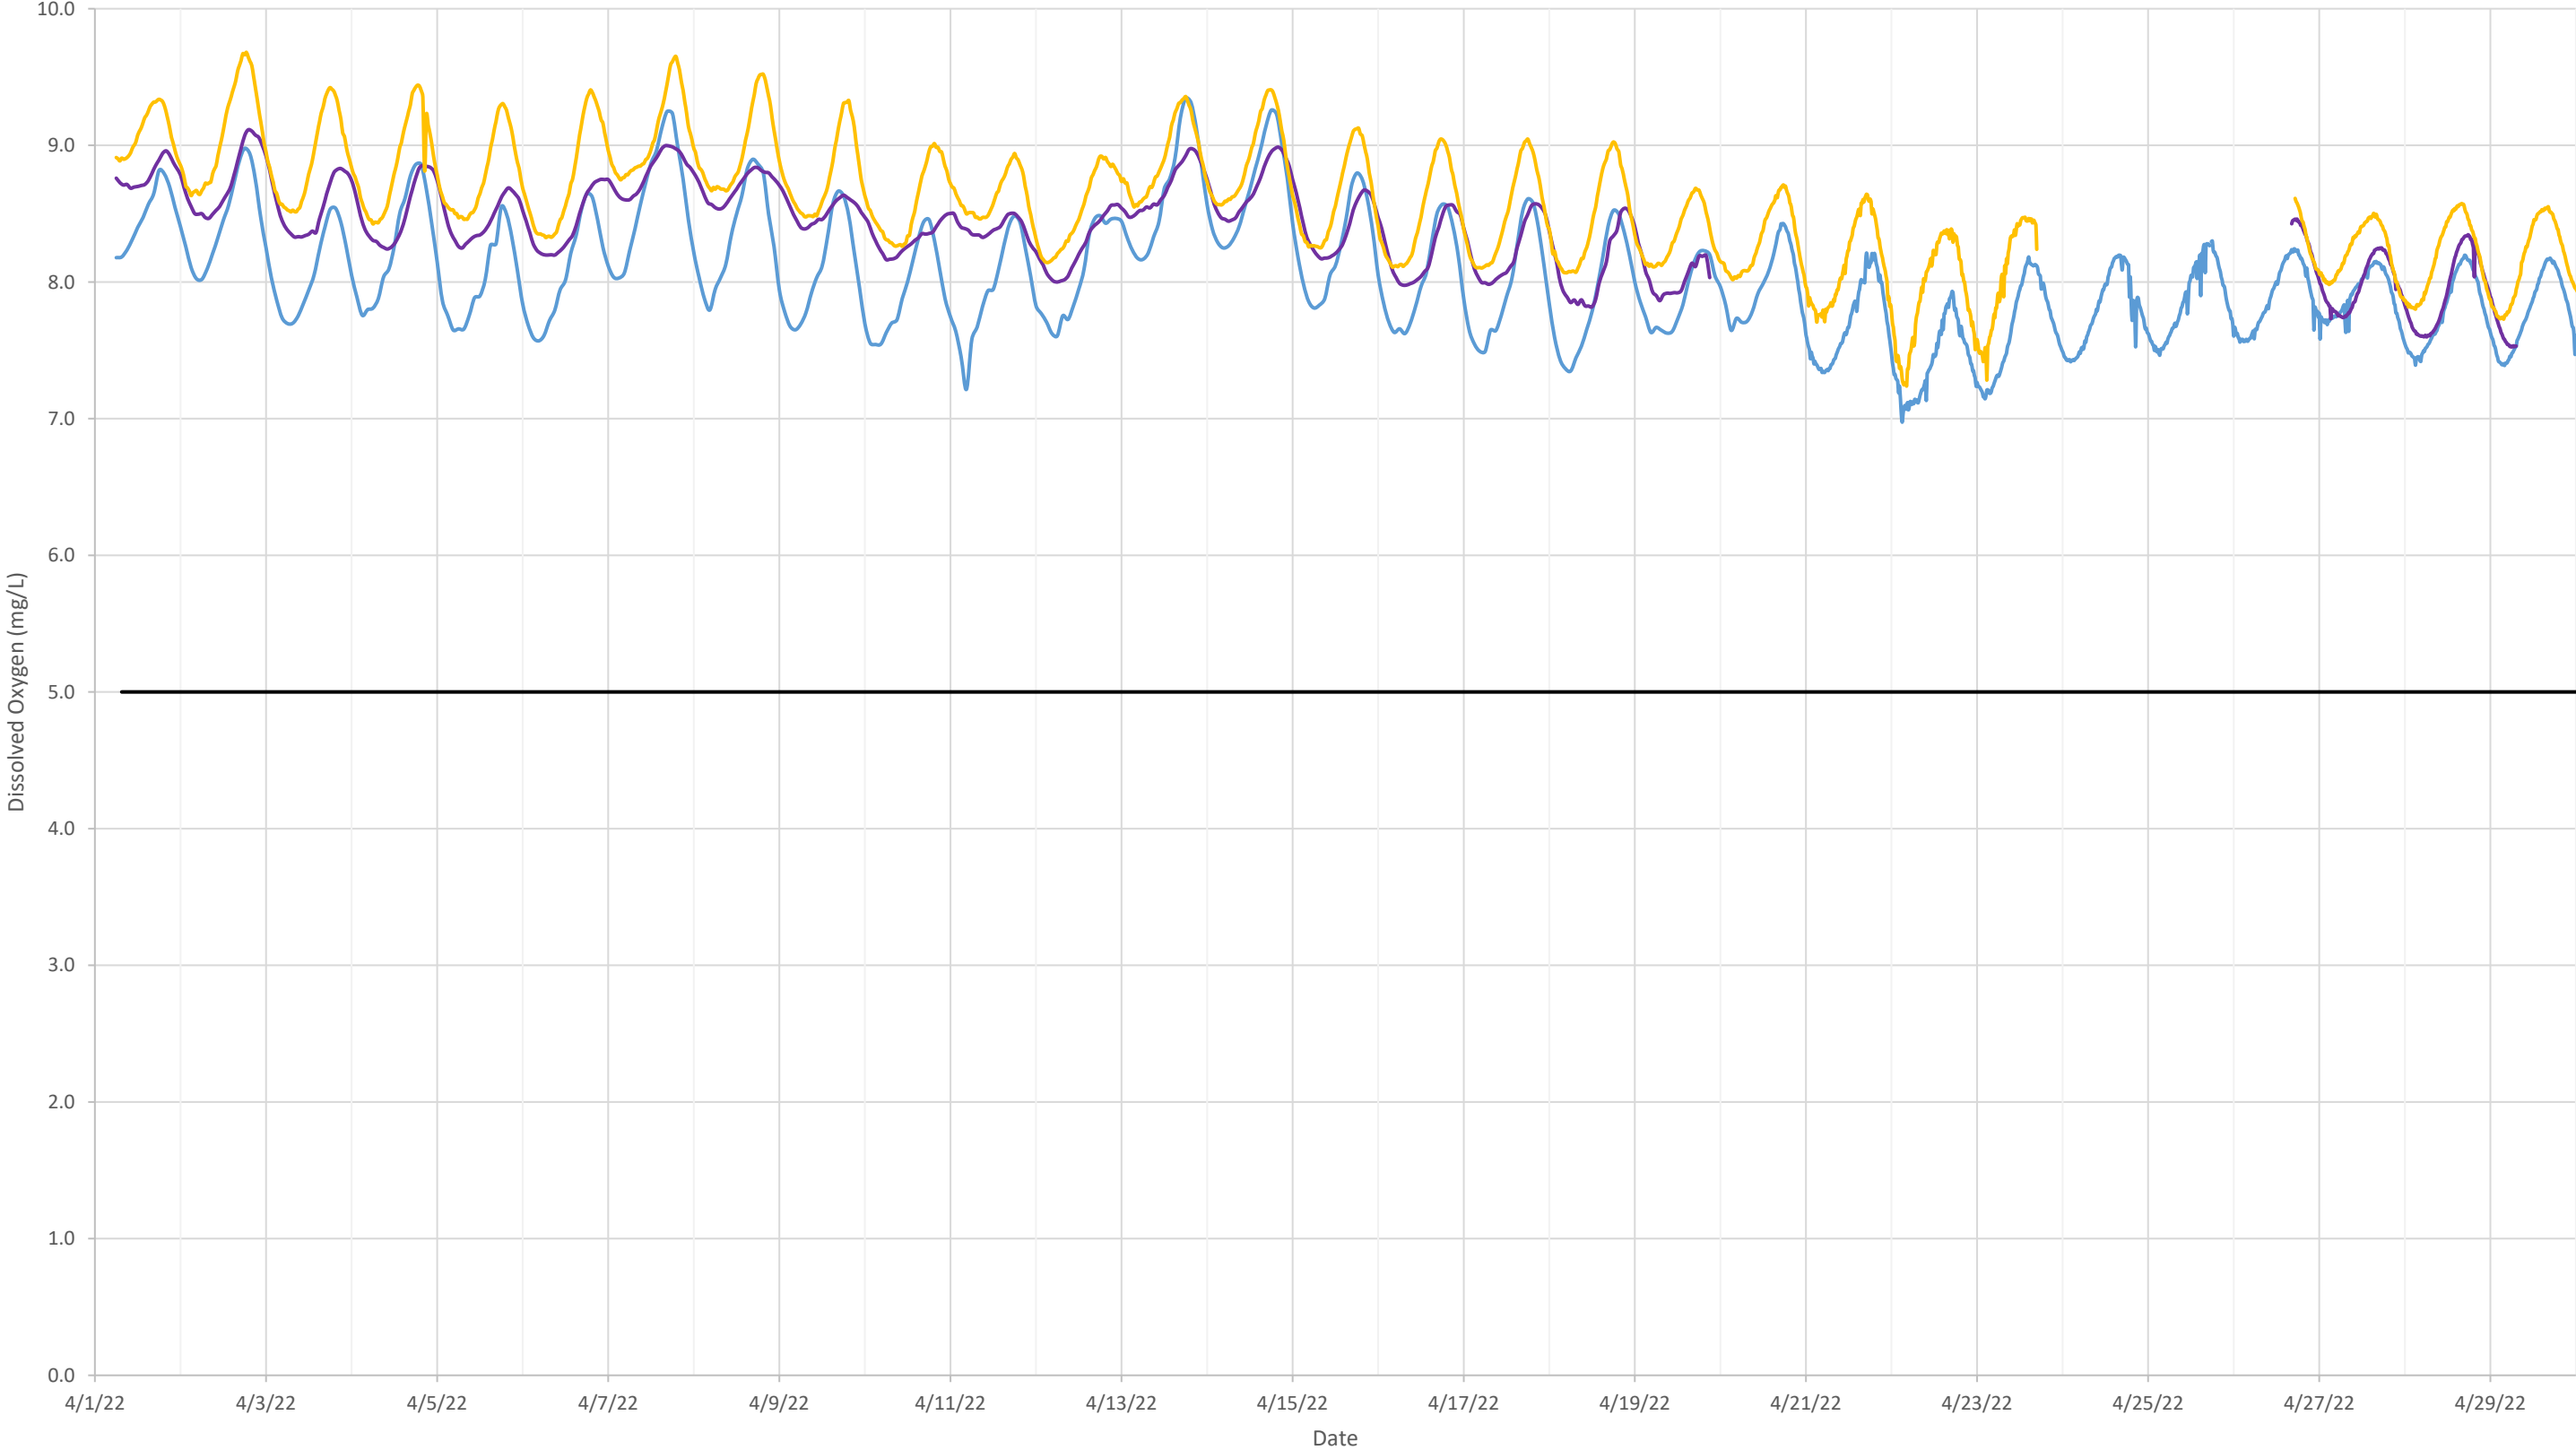
Dissolved Oxygen - All Sondes - April 2022

Isleta Central Sandia 550 DO Exceedance (5 mg/L)

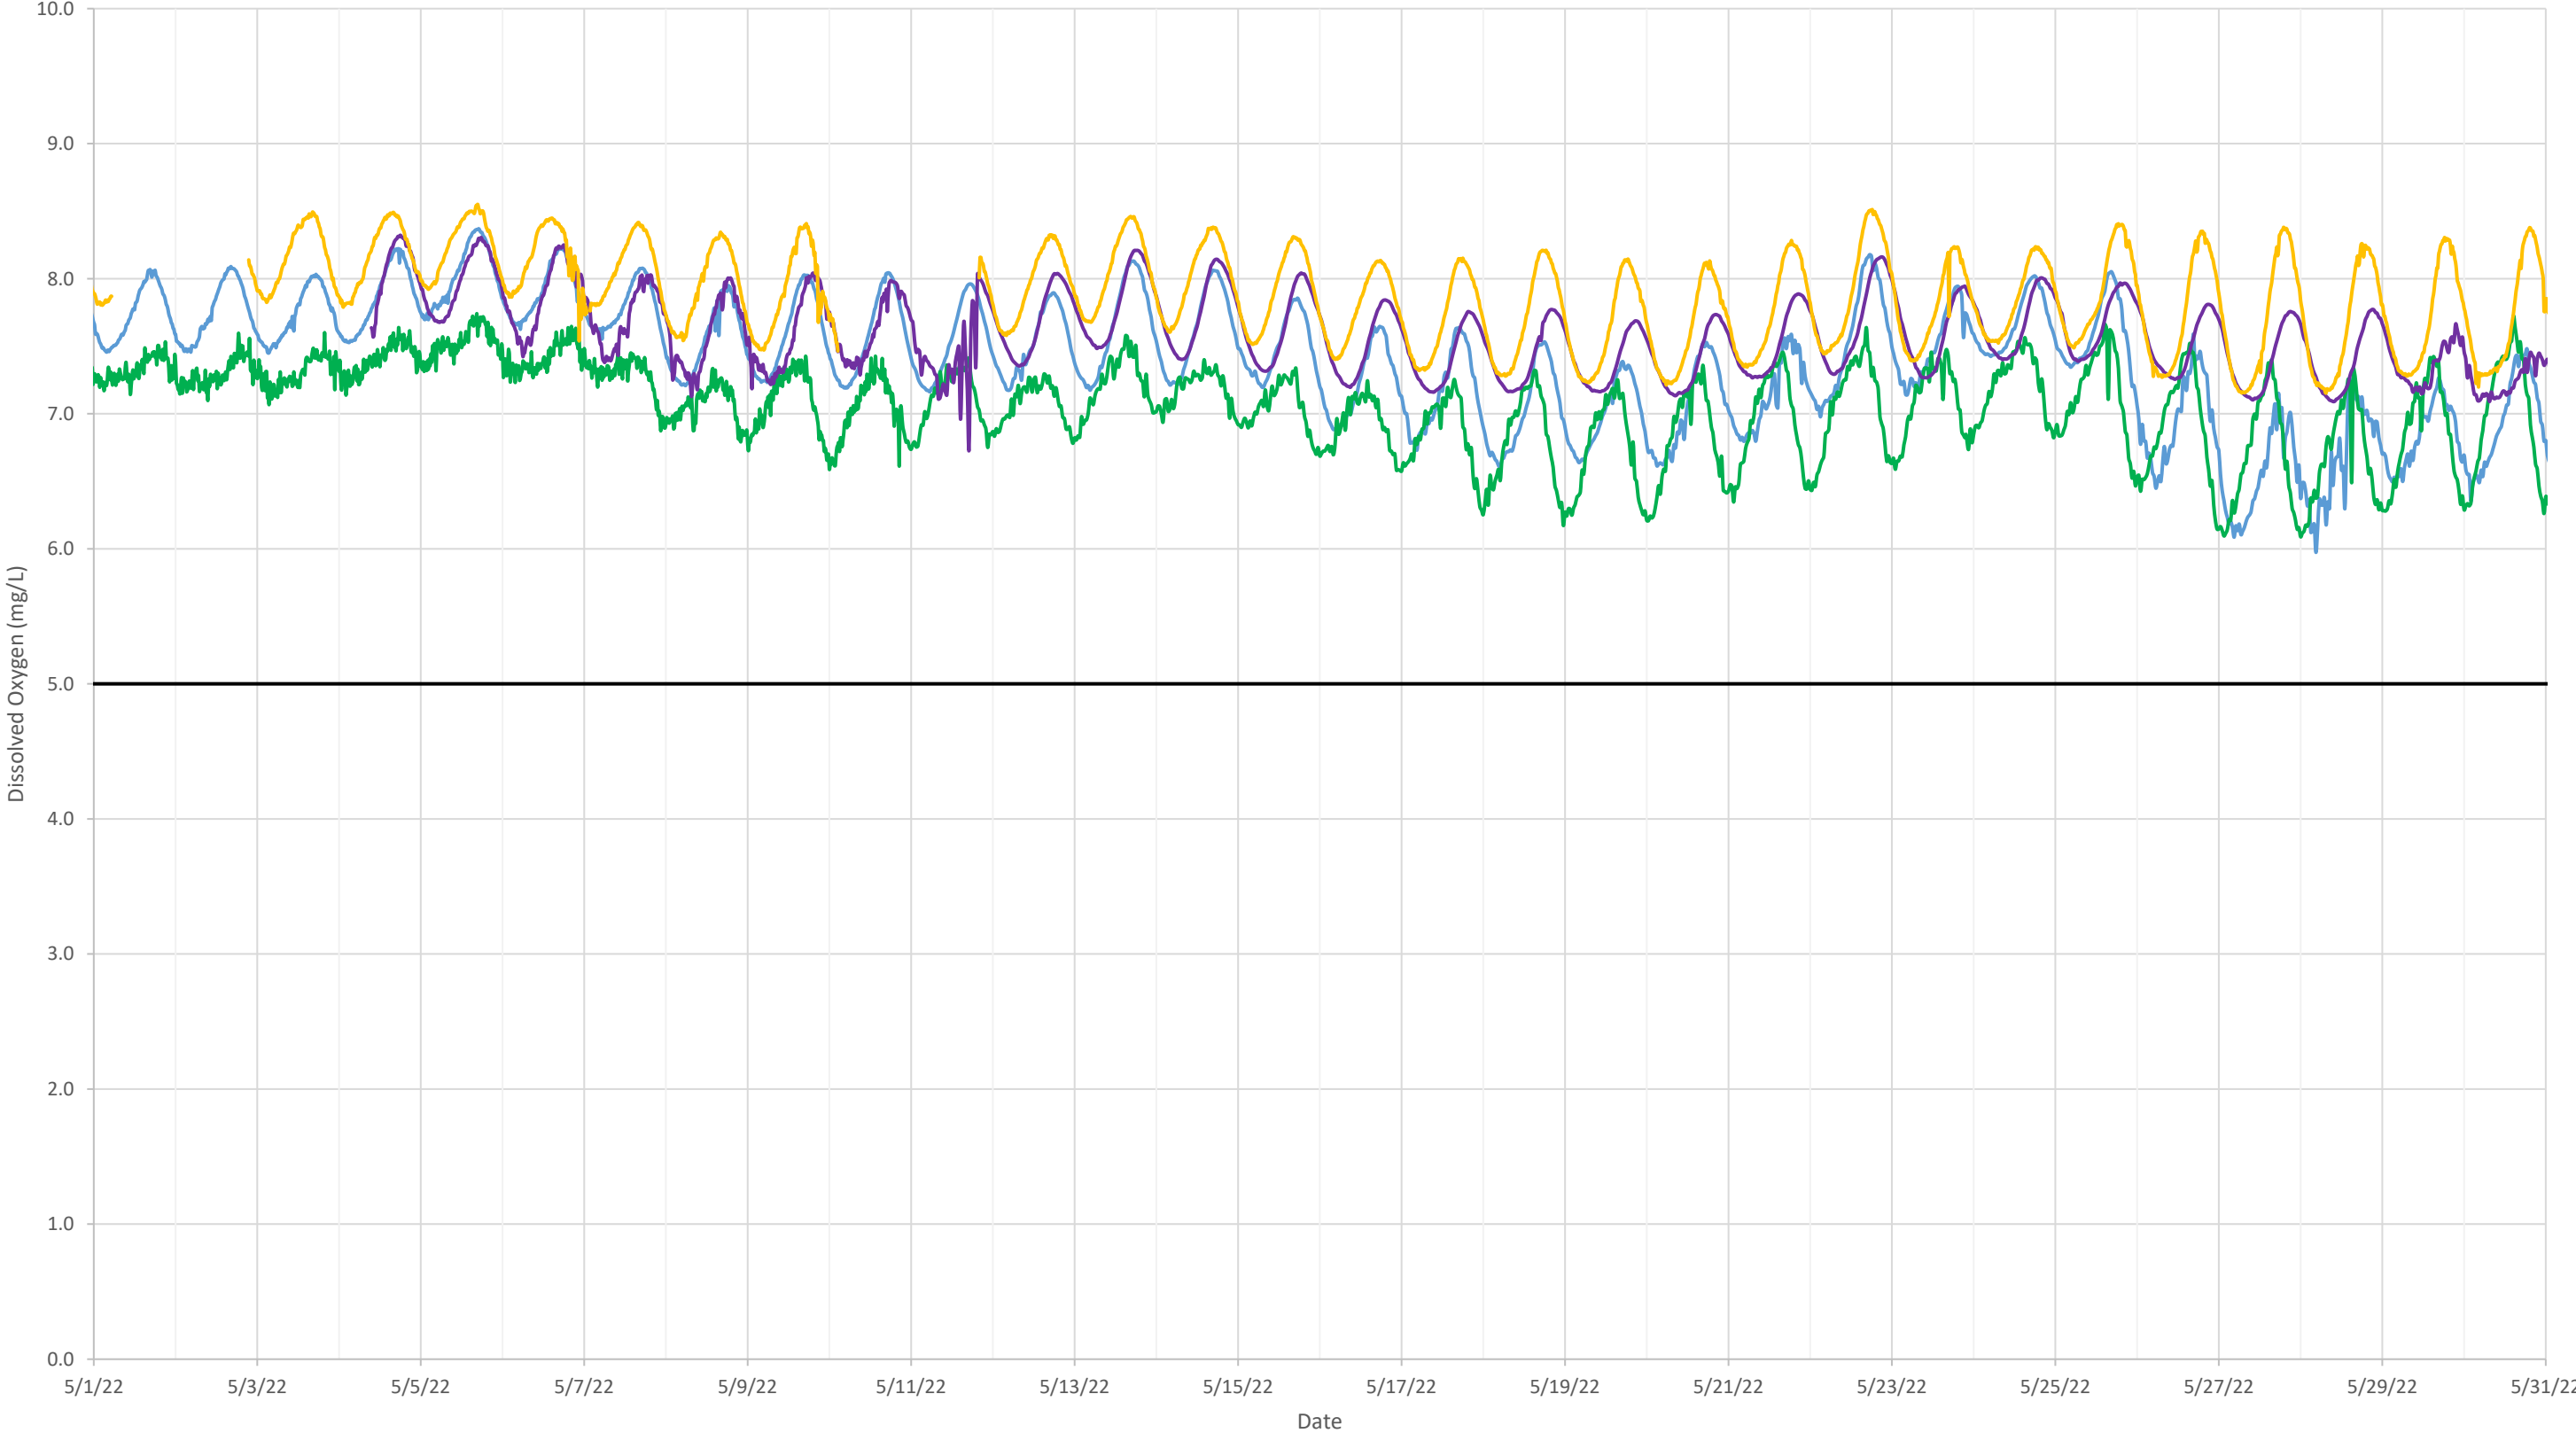
Dissolved Oxygen - All Sondes - May 2022

Isleta Central Sandia 550 DO Exceedance (5 mg/L)

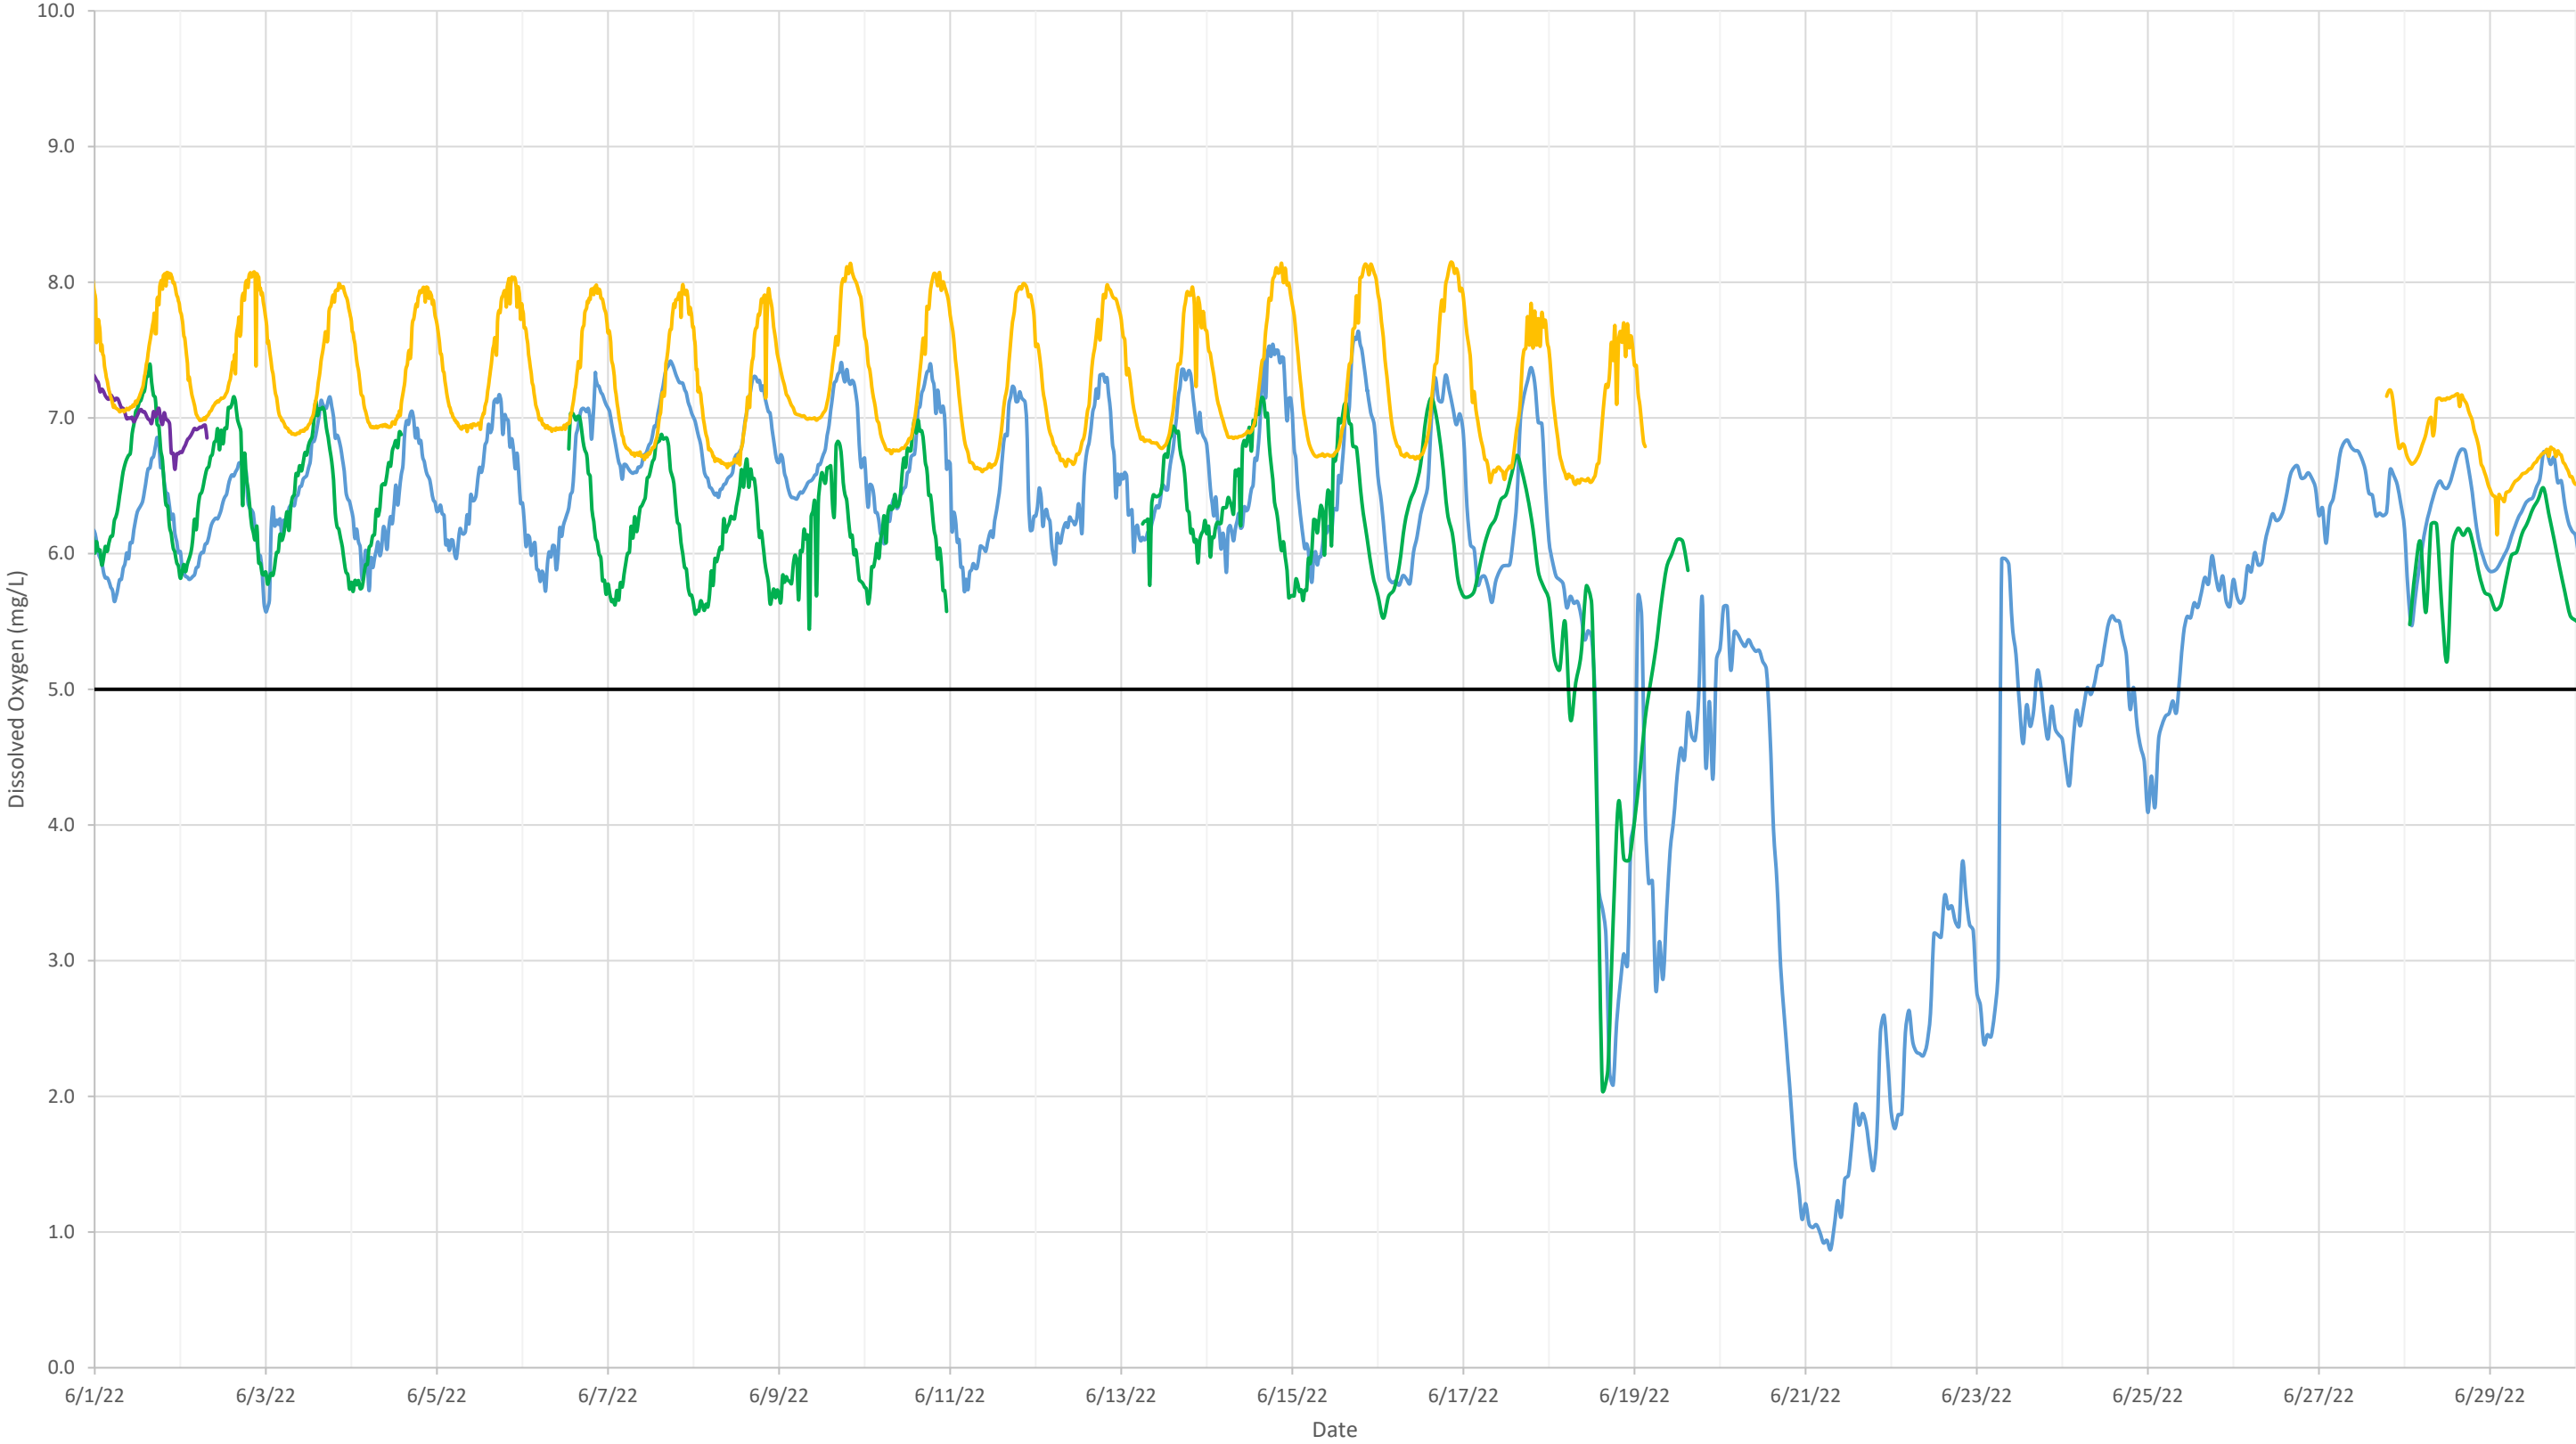
Dissolved Oxygen - All Sondes - June 2022

Isleta Central Sandia 550 DO Exceedance (5 mg/L)

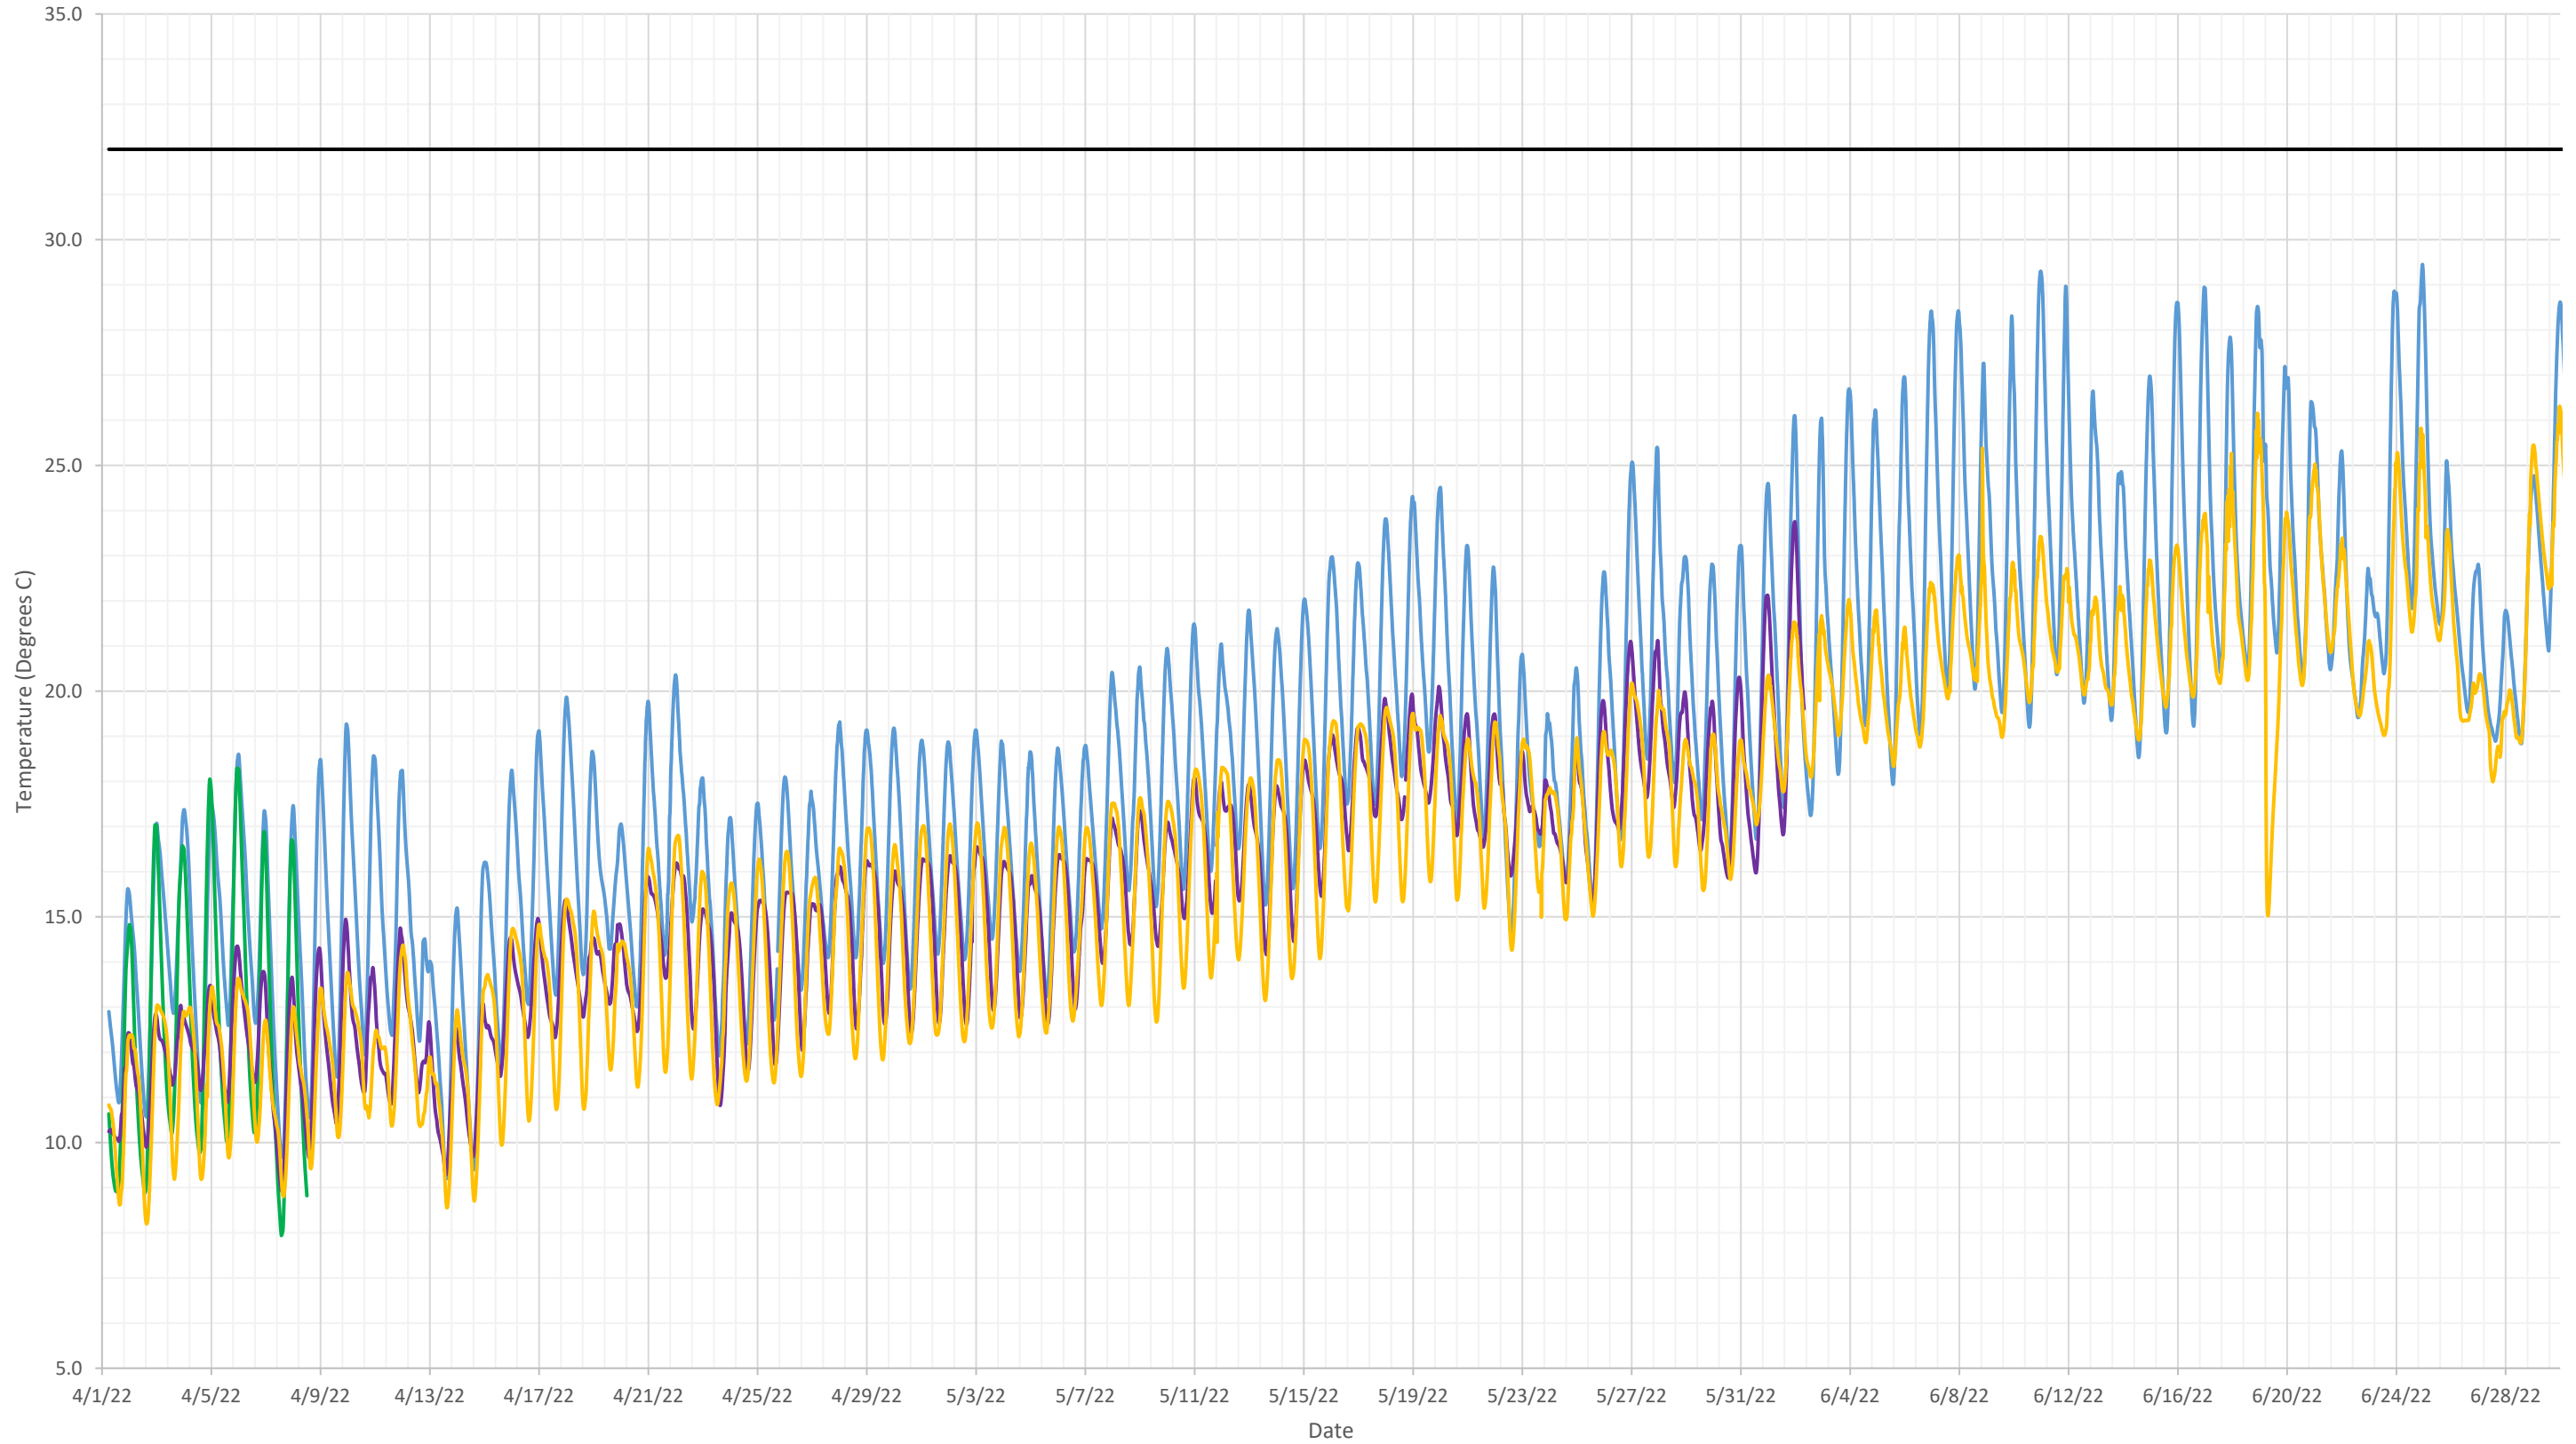
Temperature - All Sondes - Quarter 2, 2022

Isleta Central Sandia 550 Temperature Exceedance (32C)

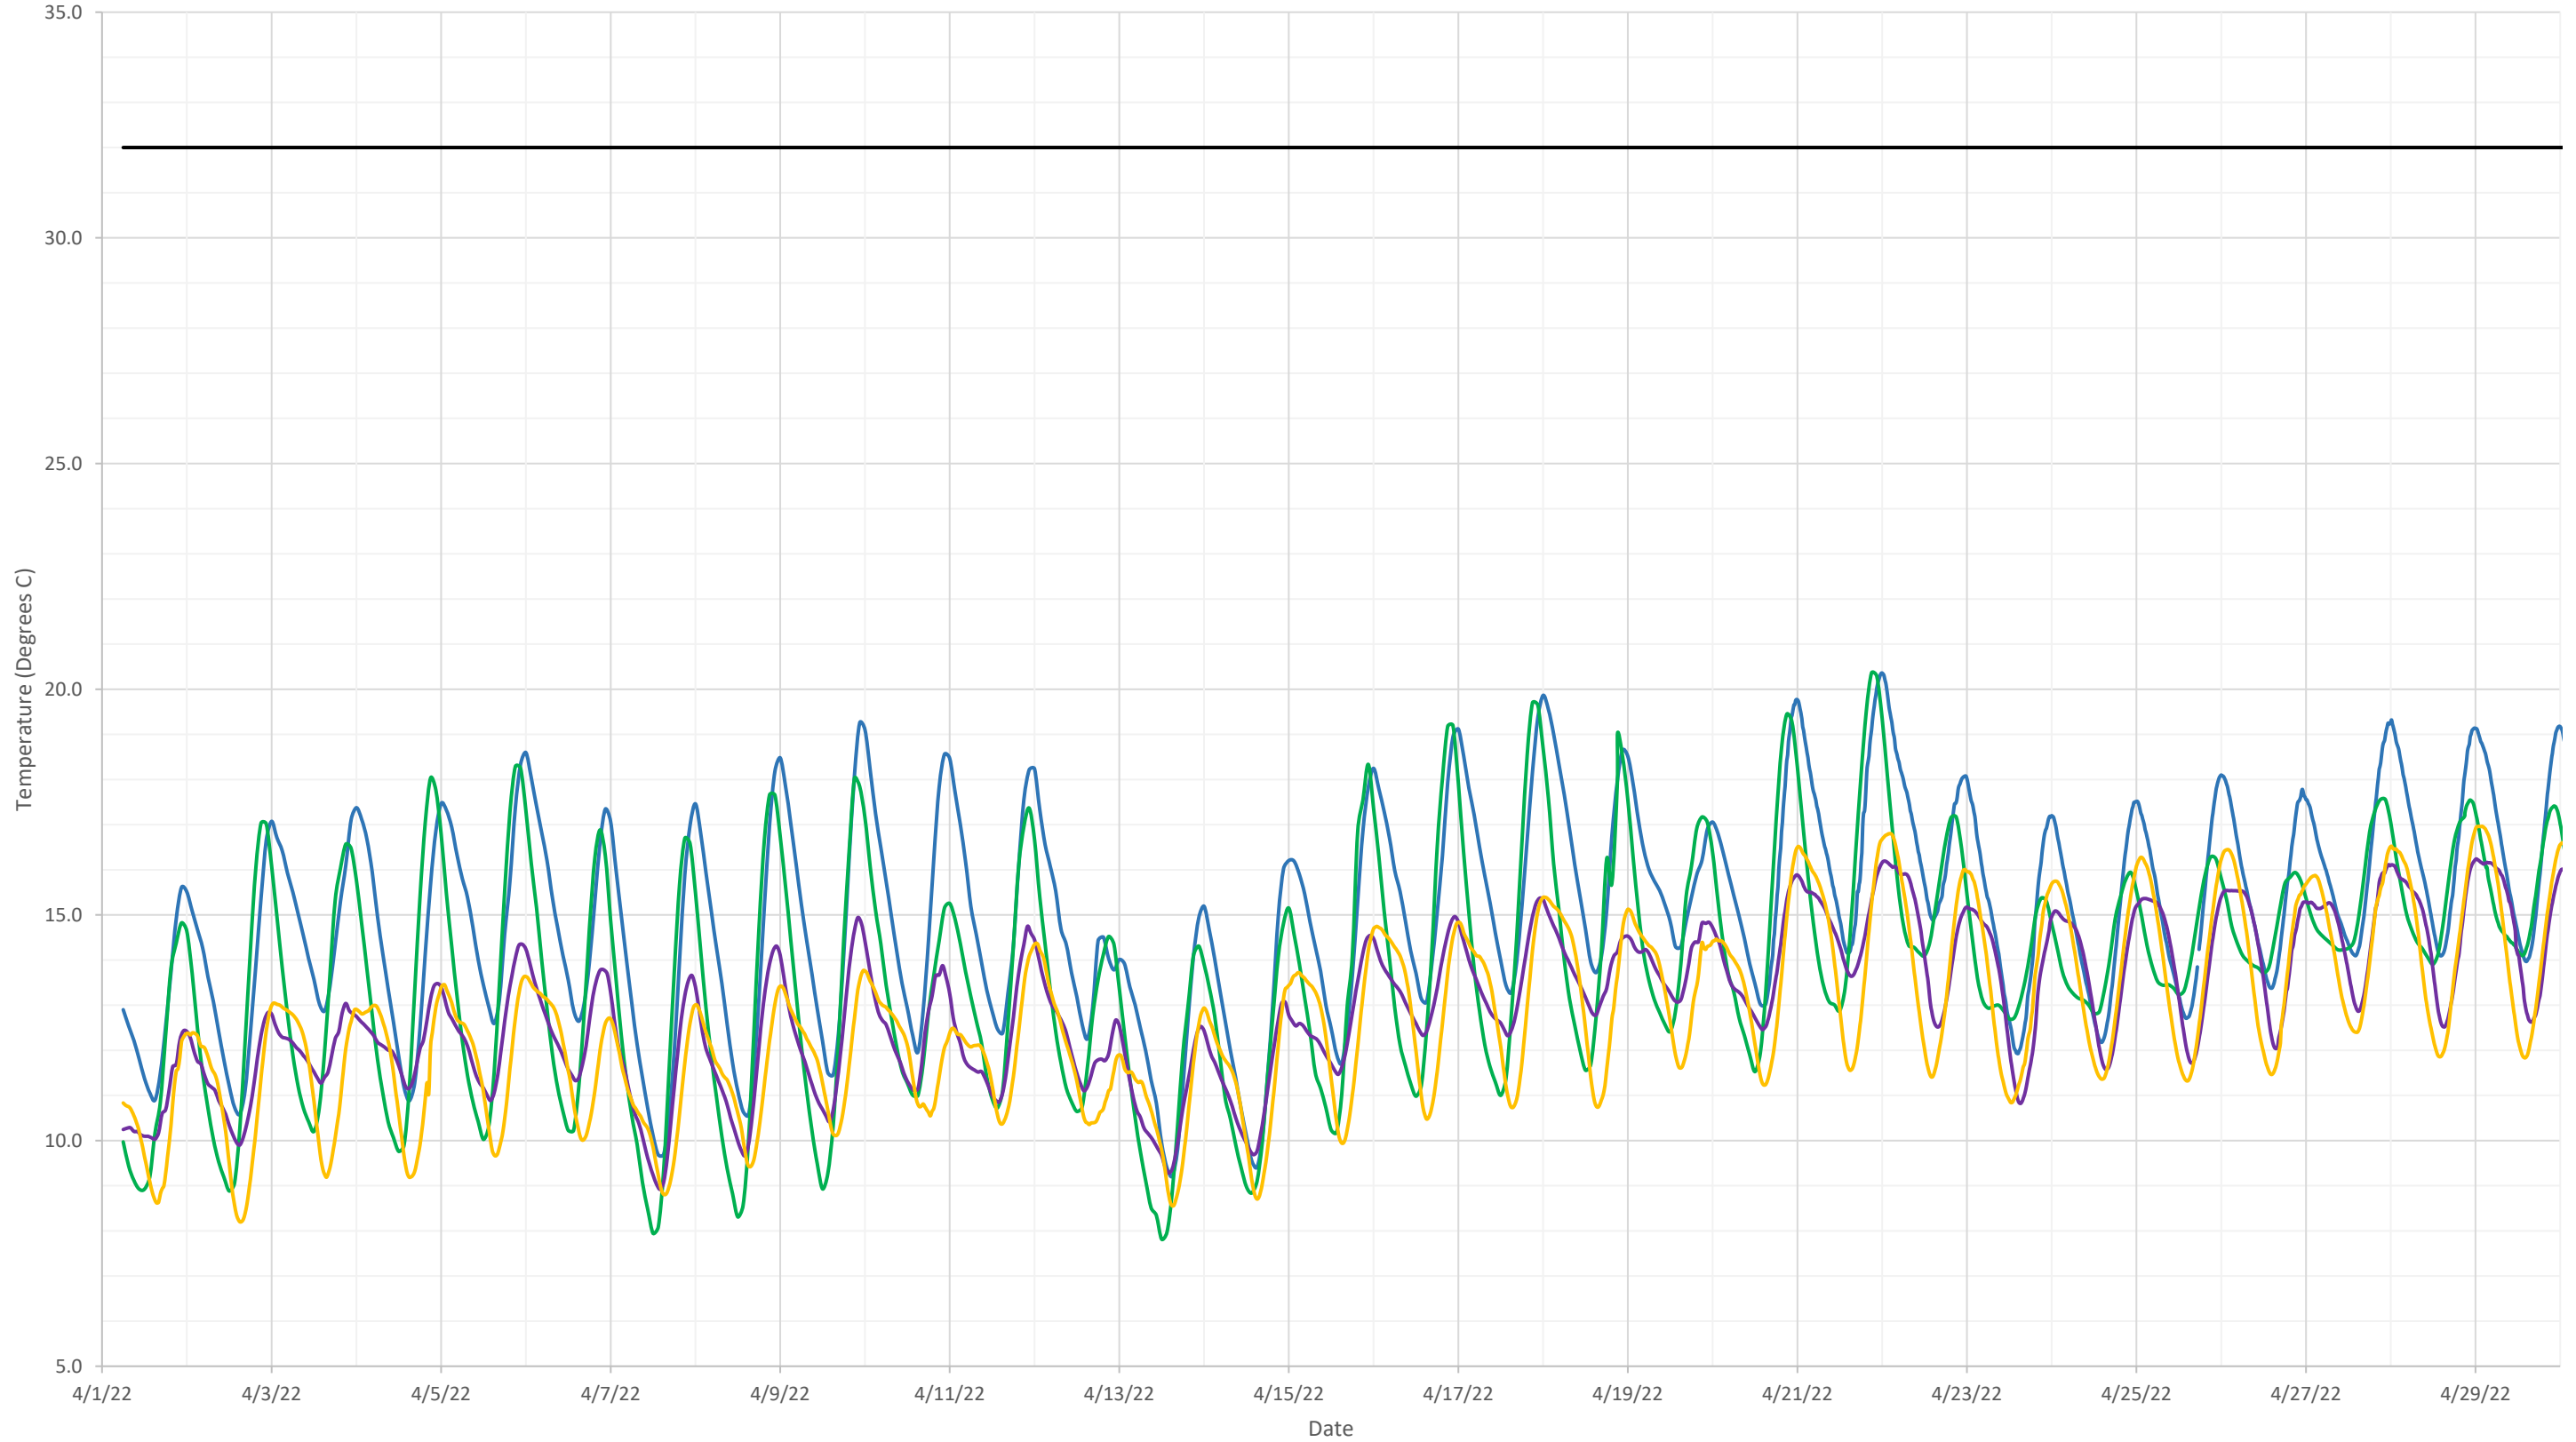
Temperature - All Sondes - April 2022

Isleta Central Sandia 550 Temperature Exceedance (32C)
