Weston Solutions, Inc.
3840 Commons Ave., NE
Albuquerque, New Mexico 87109
505-883-6520 Fax 505-837-6595
www.westonsolutions.com

Re: Second Quarter (April – June) 2022 In-Stream Water Quality Monitoring Memo

1 Background

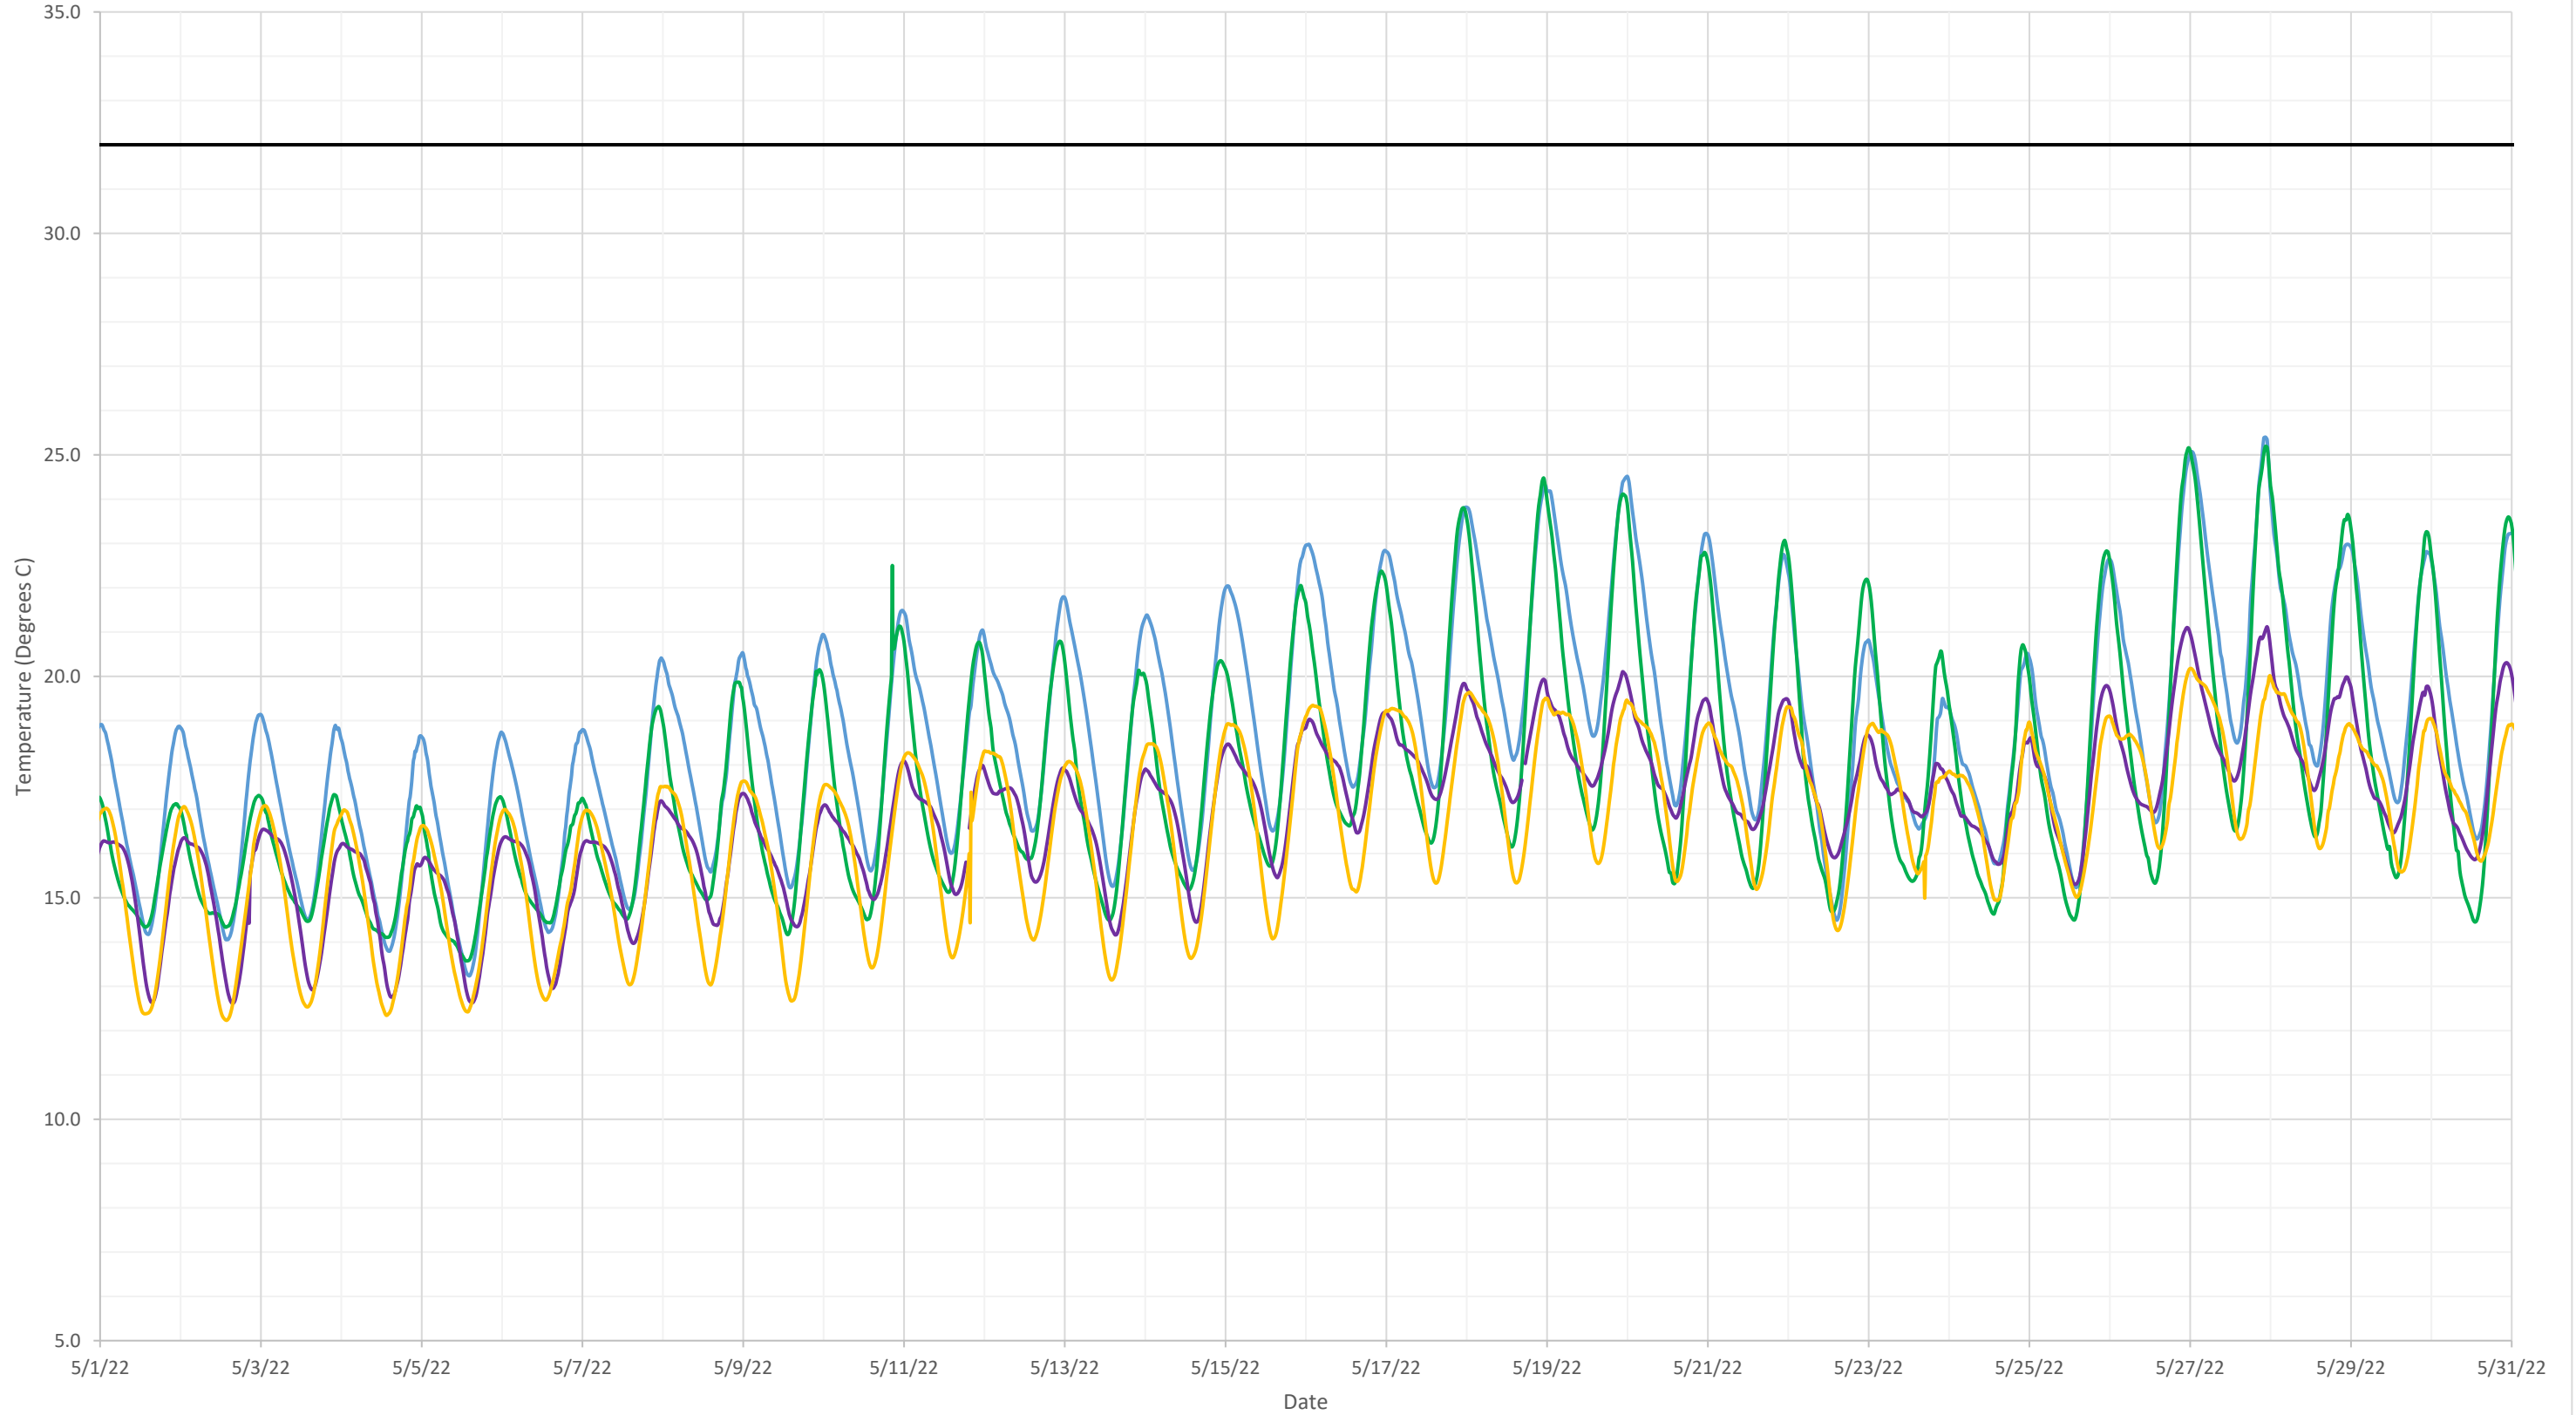
Temperature - All Sondes - May 2022

Isleta Central Sandia 550 Temperature Exceedance (32C)

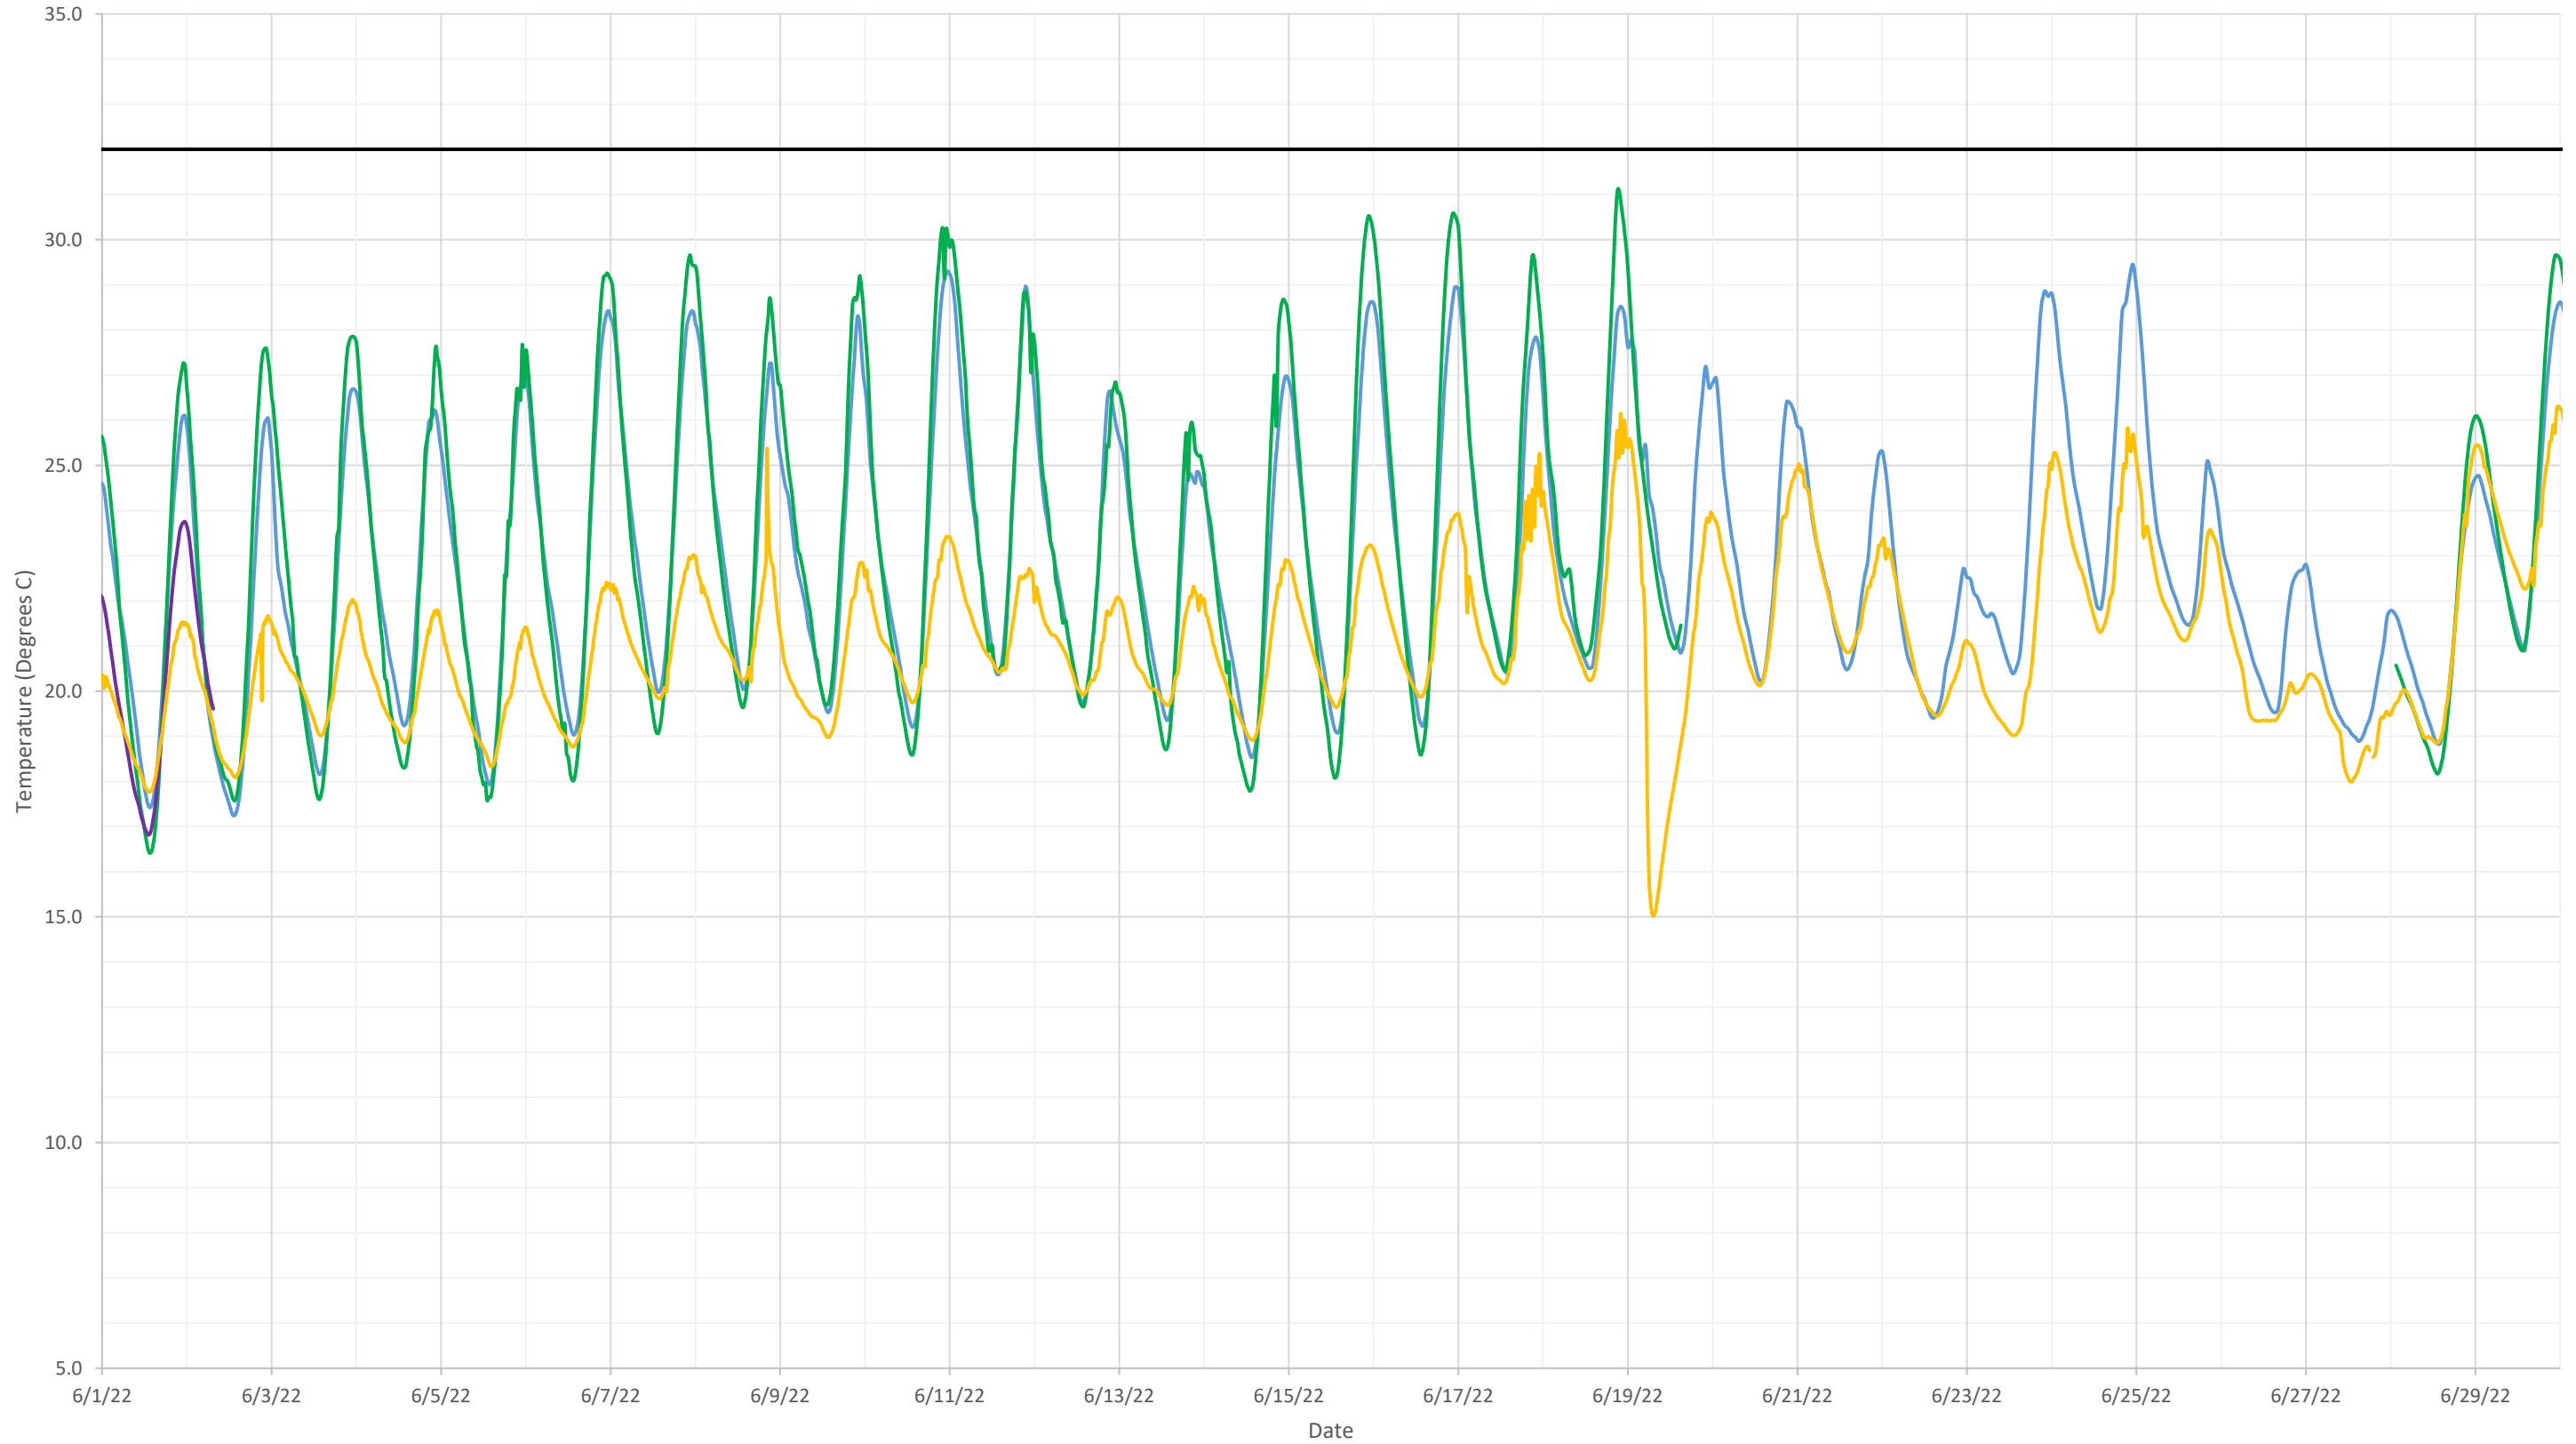
Temperature - All Sondes - June 2022

Isleta Central Sandia 550 Temperature Exceedance (32C)

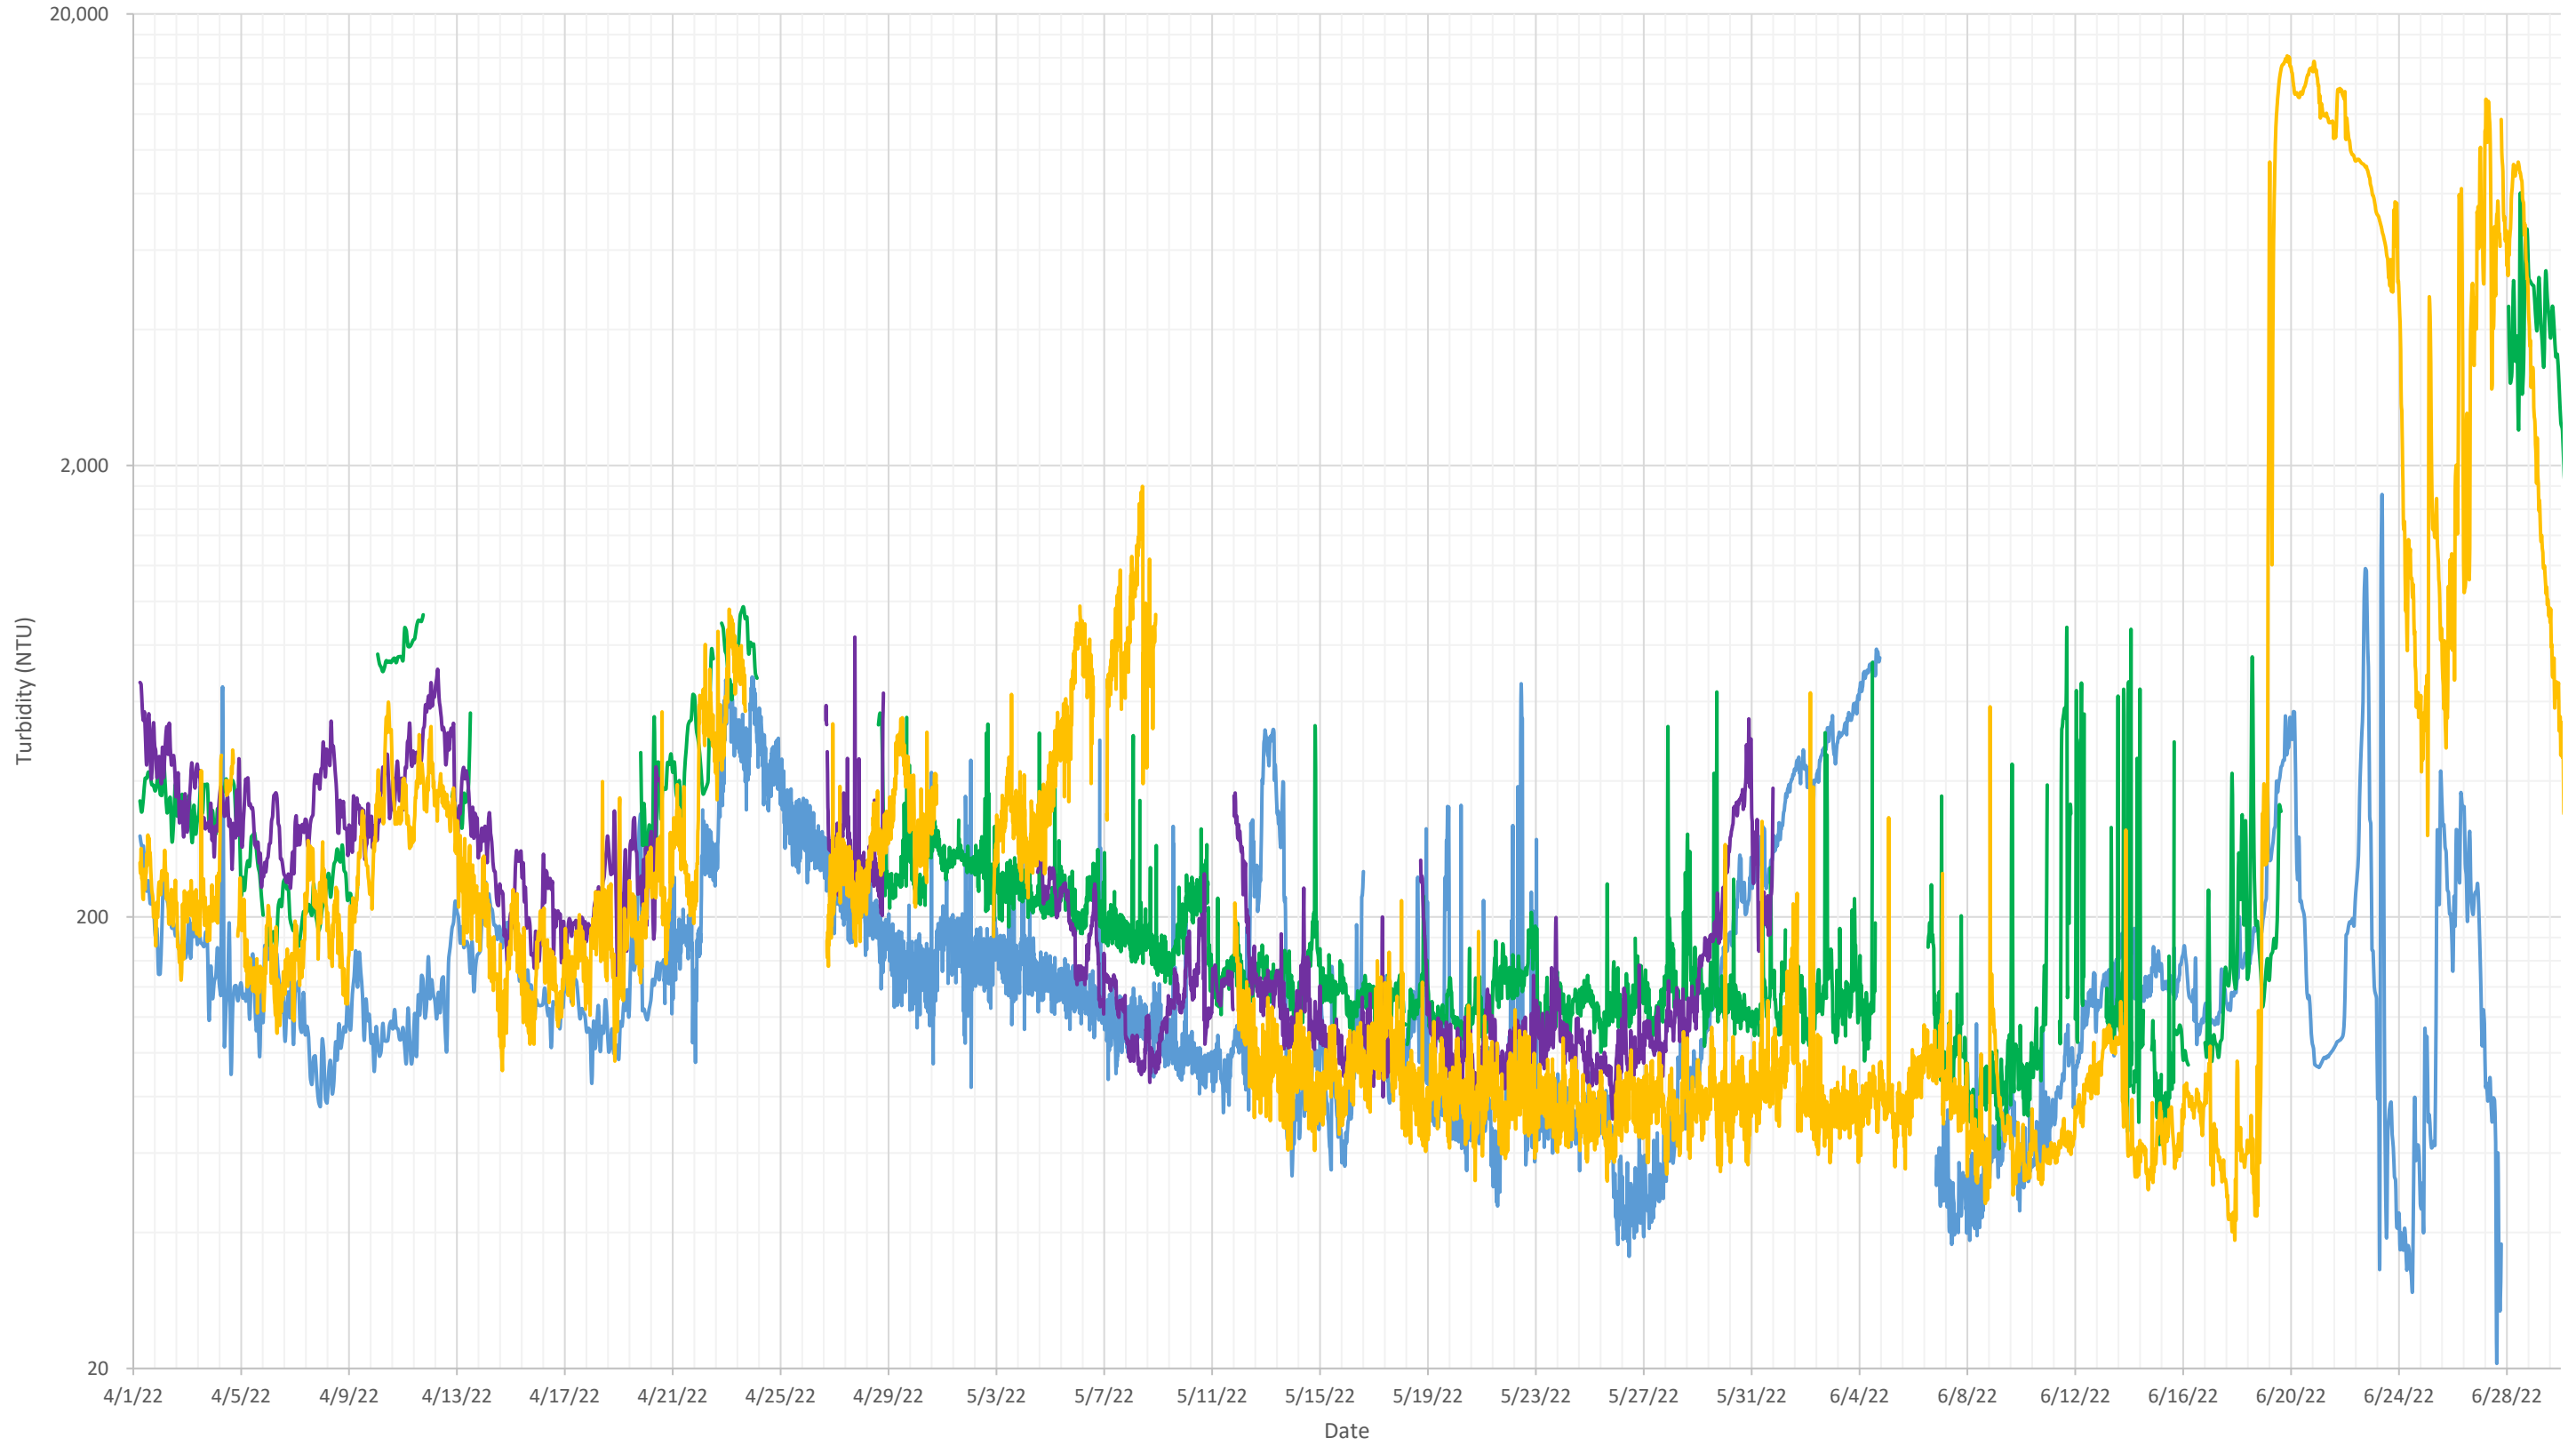
Turbidity - All Sondes - Quarter 2, 2022

Isleta Central Sandia 550

Turbidity attributable to other than natural causes shall not reduce light transmission to a point where aquatic biota are inhibited or to a point that causes an unaesthetic and substantial visible contrast with the natural appearance of the water. Specifically, turbidity shall not exceed 5 NTU over background when background turbidity is 50 NTU or less, with no more than 10 percent increase when background turbidity is more than 50 NTU.

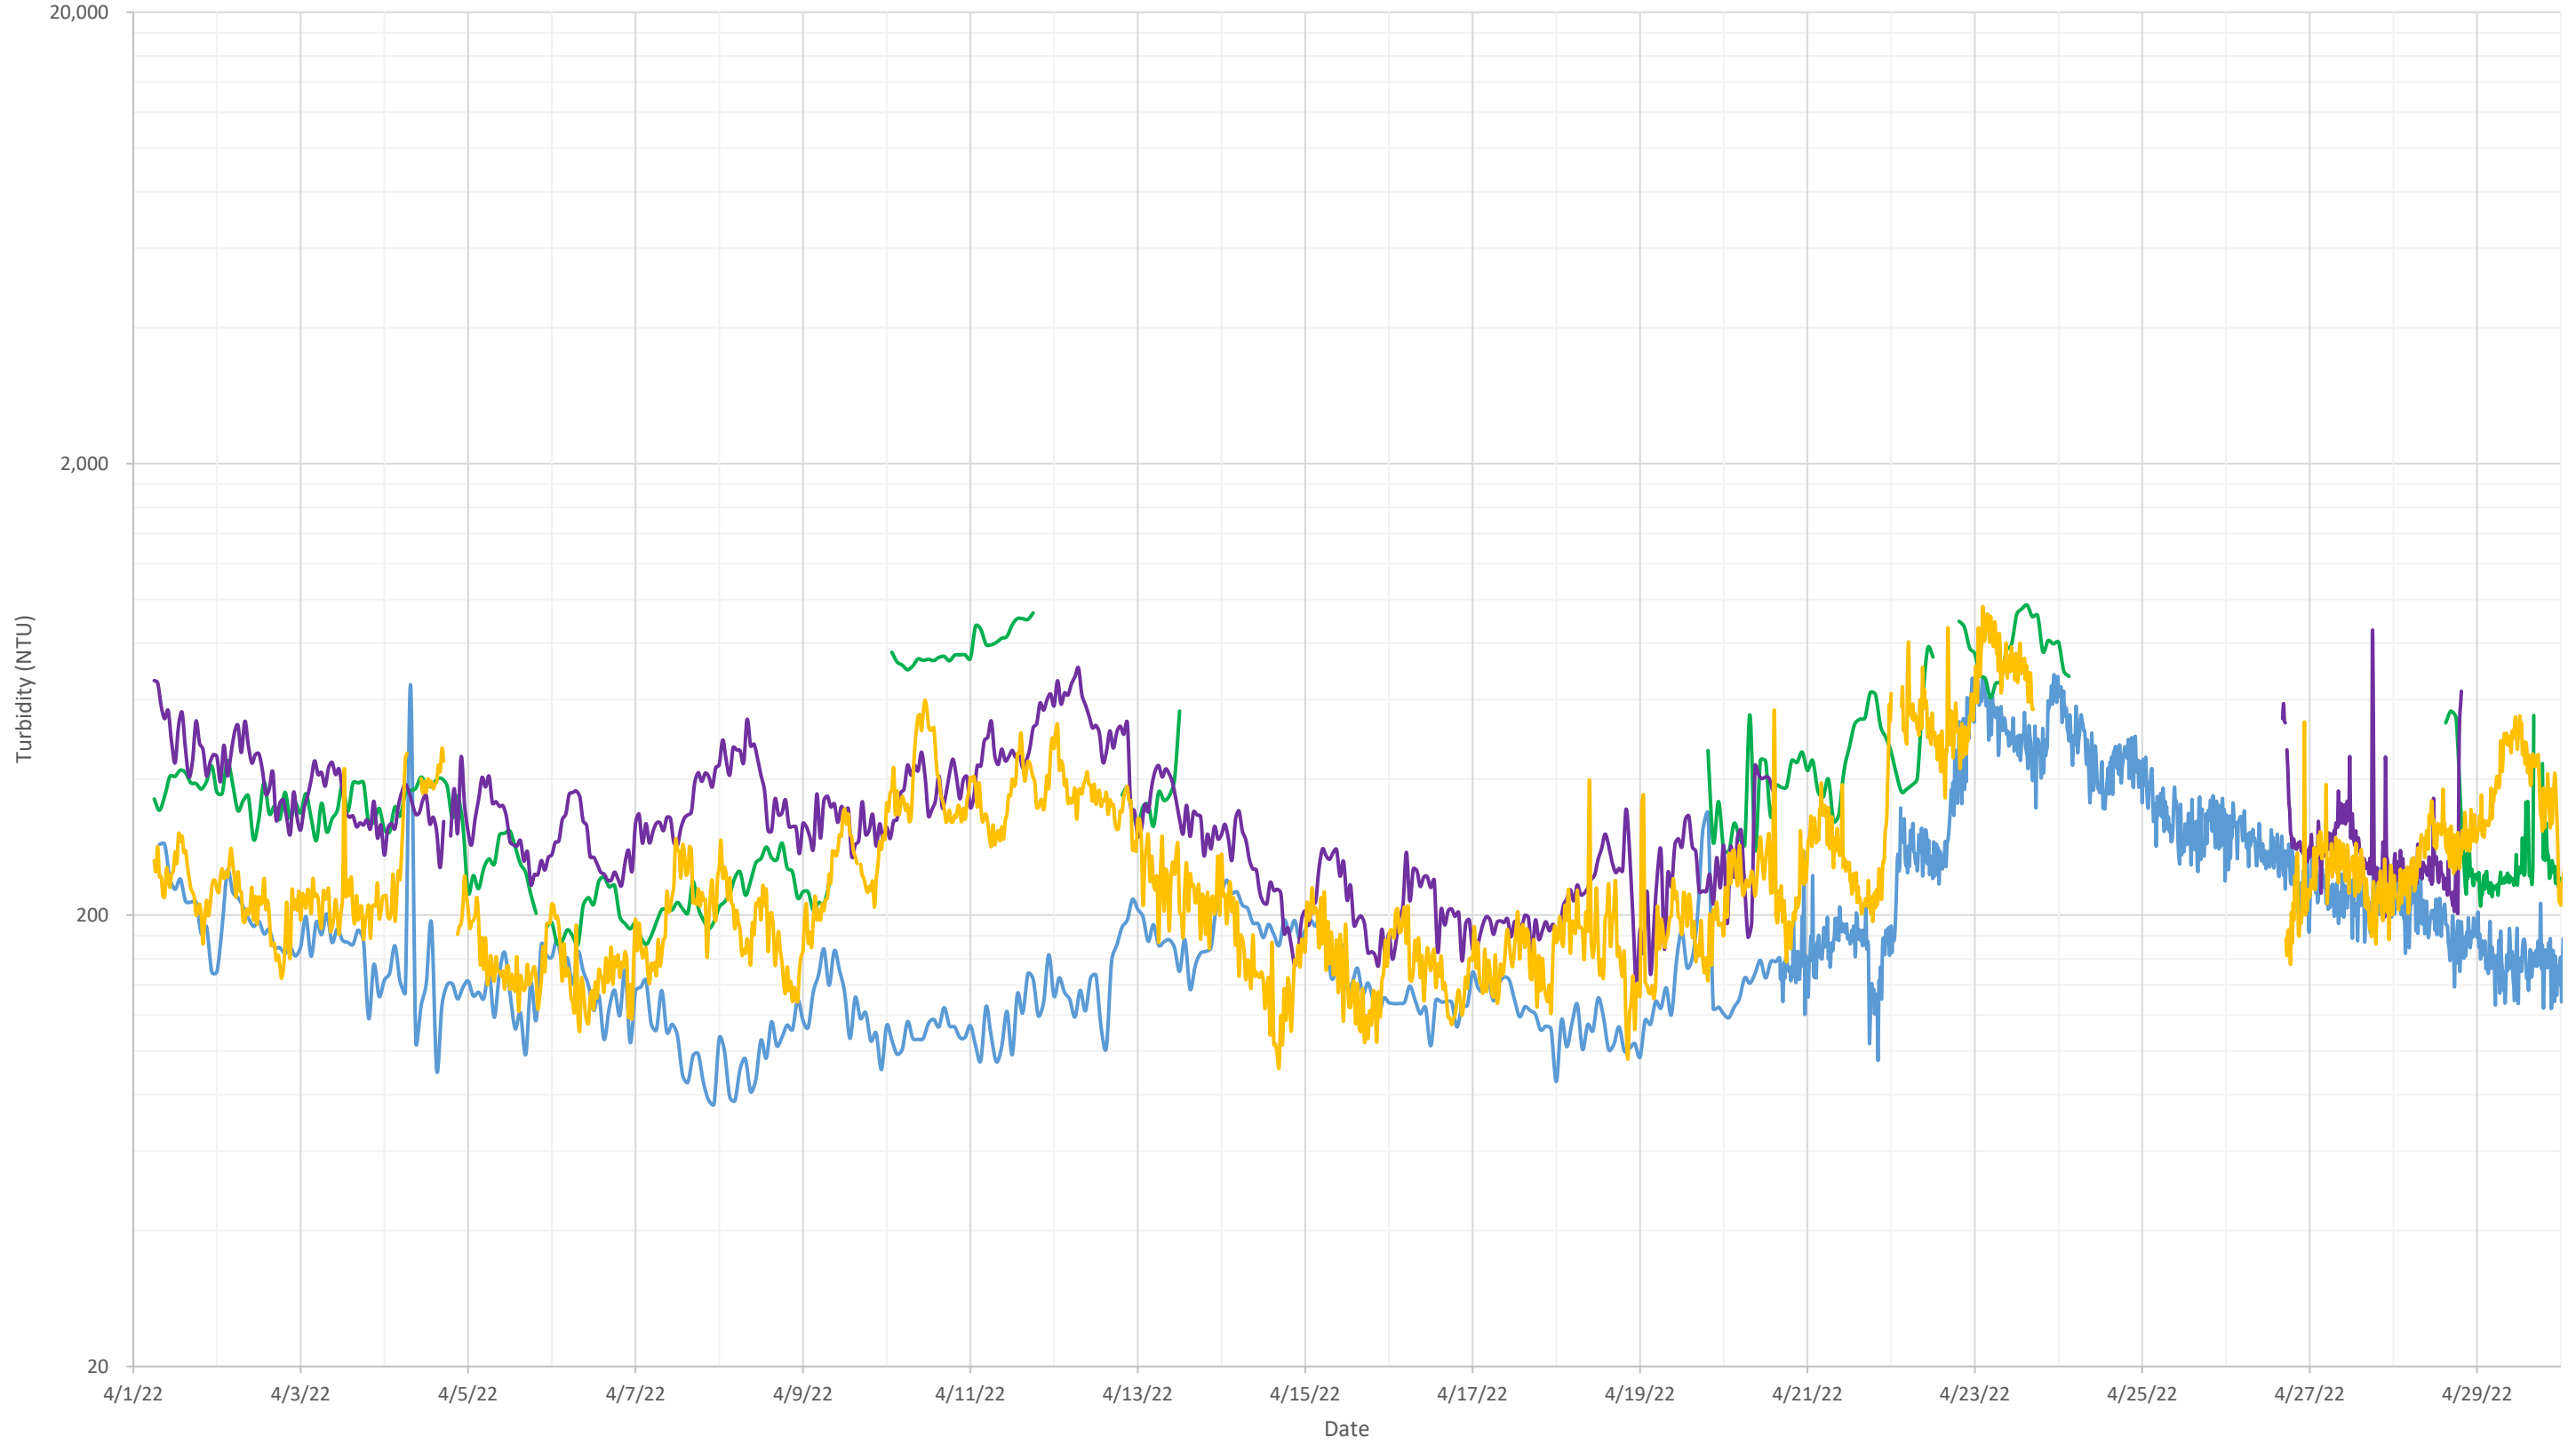
Turbidity - All Sondes - April 2022

Isleta Central Sandia 550

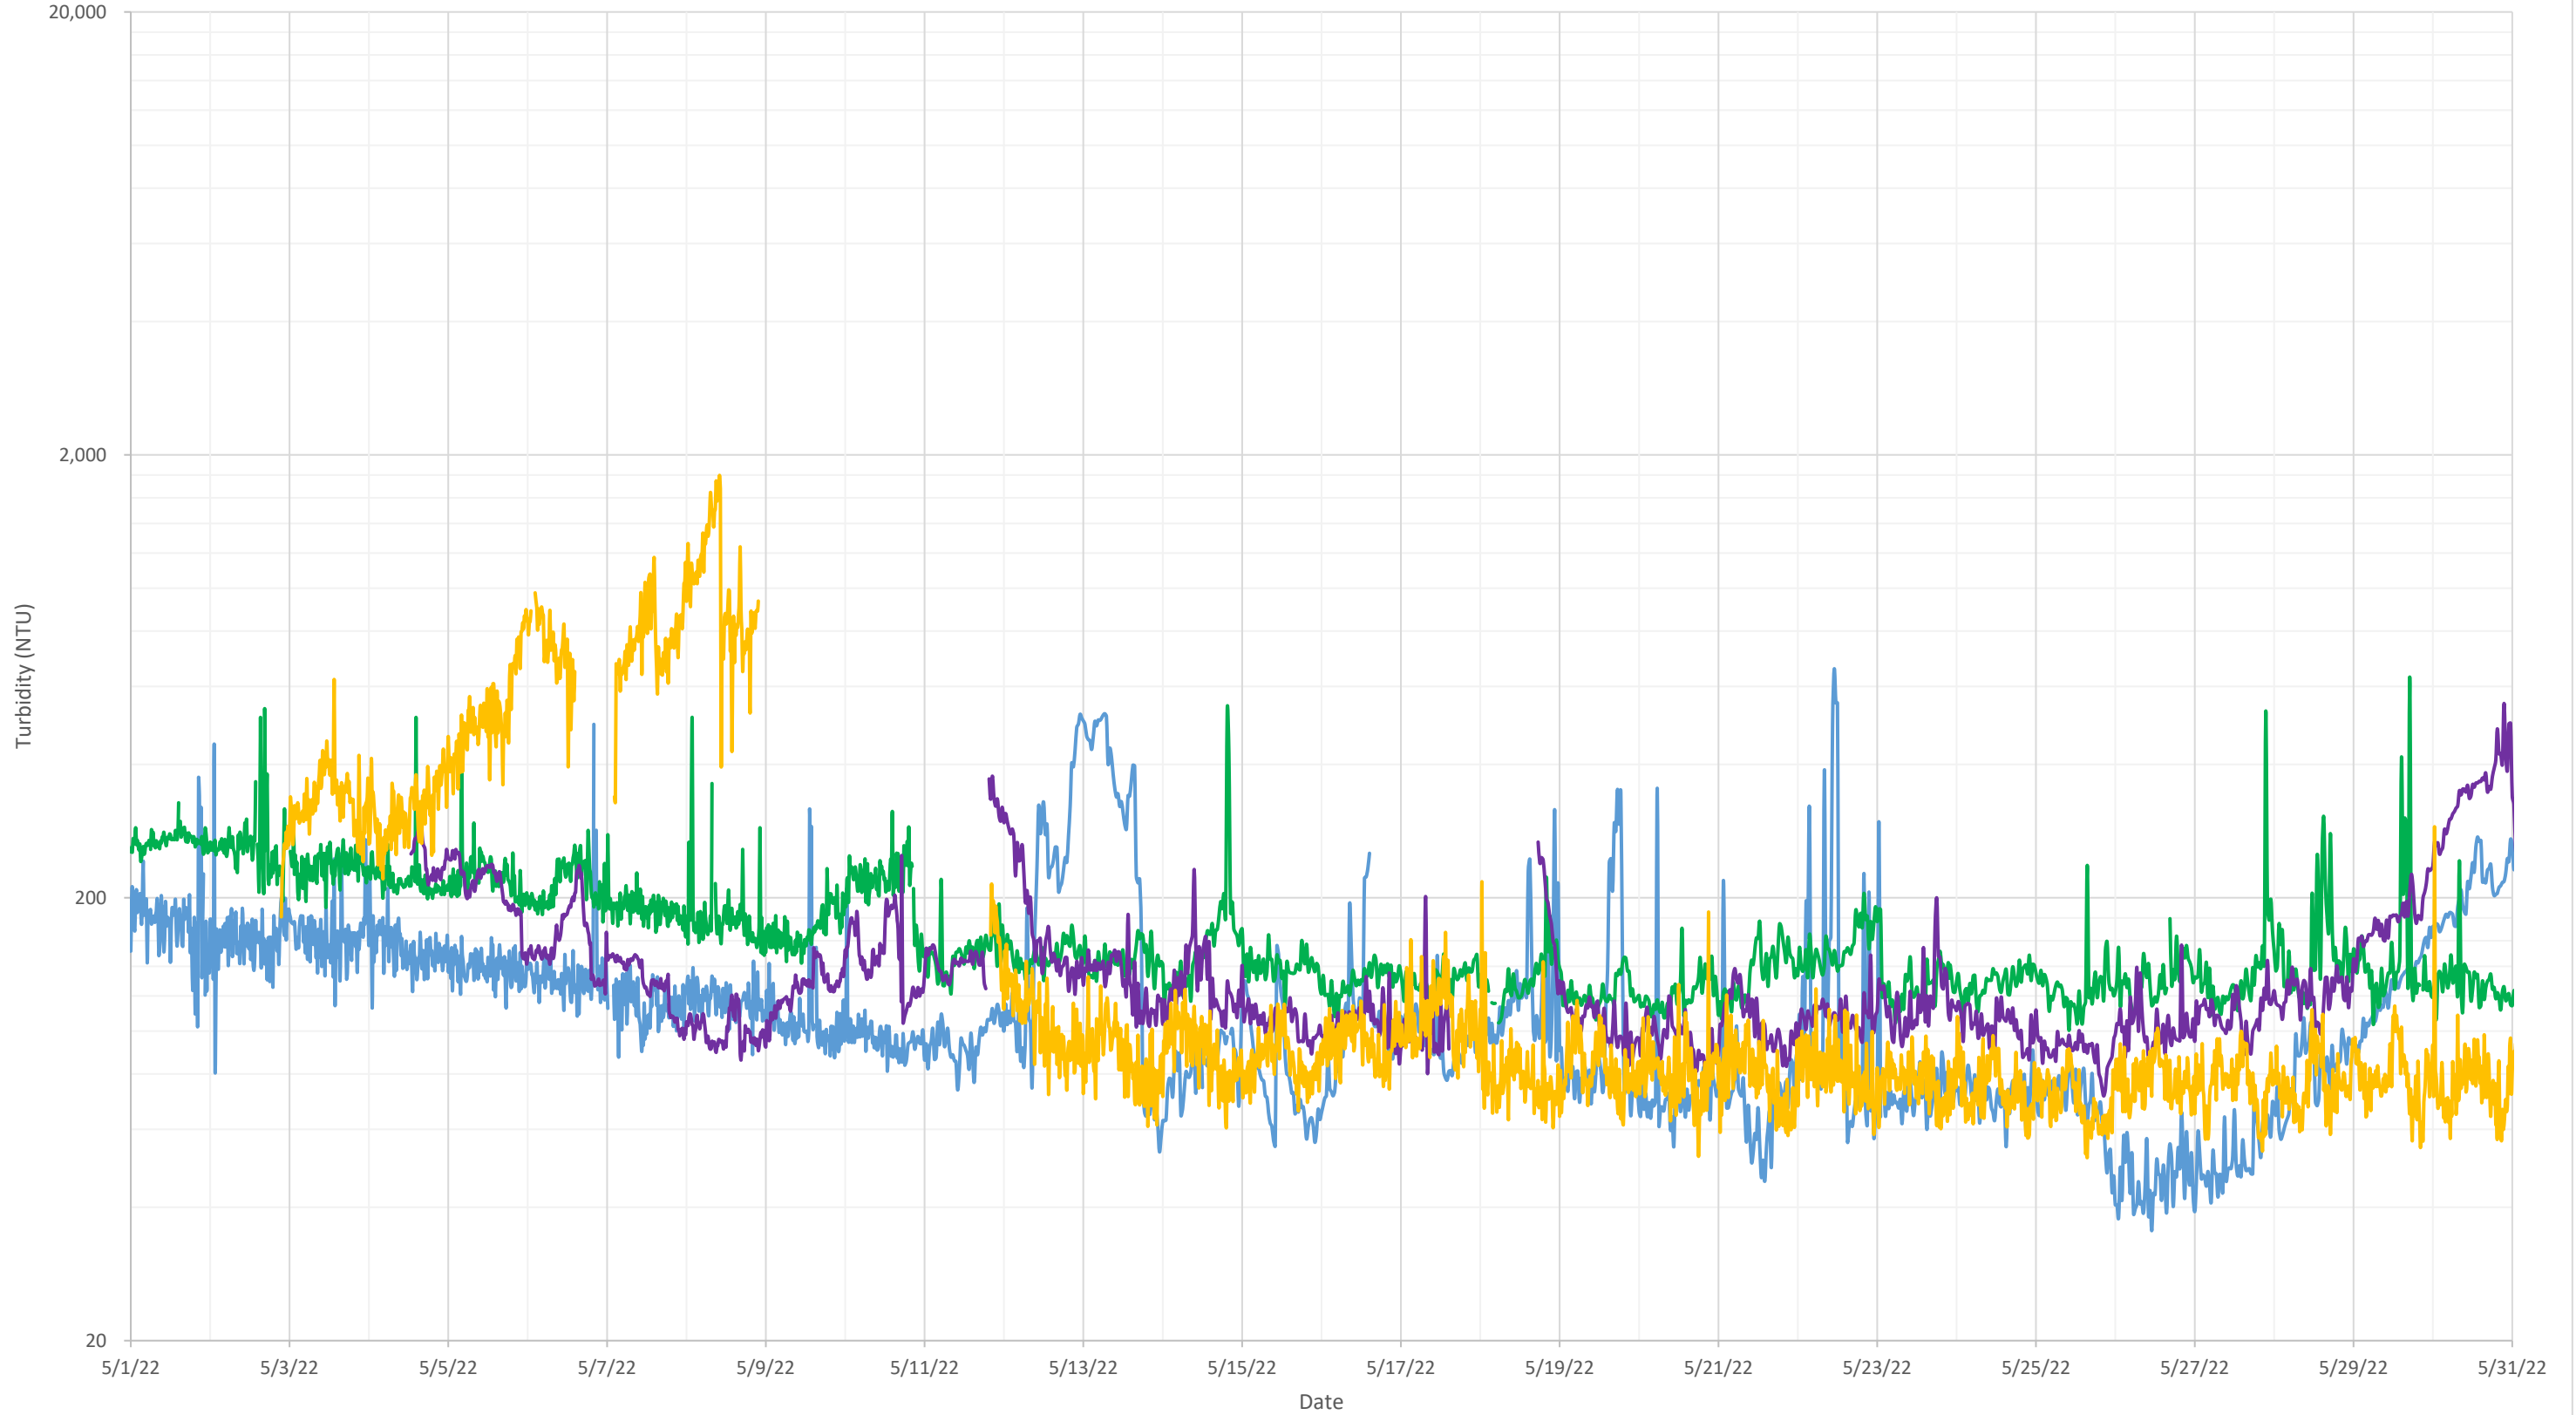
Turbidity - All Sondes - May 2022

Isleta Central Sandia 550

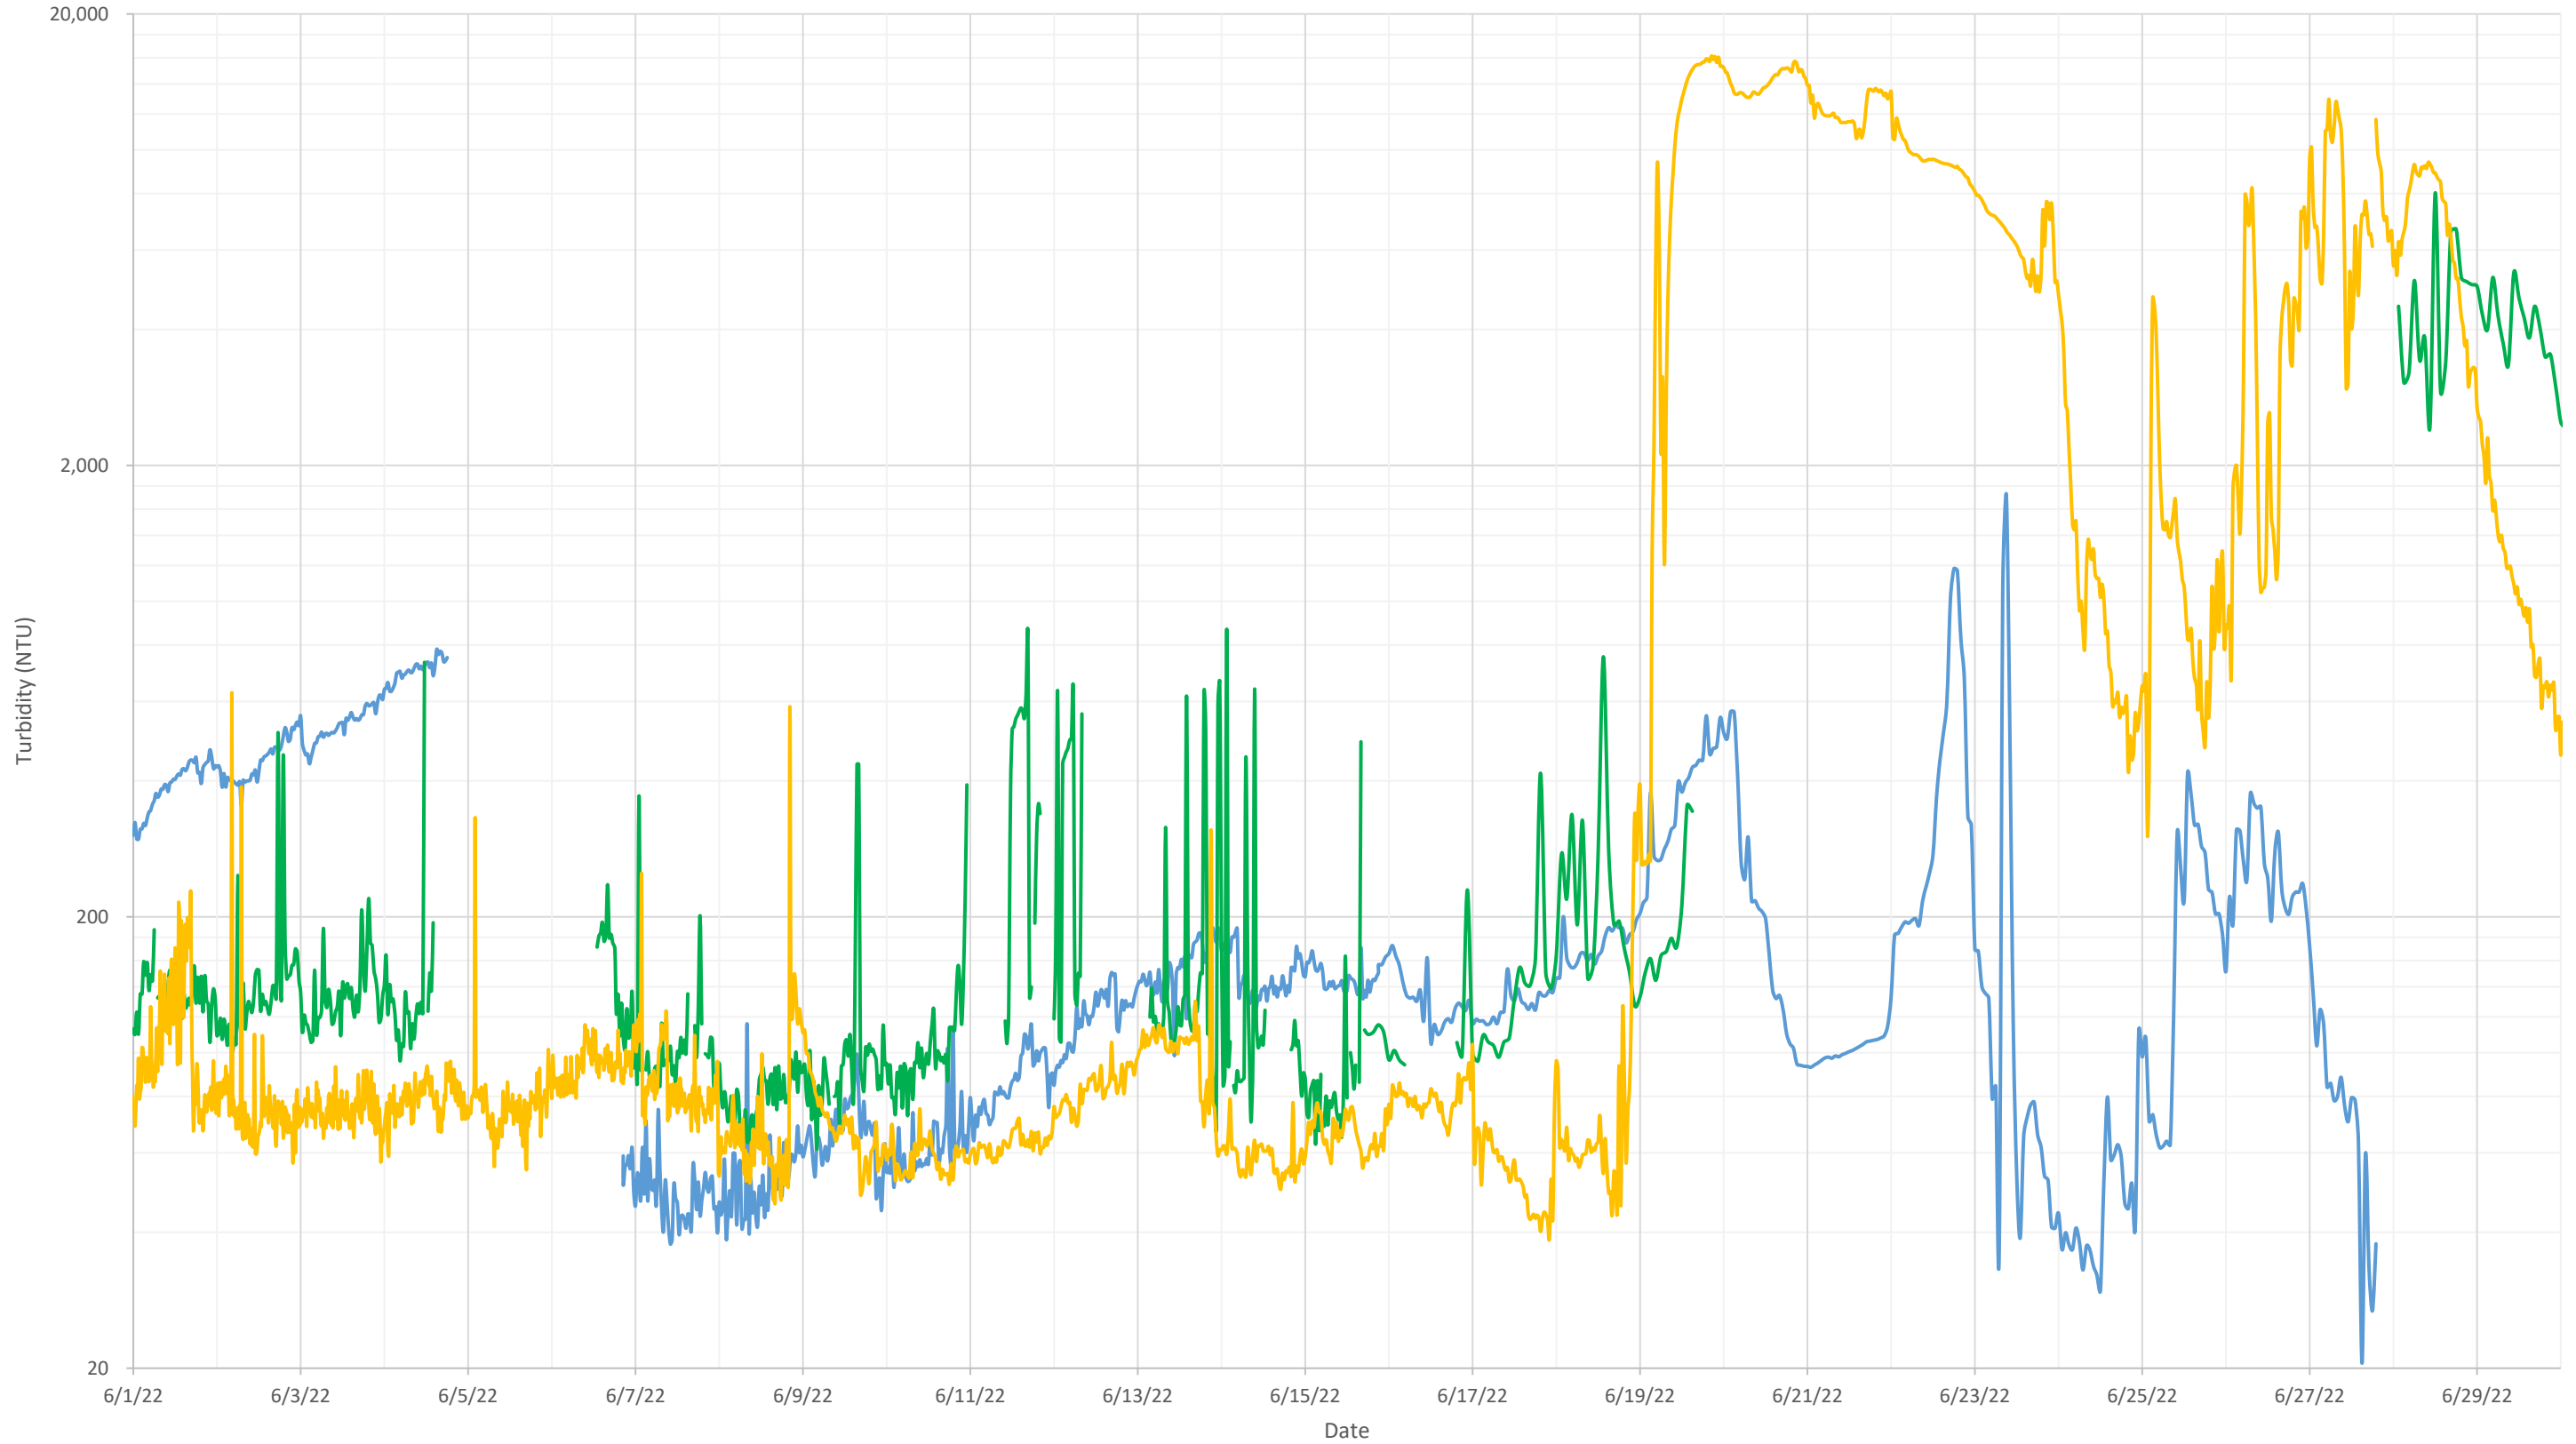
Turbidity - All Sondes - June 2022

Isleta Central Sandia 550
