**Re: Third Quarter (July – September) 2022 In-Stream Water Quality Monitoring Memo**

## **1 Background**

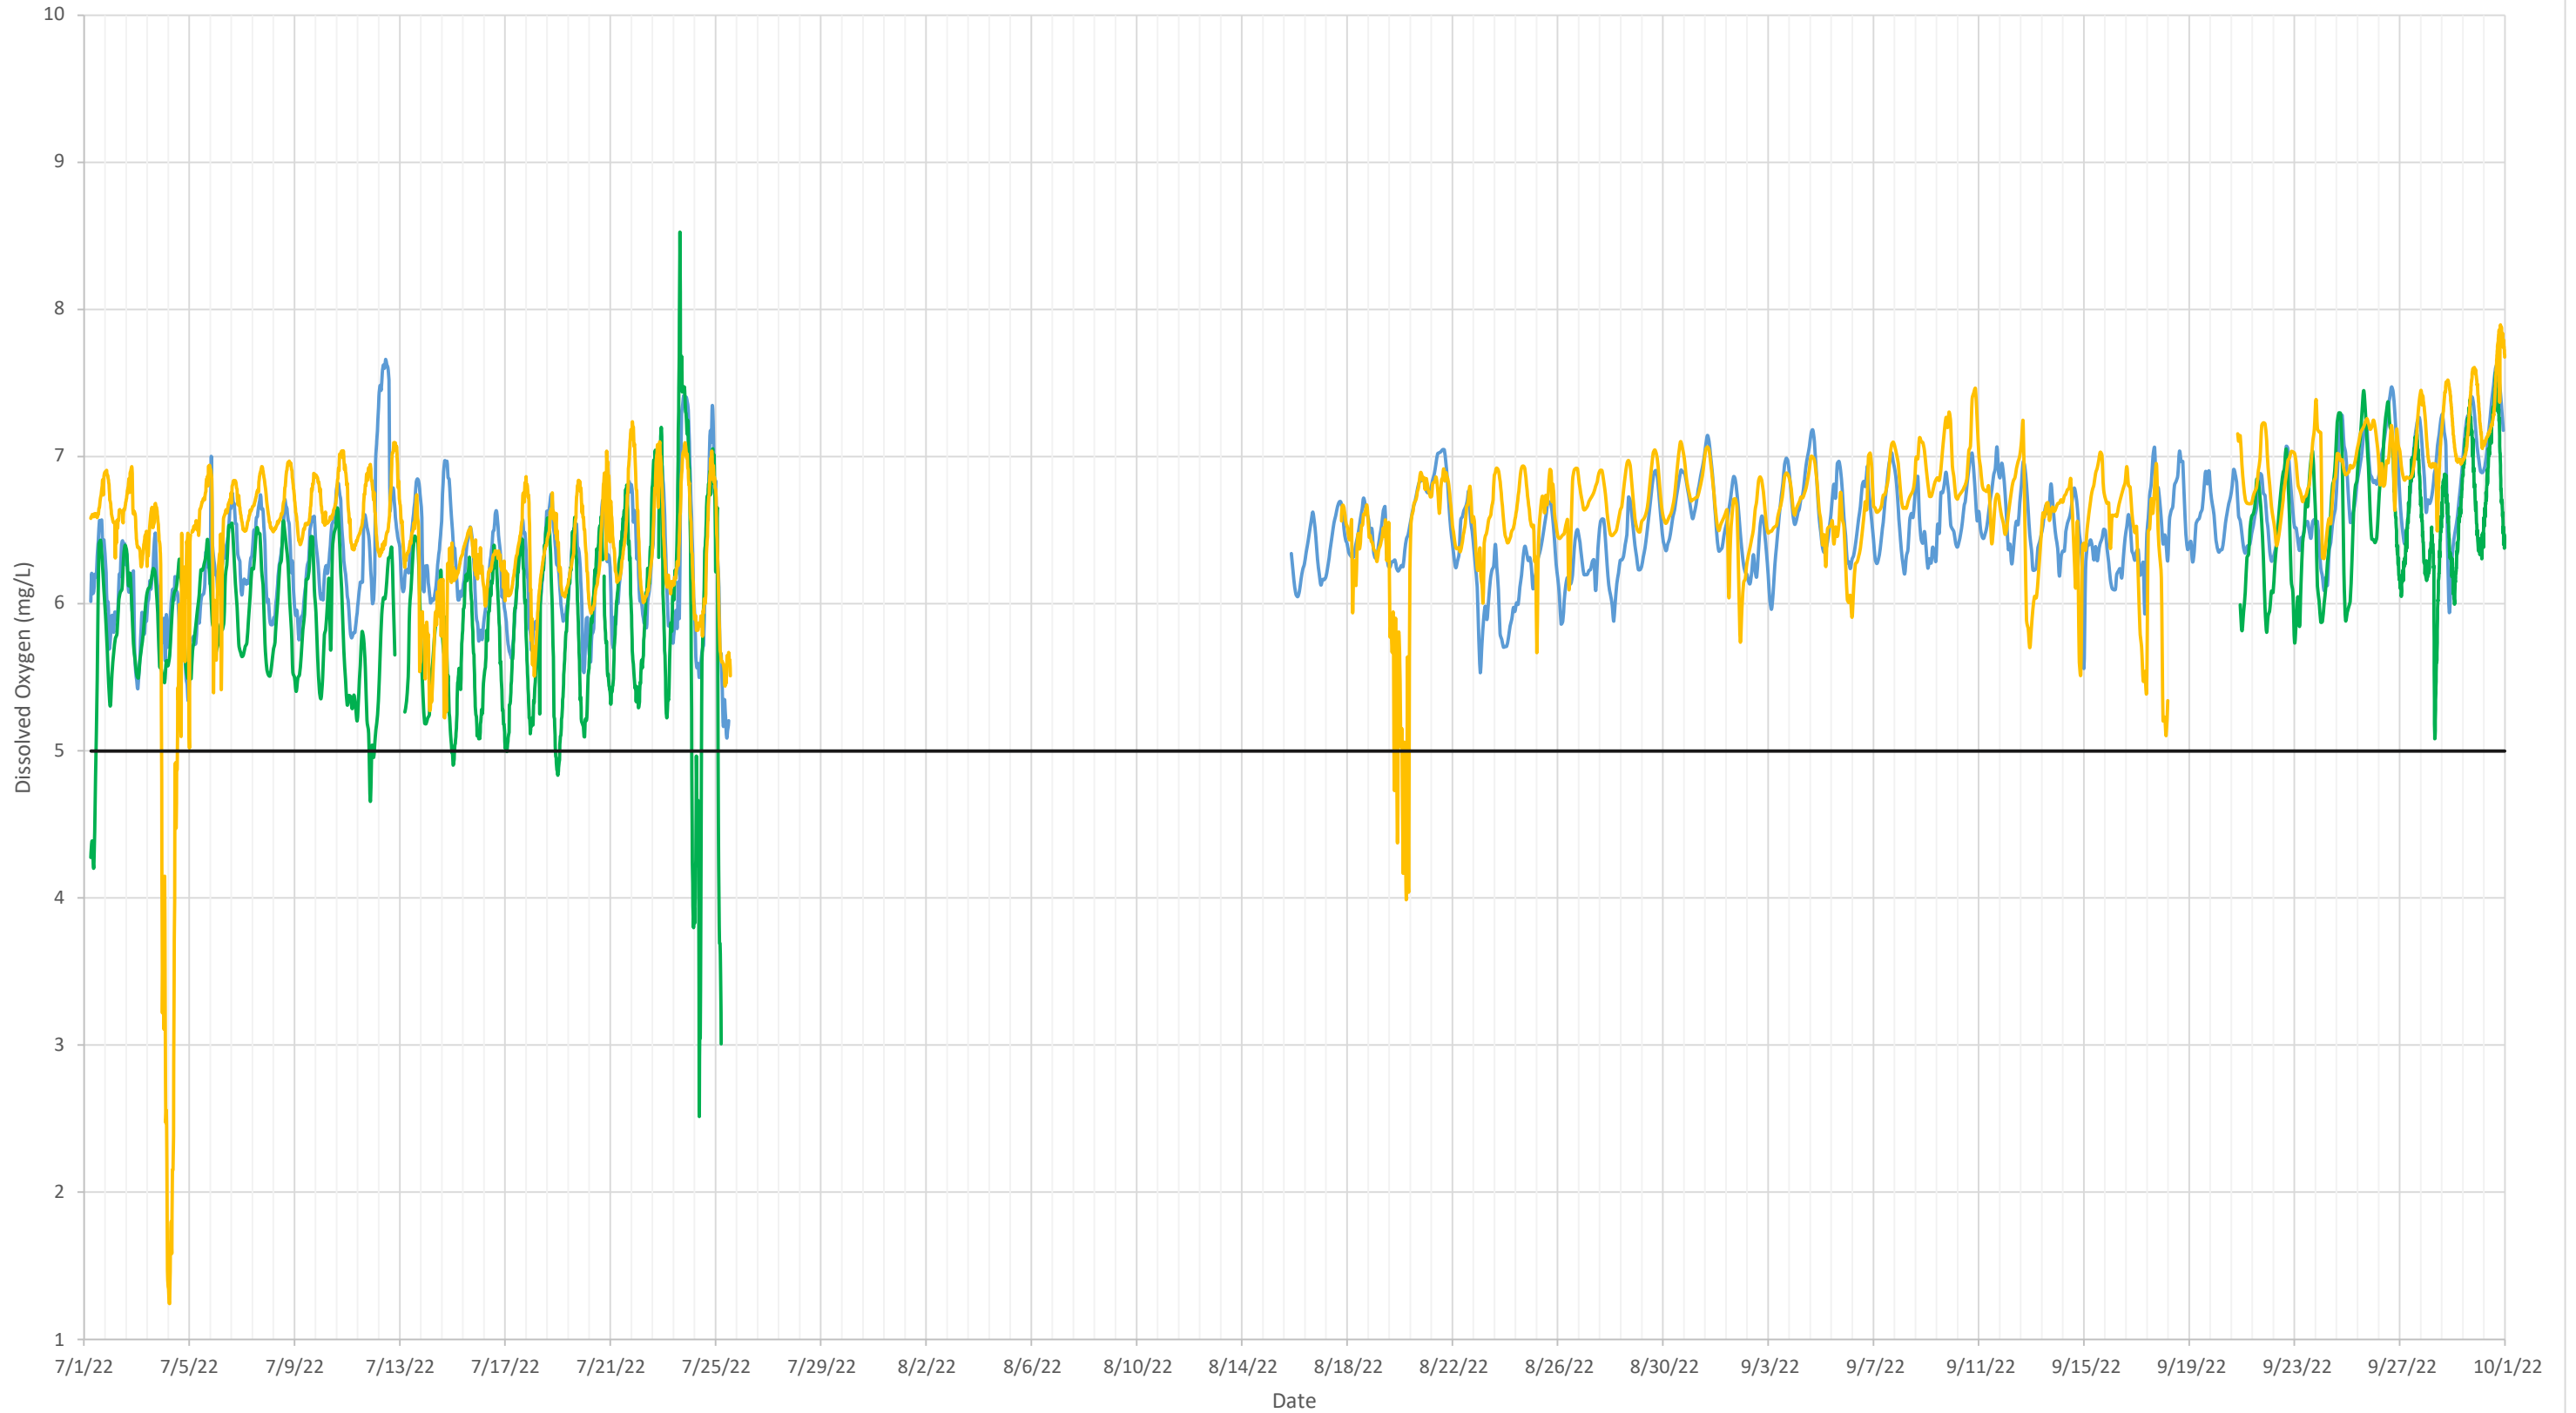
### Dissolved Oxygen - All Sondes - Quarter 3, 2022

Isleta Central Sandia 550 DO Exceedance (5 mg/L)

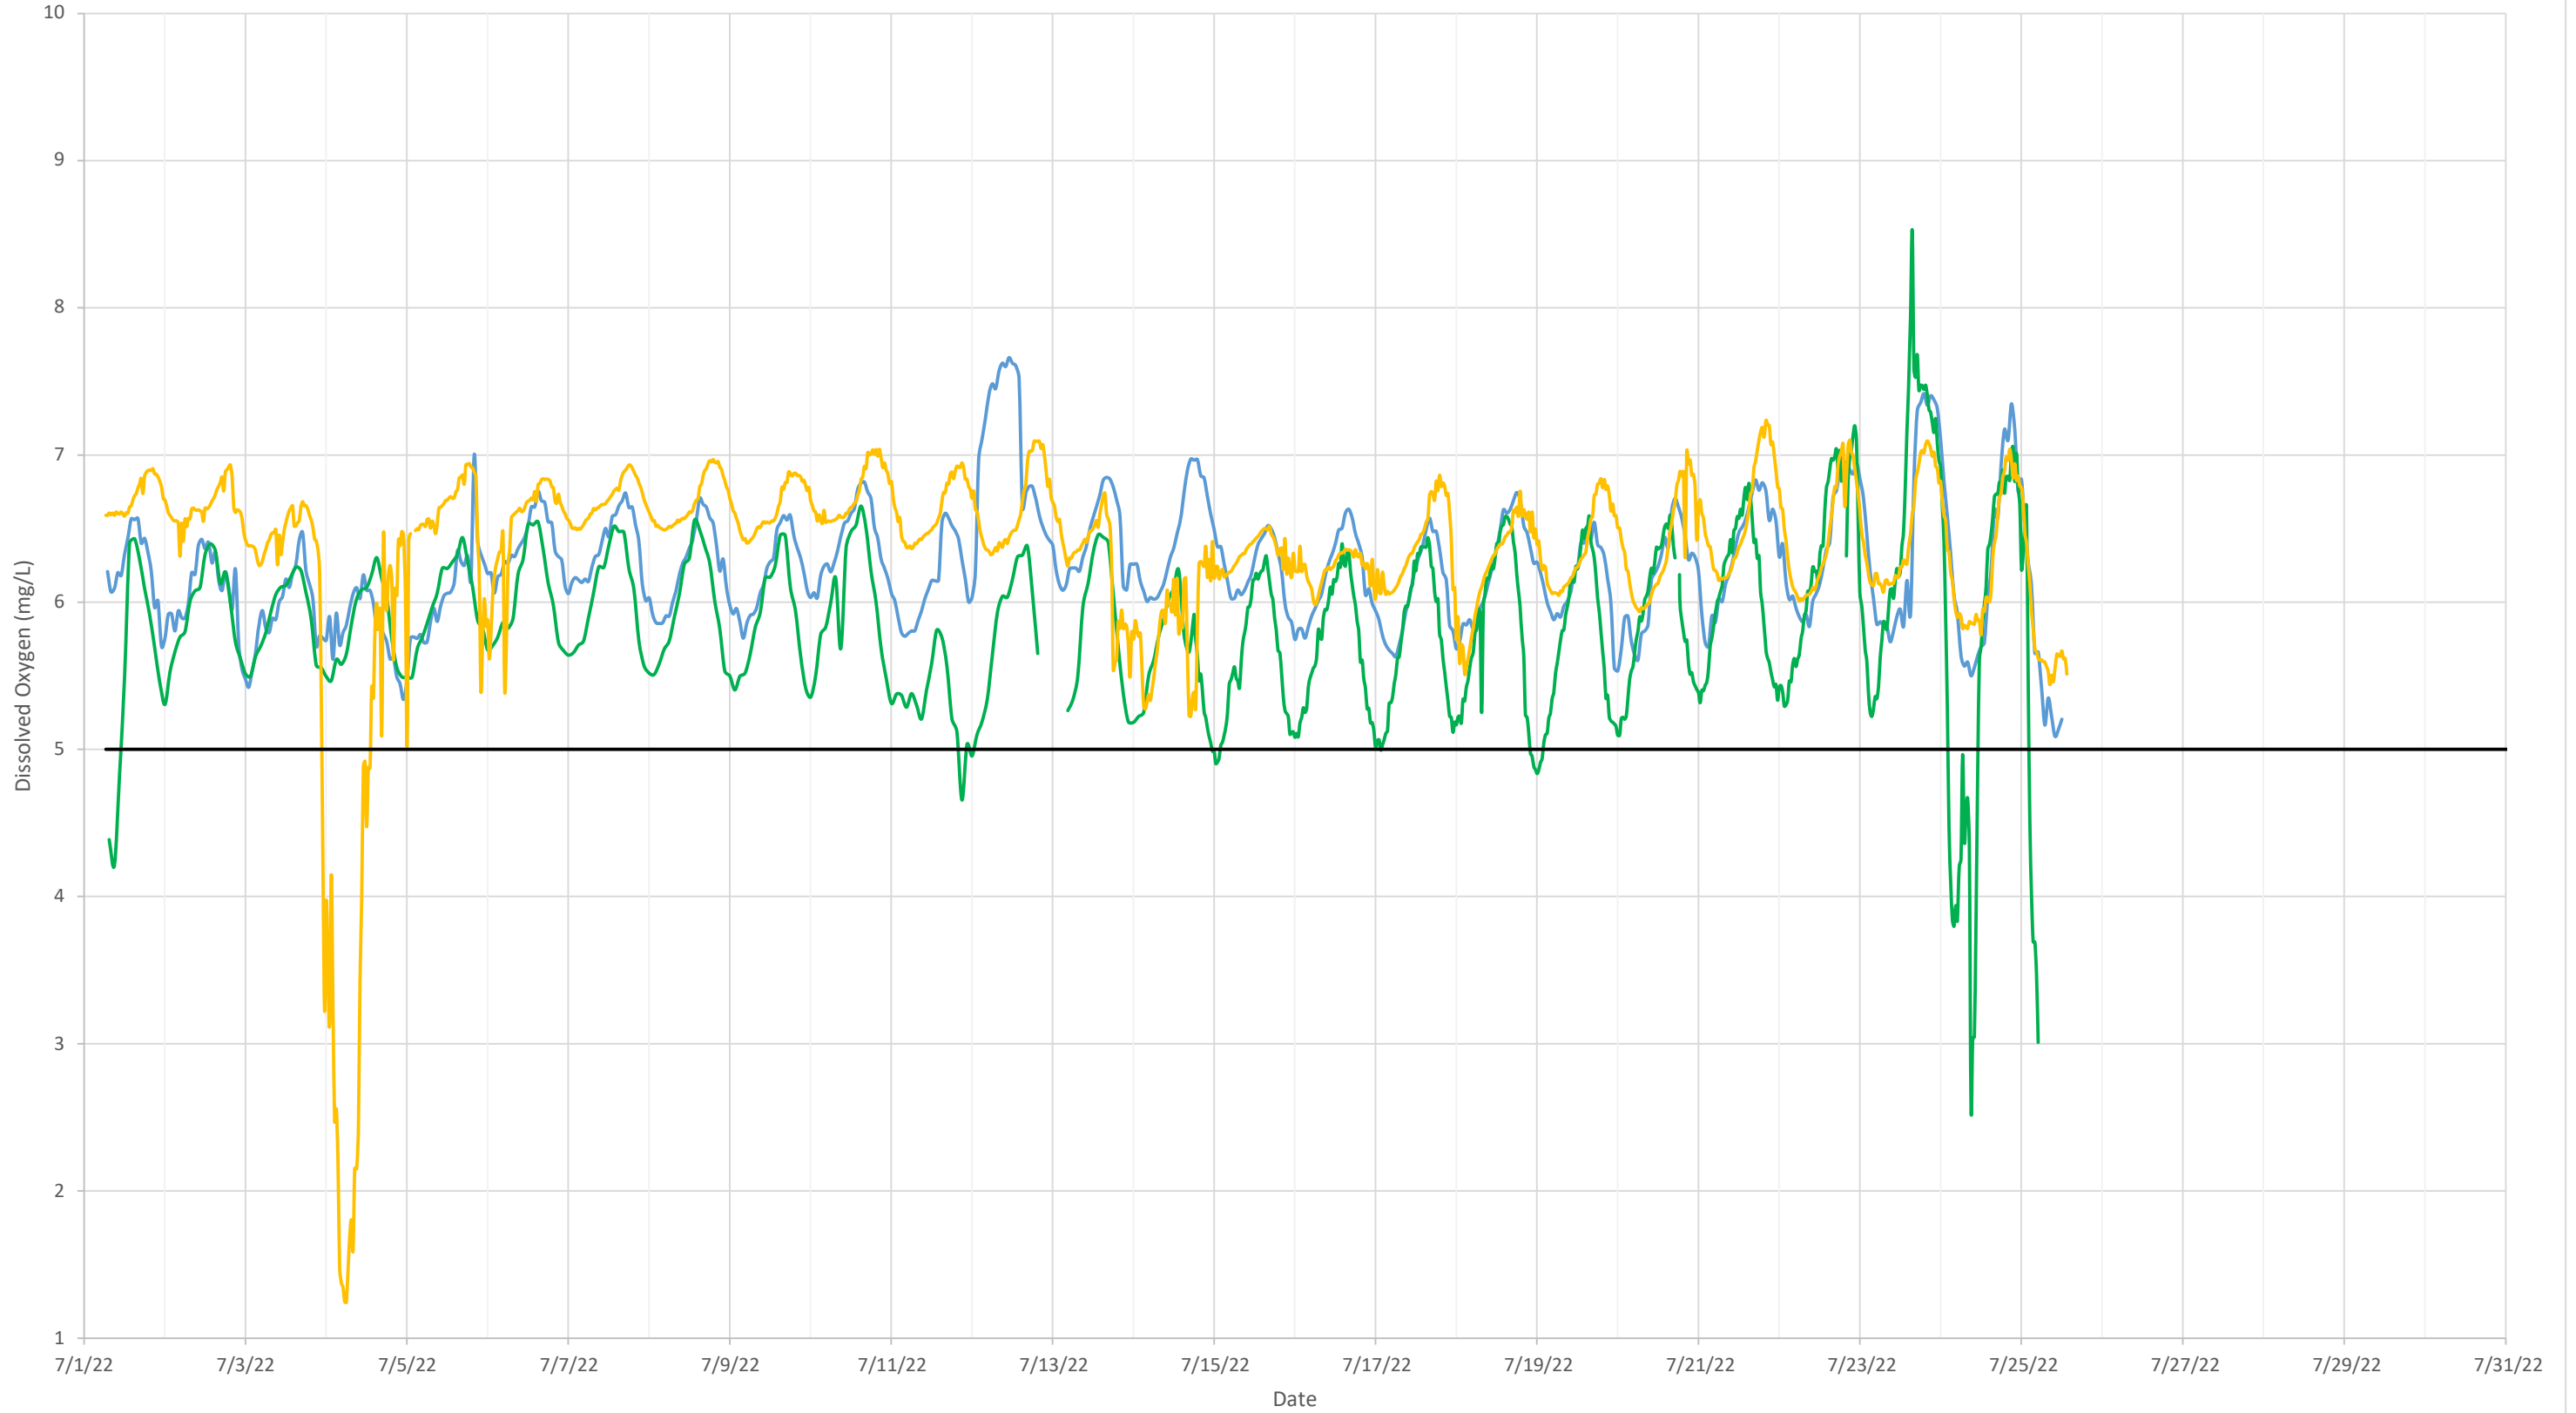
Dissolved Oxygen - All Sondes - July 2022

Isleta Central Sandia 550 DO Exceedance (5 mg/L)

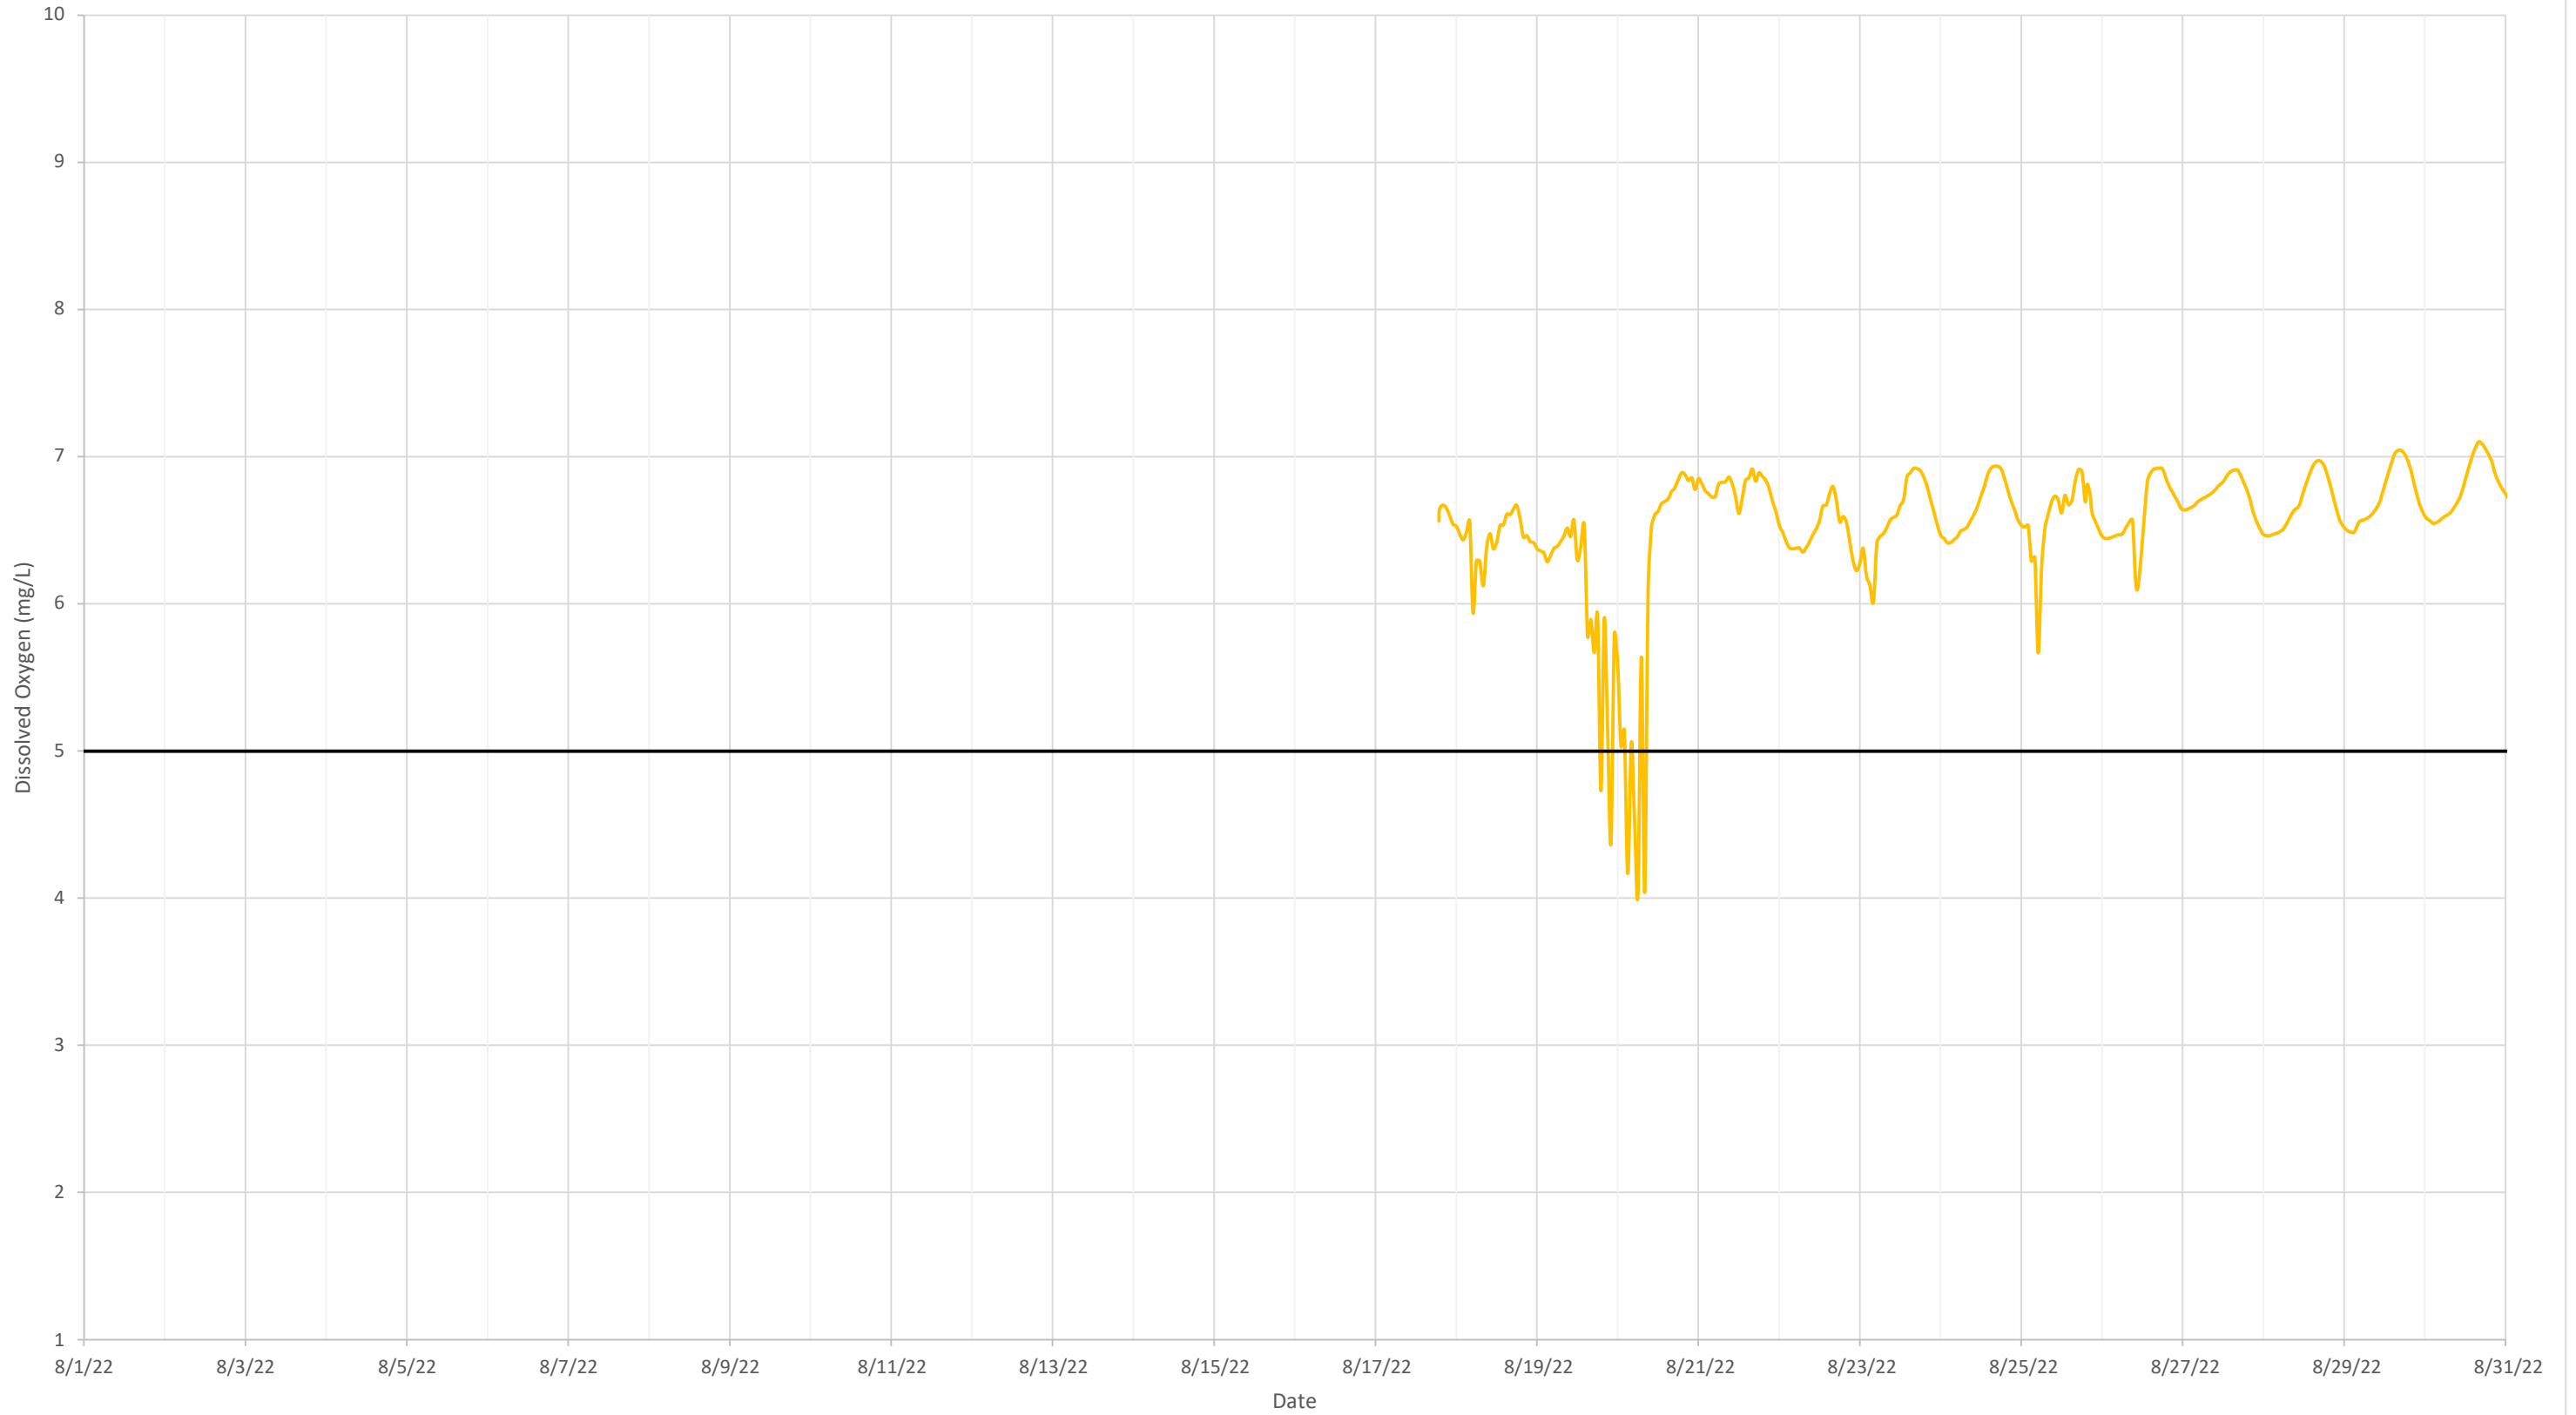
### Dissolved Oxygen - All Sondes - August 2022

Isleta Central Sandia 550 DO Exceedance (5 mg/L)

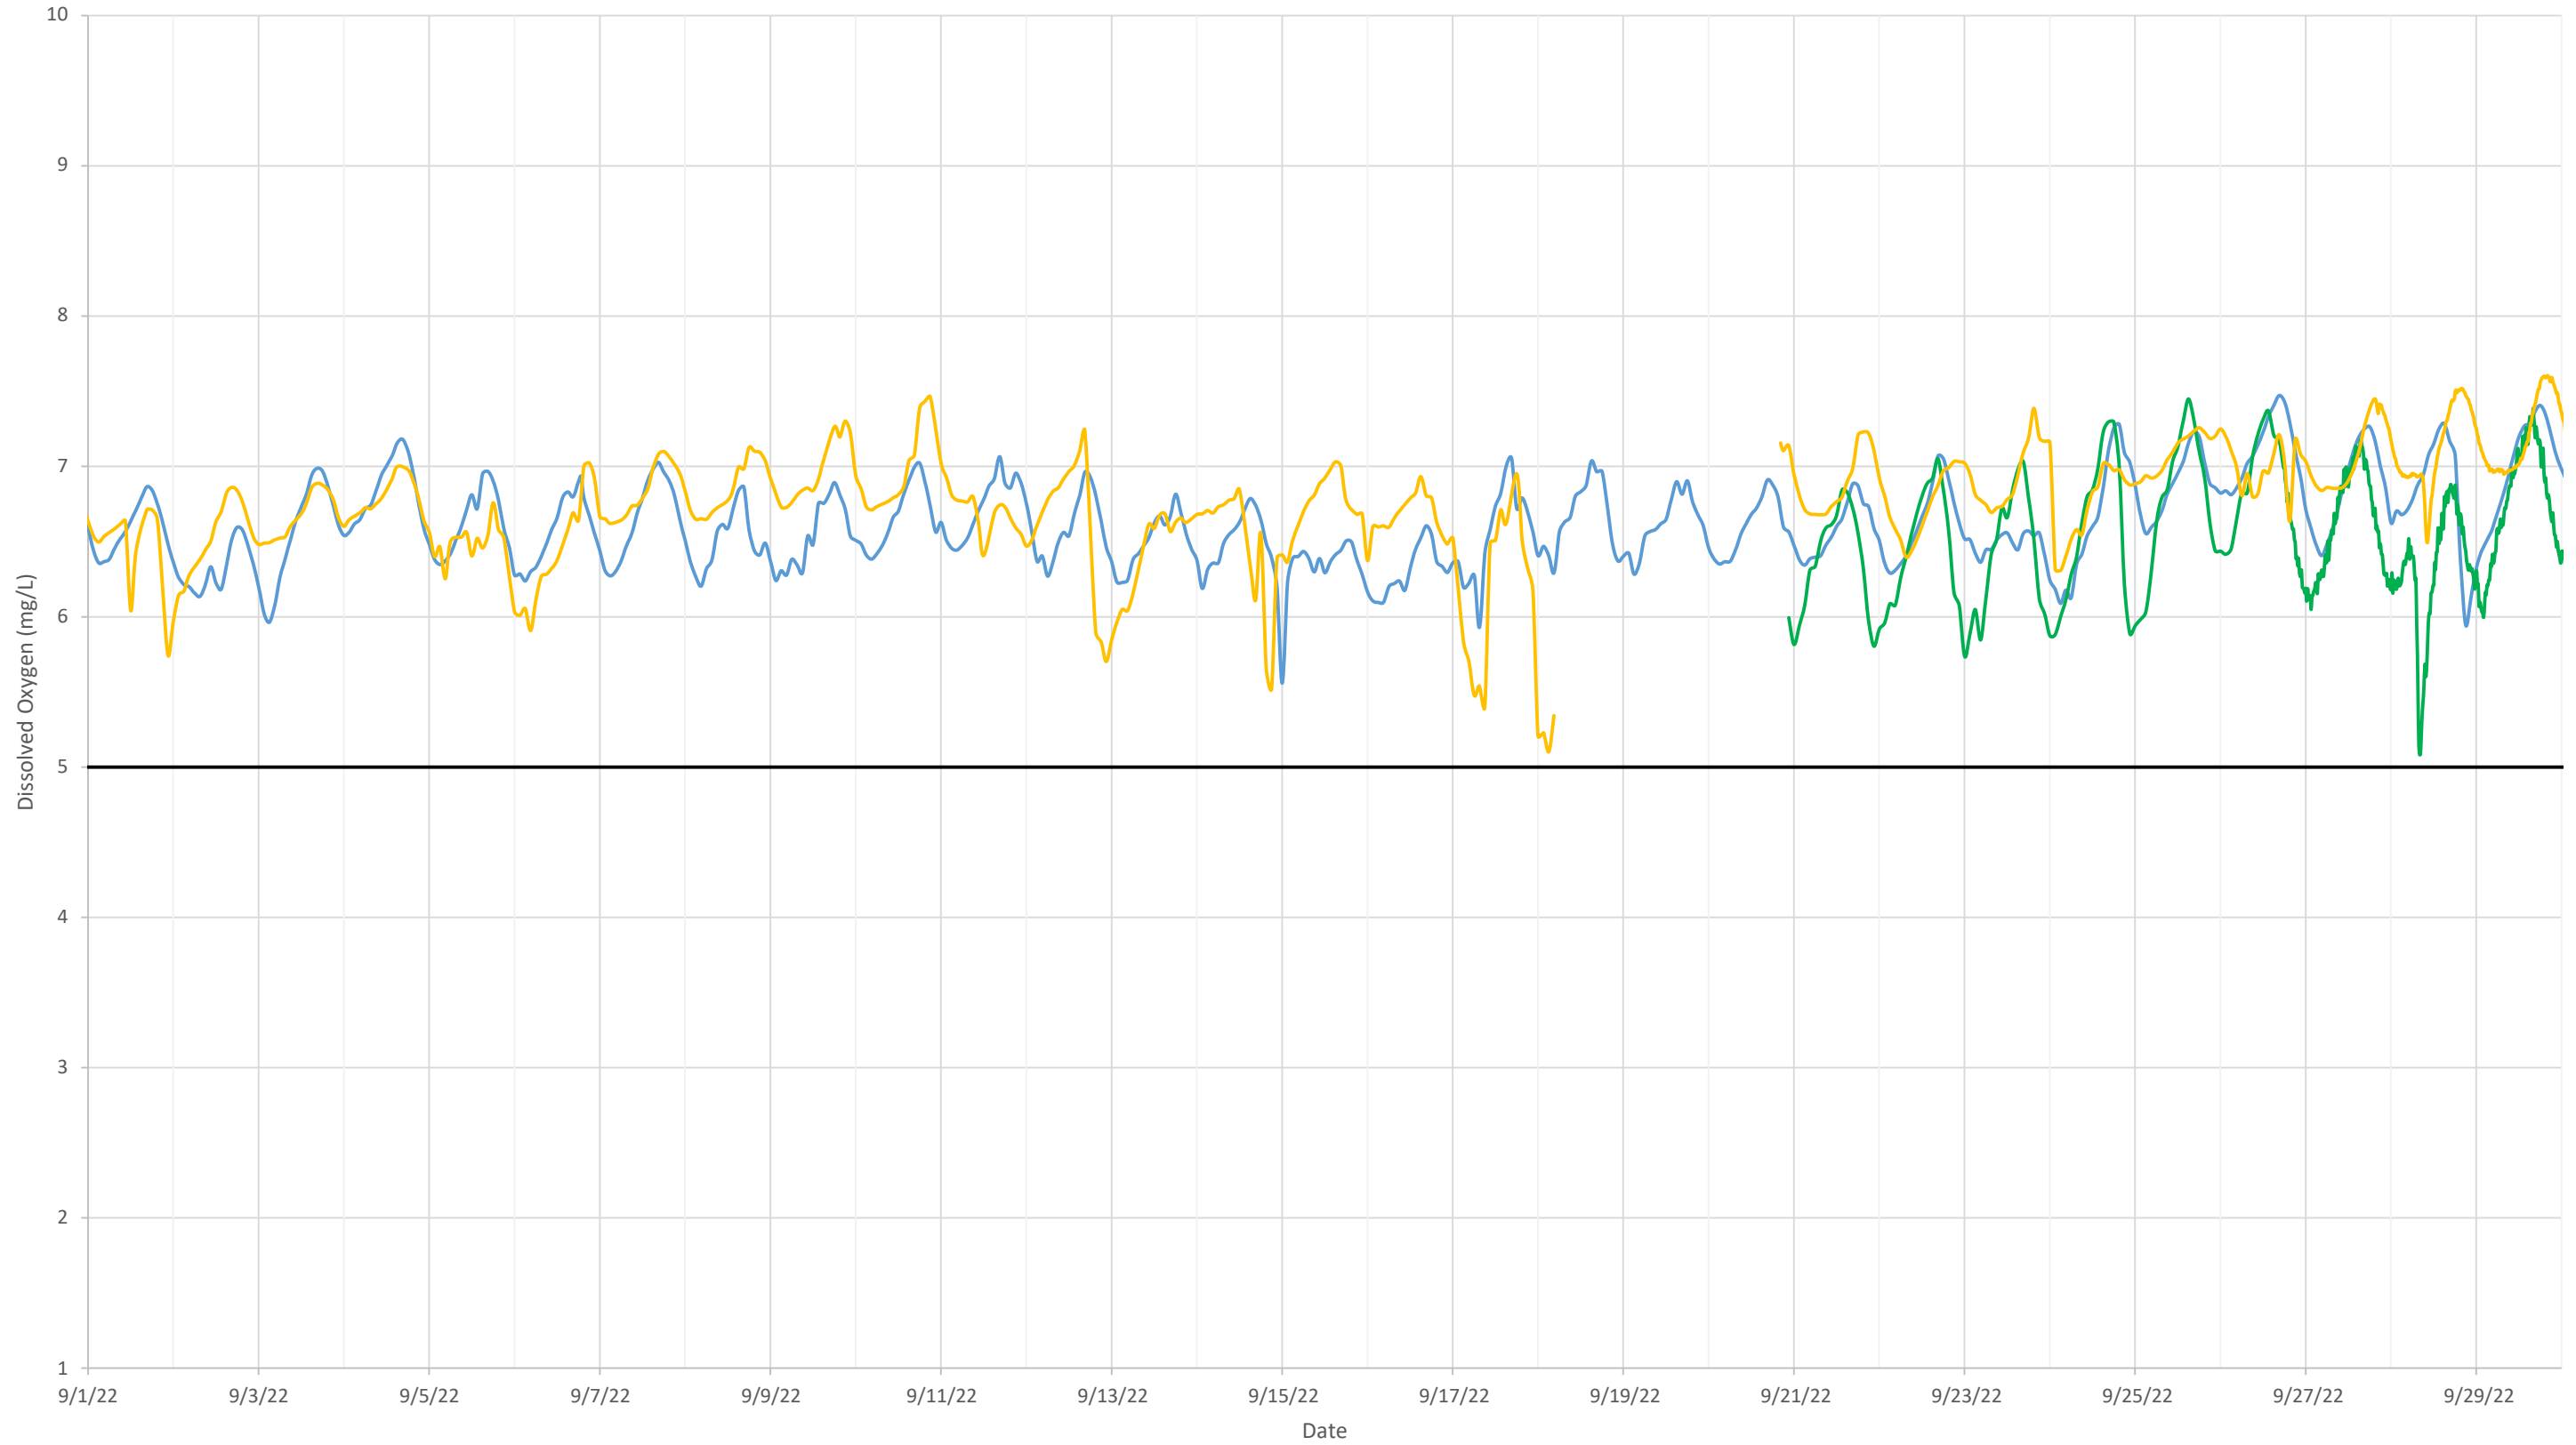
Dissolved Oxygen - All Sondes - September 2022

Isleta Central Sandia 550 DO Exceedance (5 mg/L)

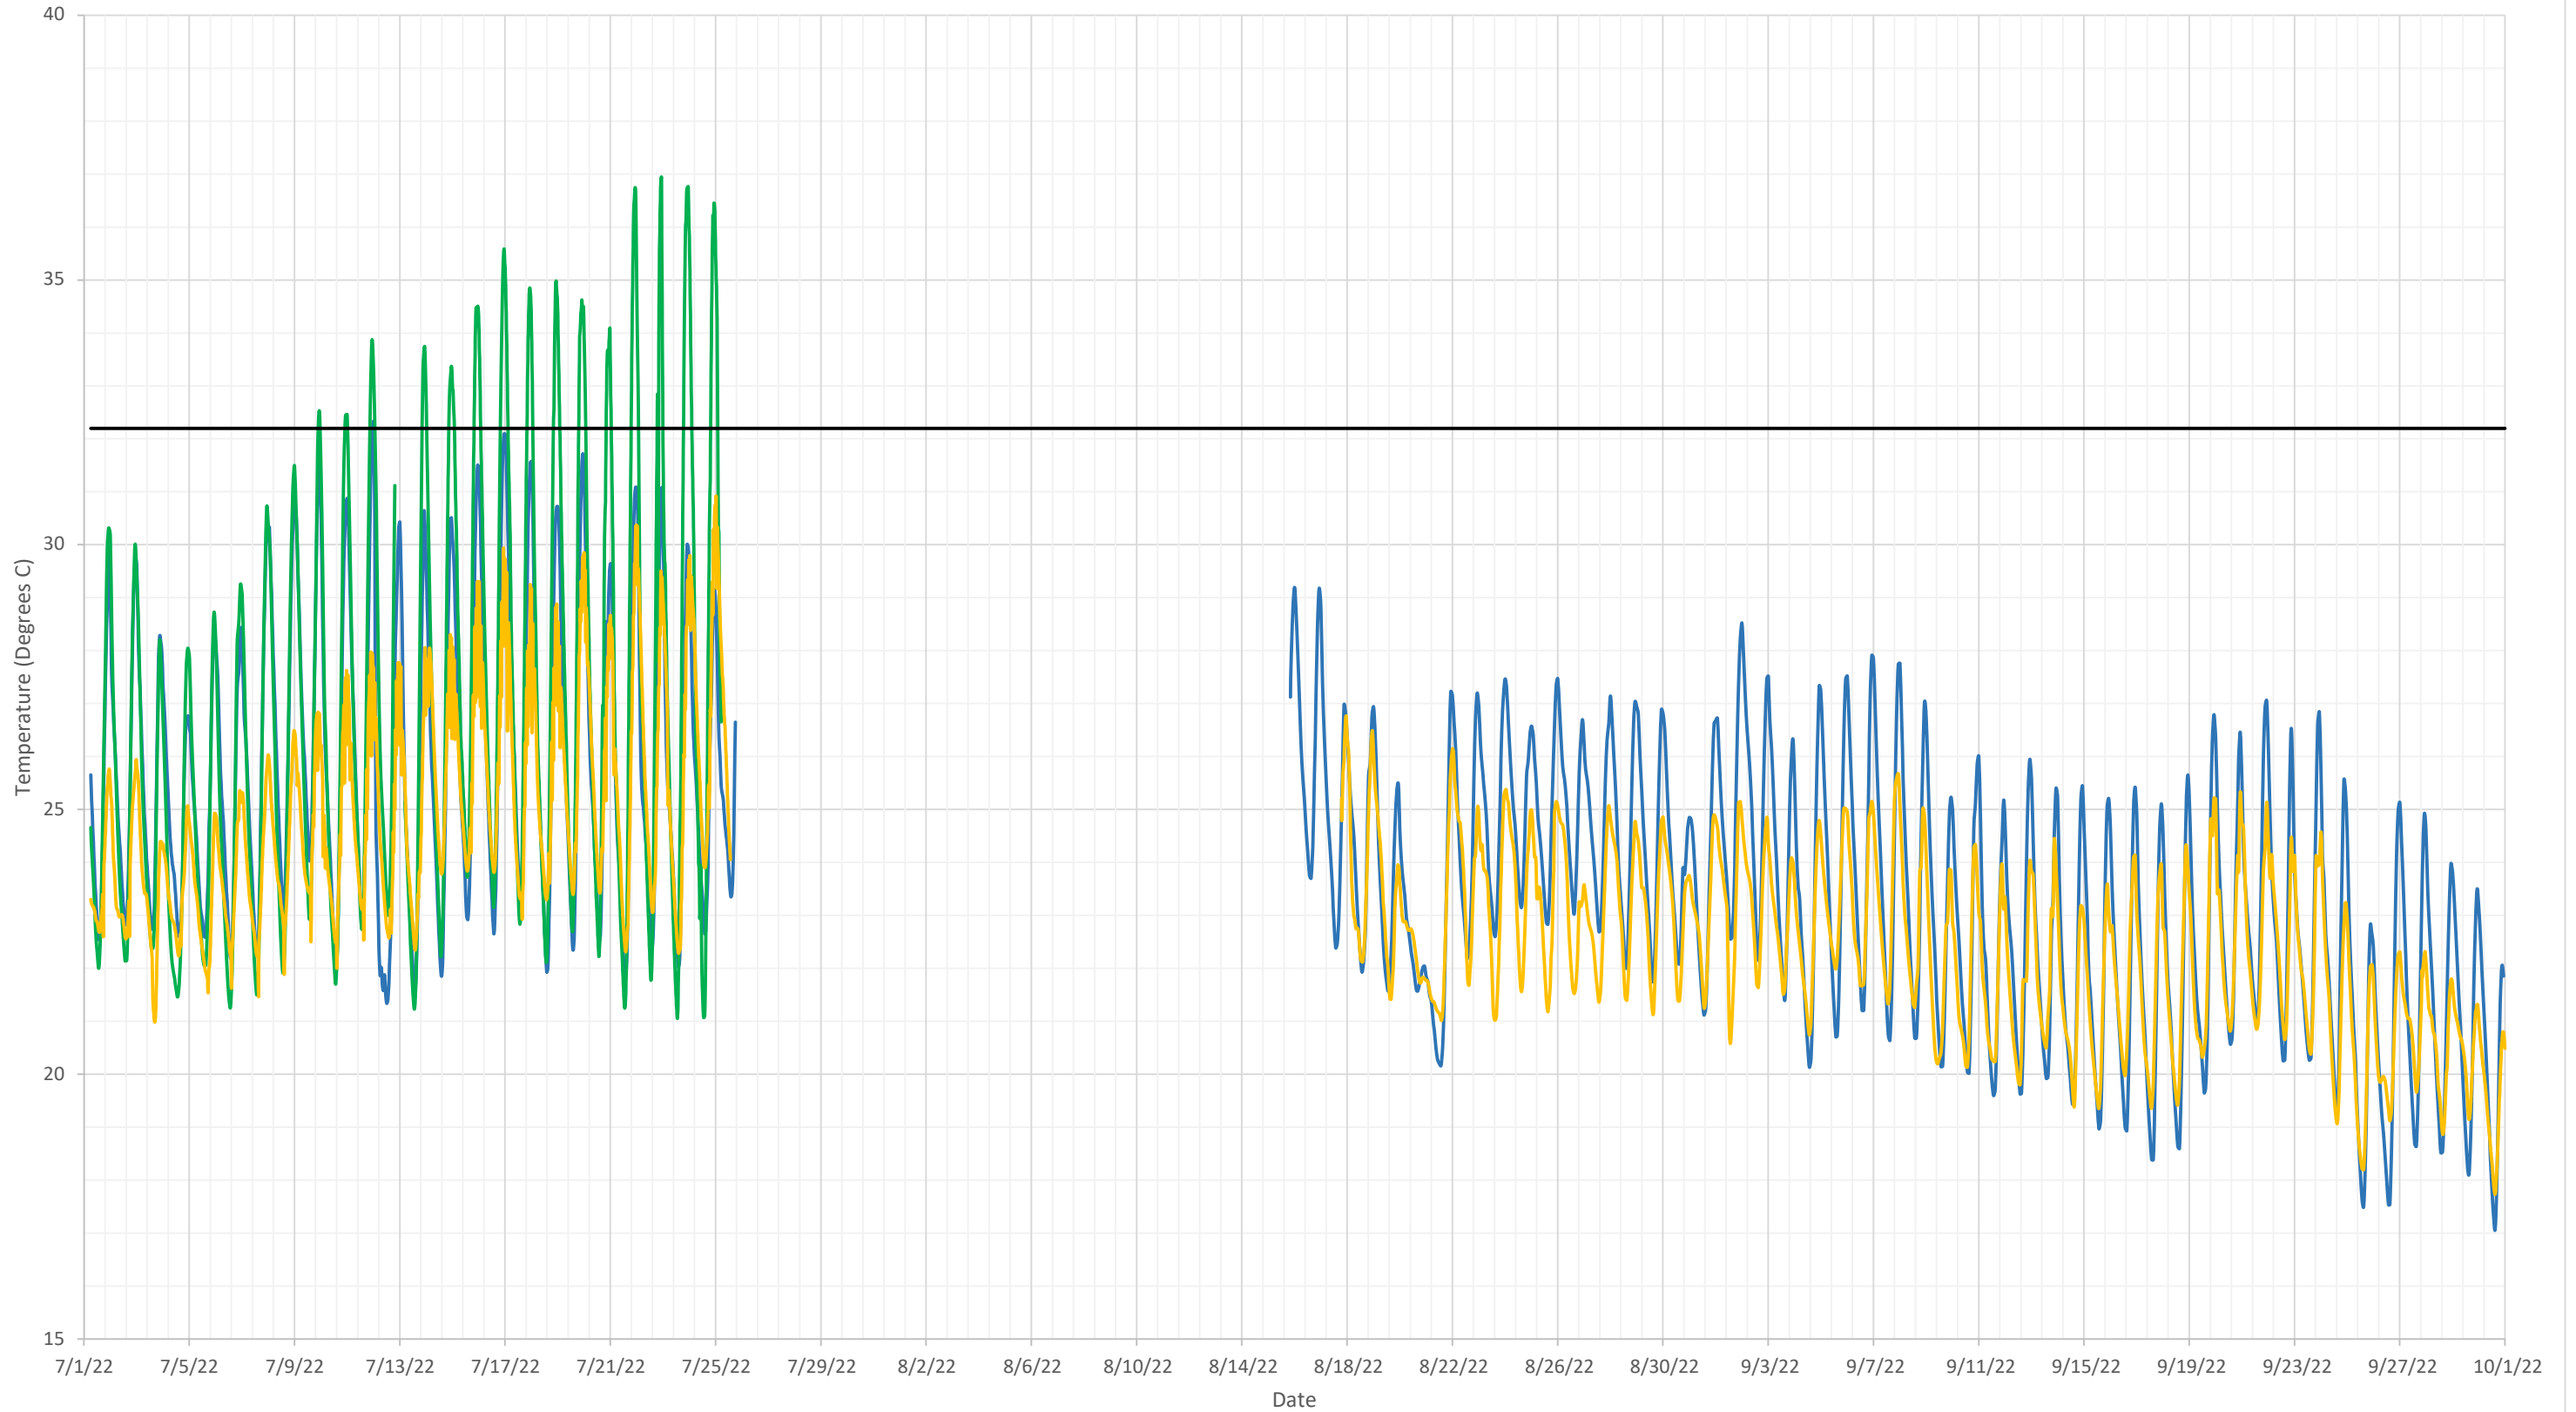
### Temperature - All Sondes - Quarter 3, 2022

Isleta Central Sandia 550 Temperature Exceedance (32F)

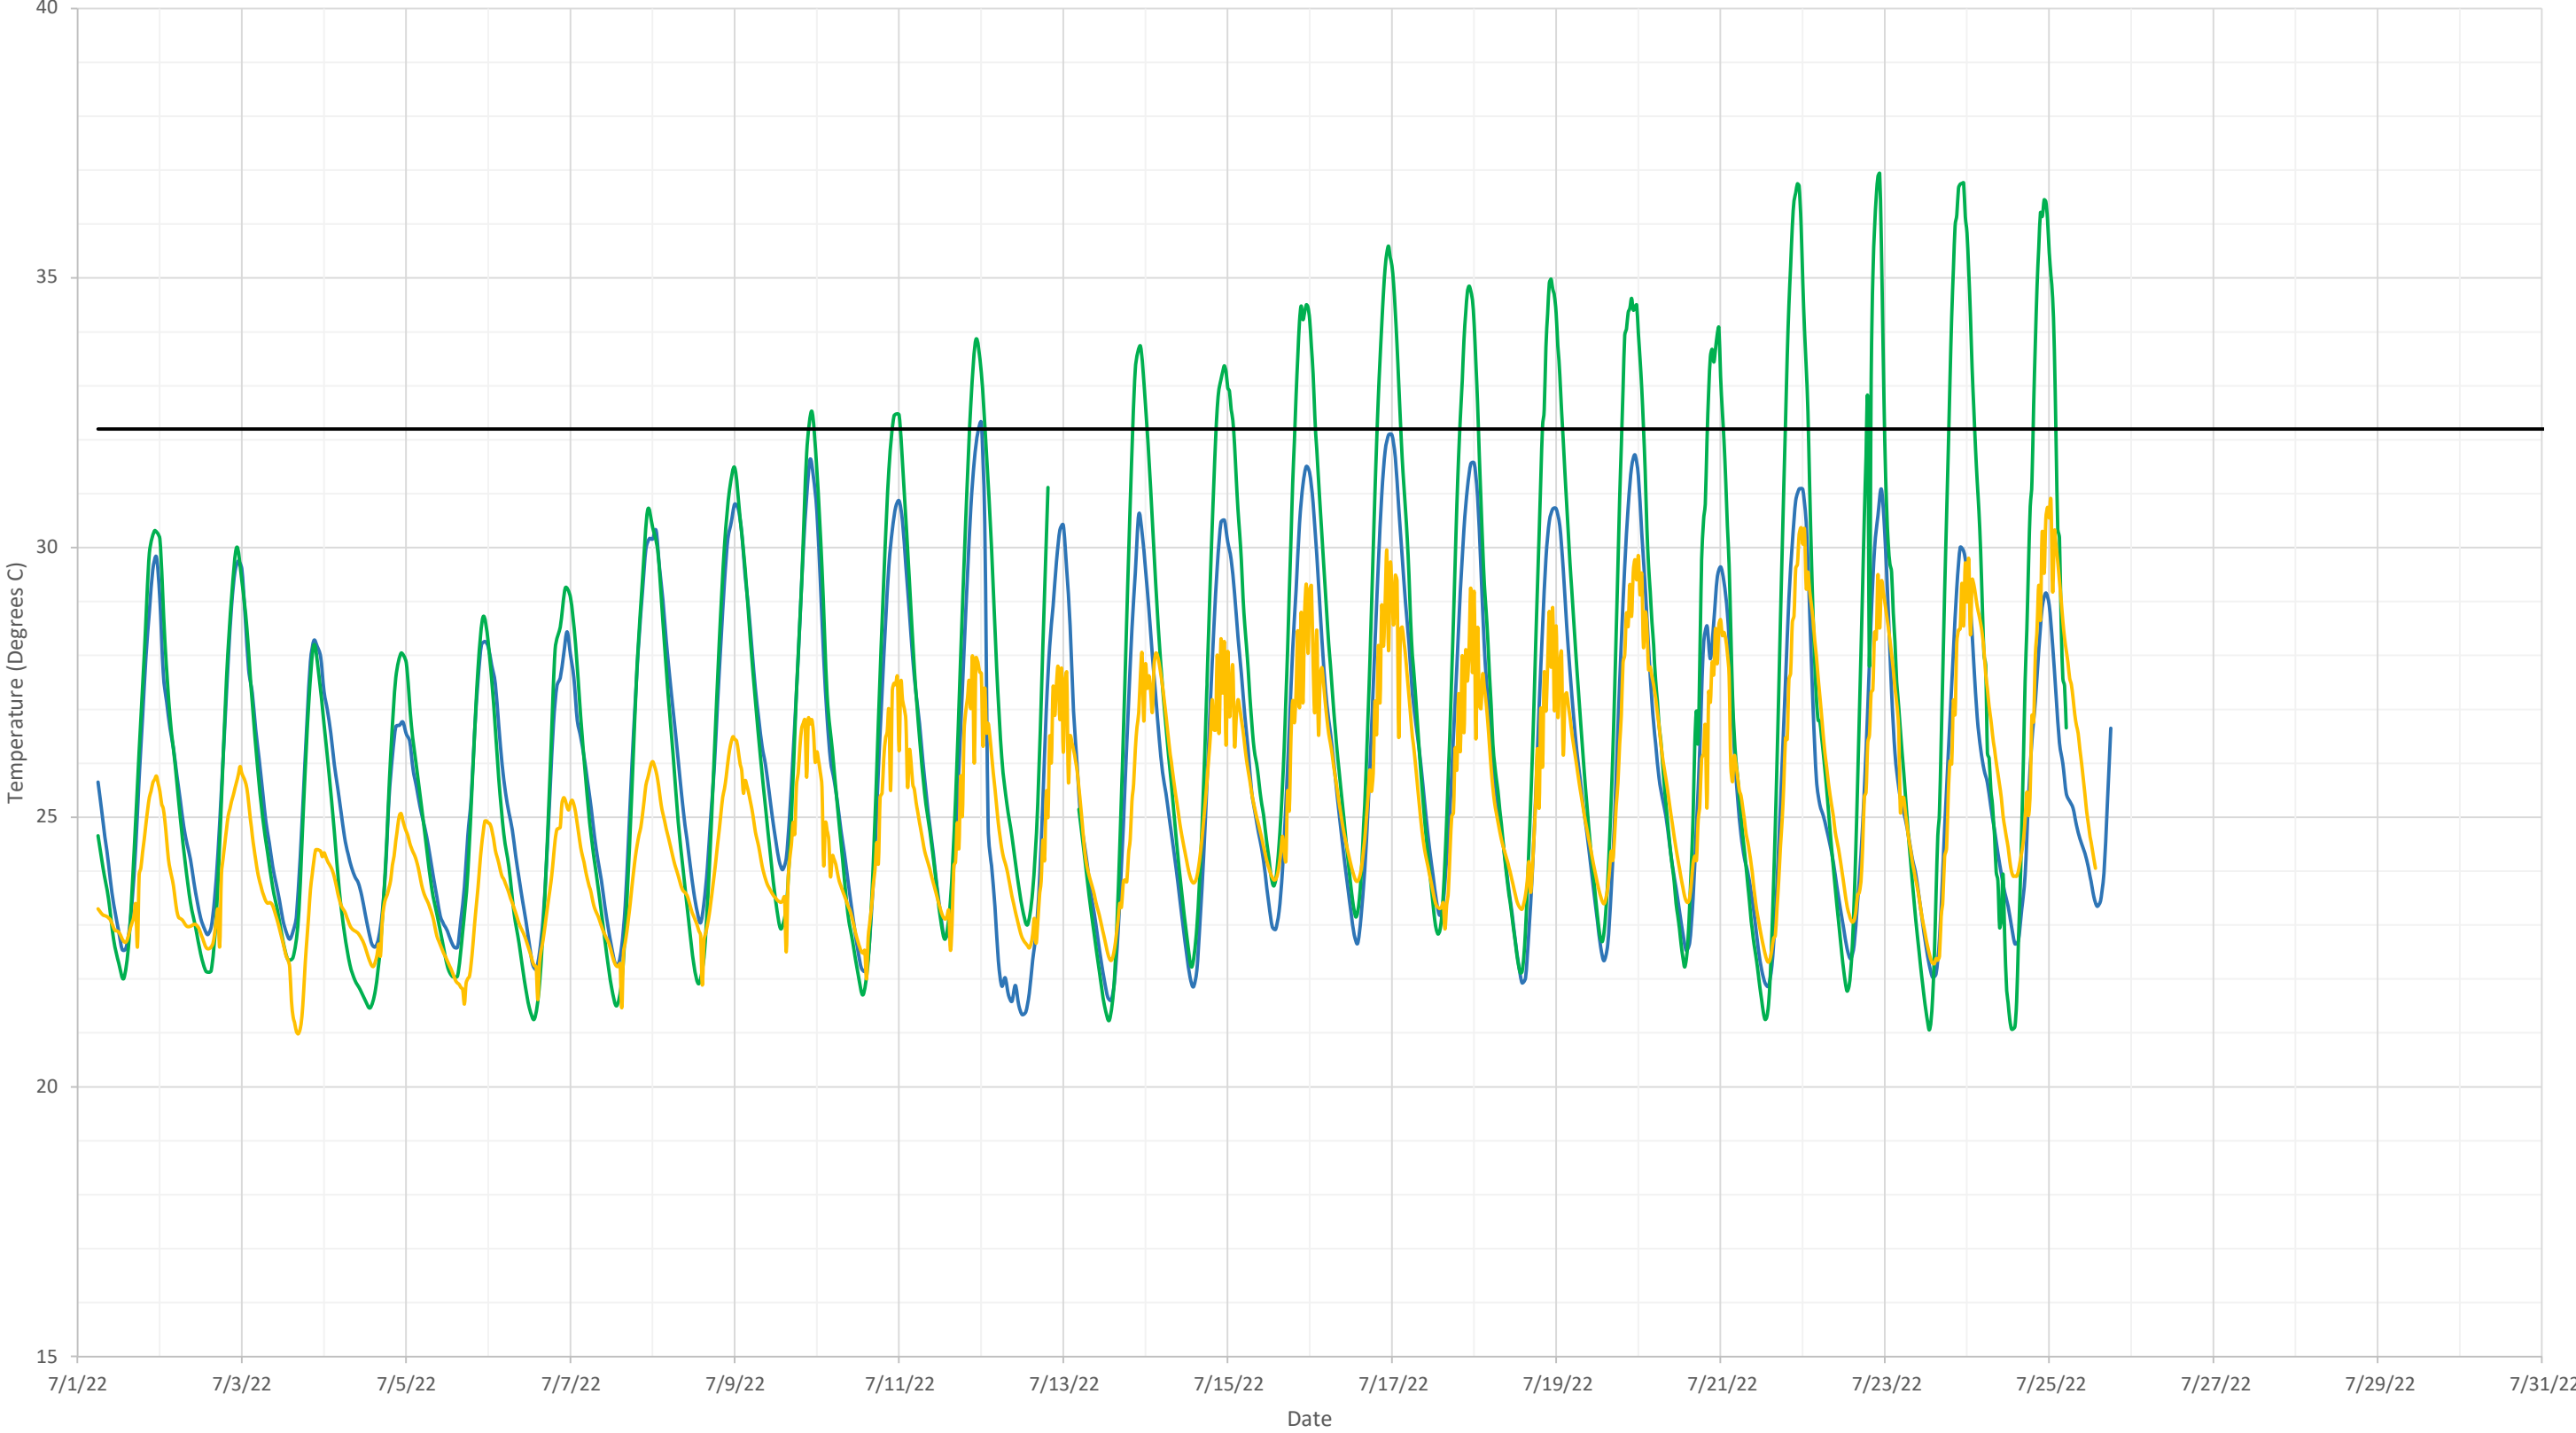
Temperature - All Sondes - July 2022

Isleta Central Sandia 550 Temperature Exceedance (32F)
