**Re: Third Quarter (July – September) 2022 In-Stream Water Quality Monitoring Memo**

## **1 Background**

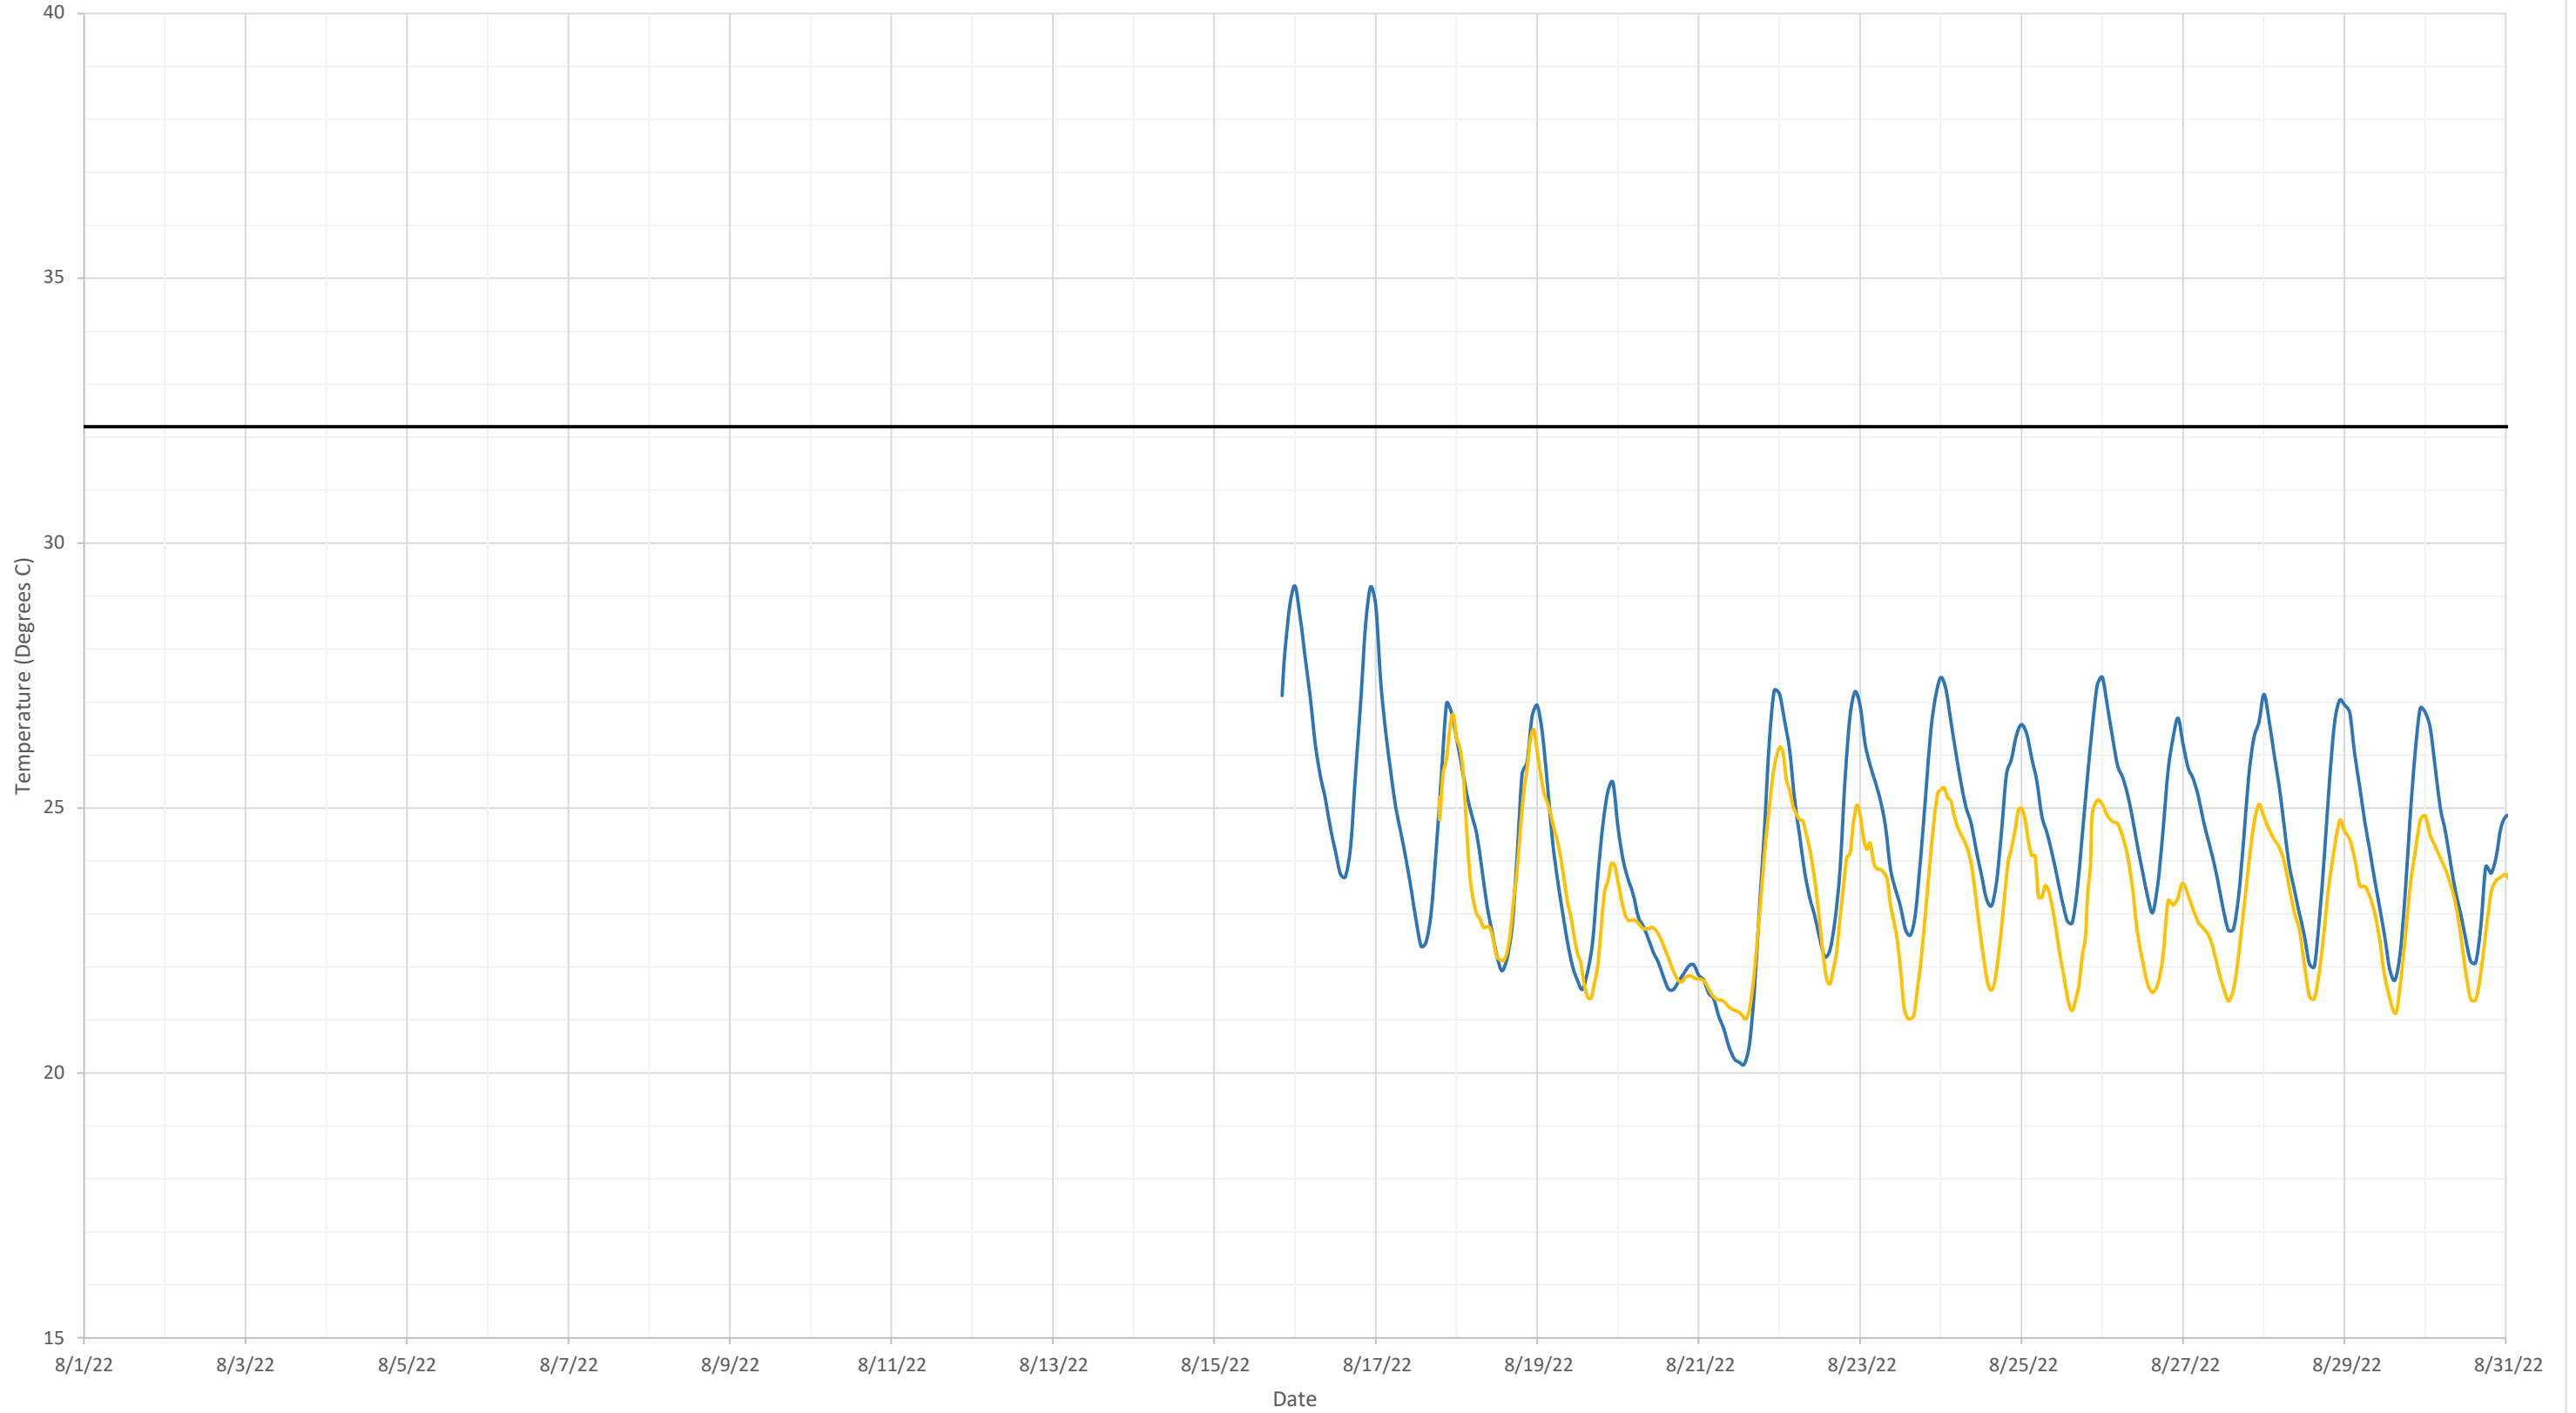
### Temperature - All Sondes - August 2022

Isleta Central Sandia 550 Temperature Exceedance (32F)

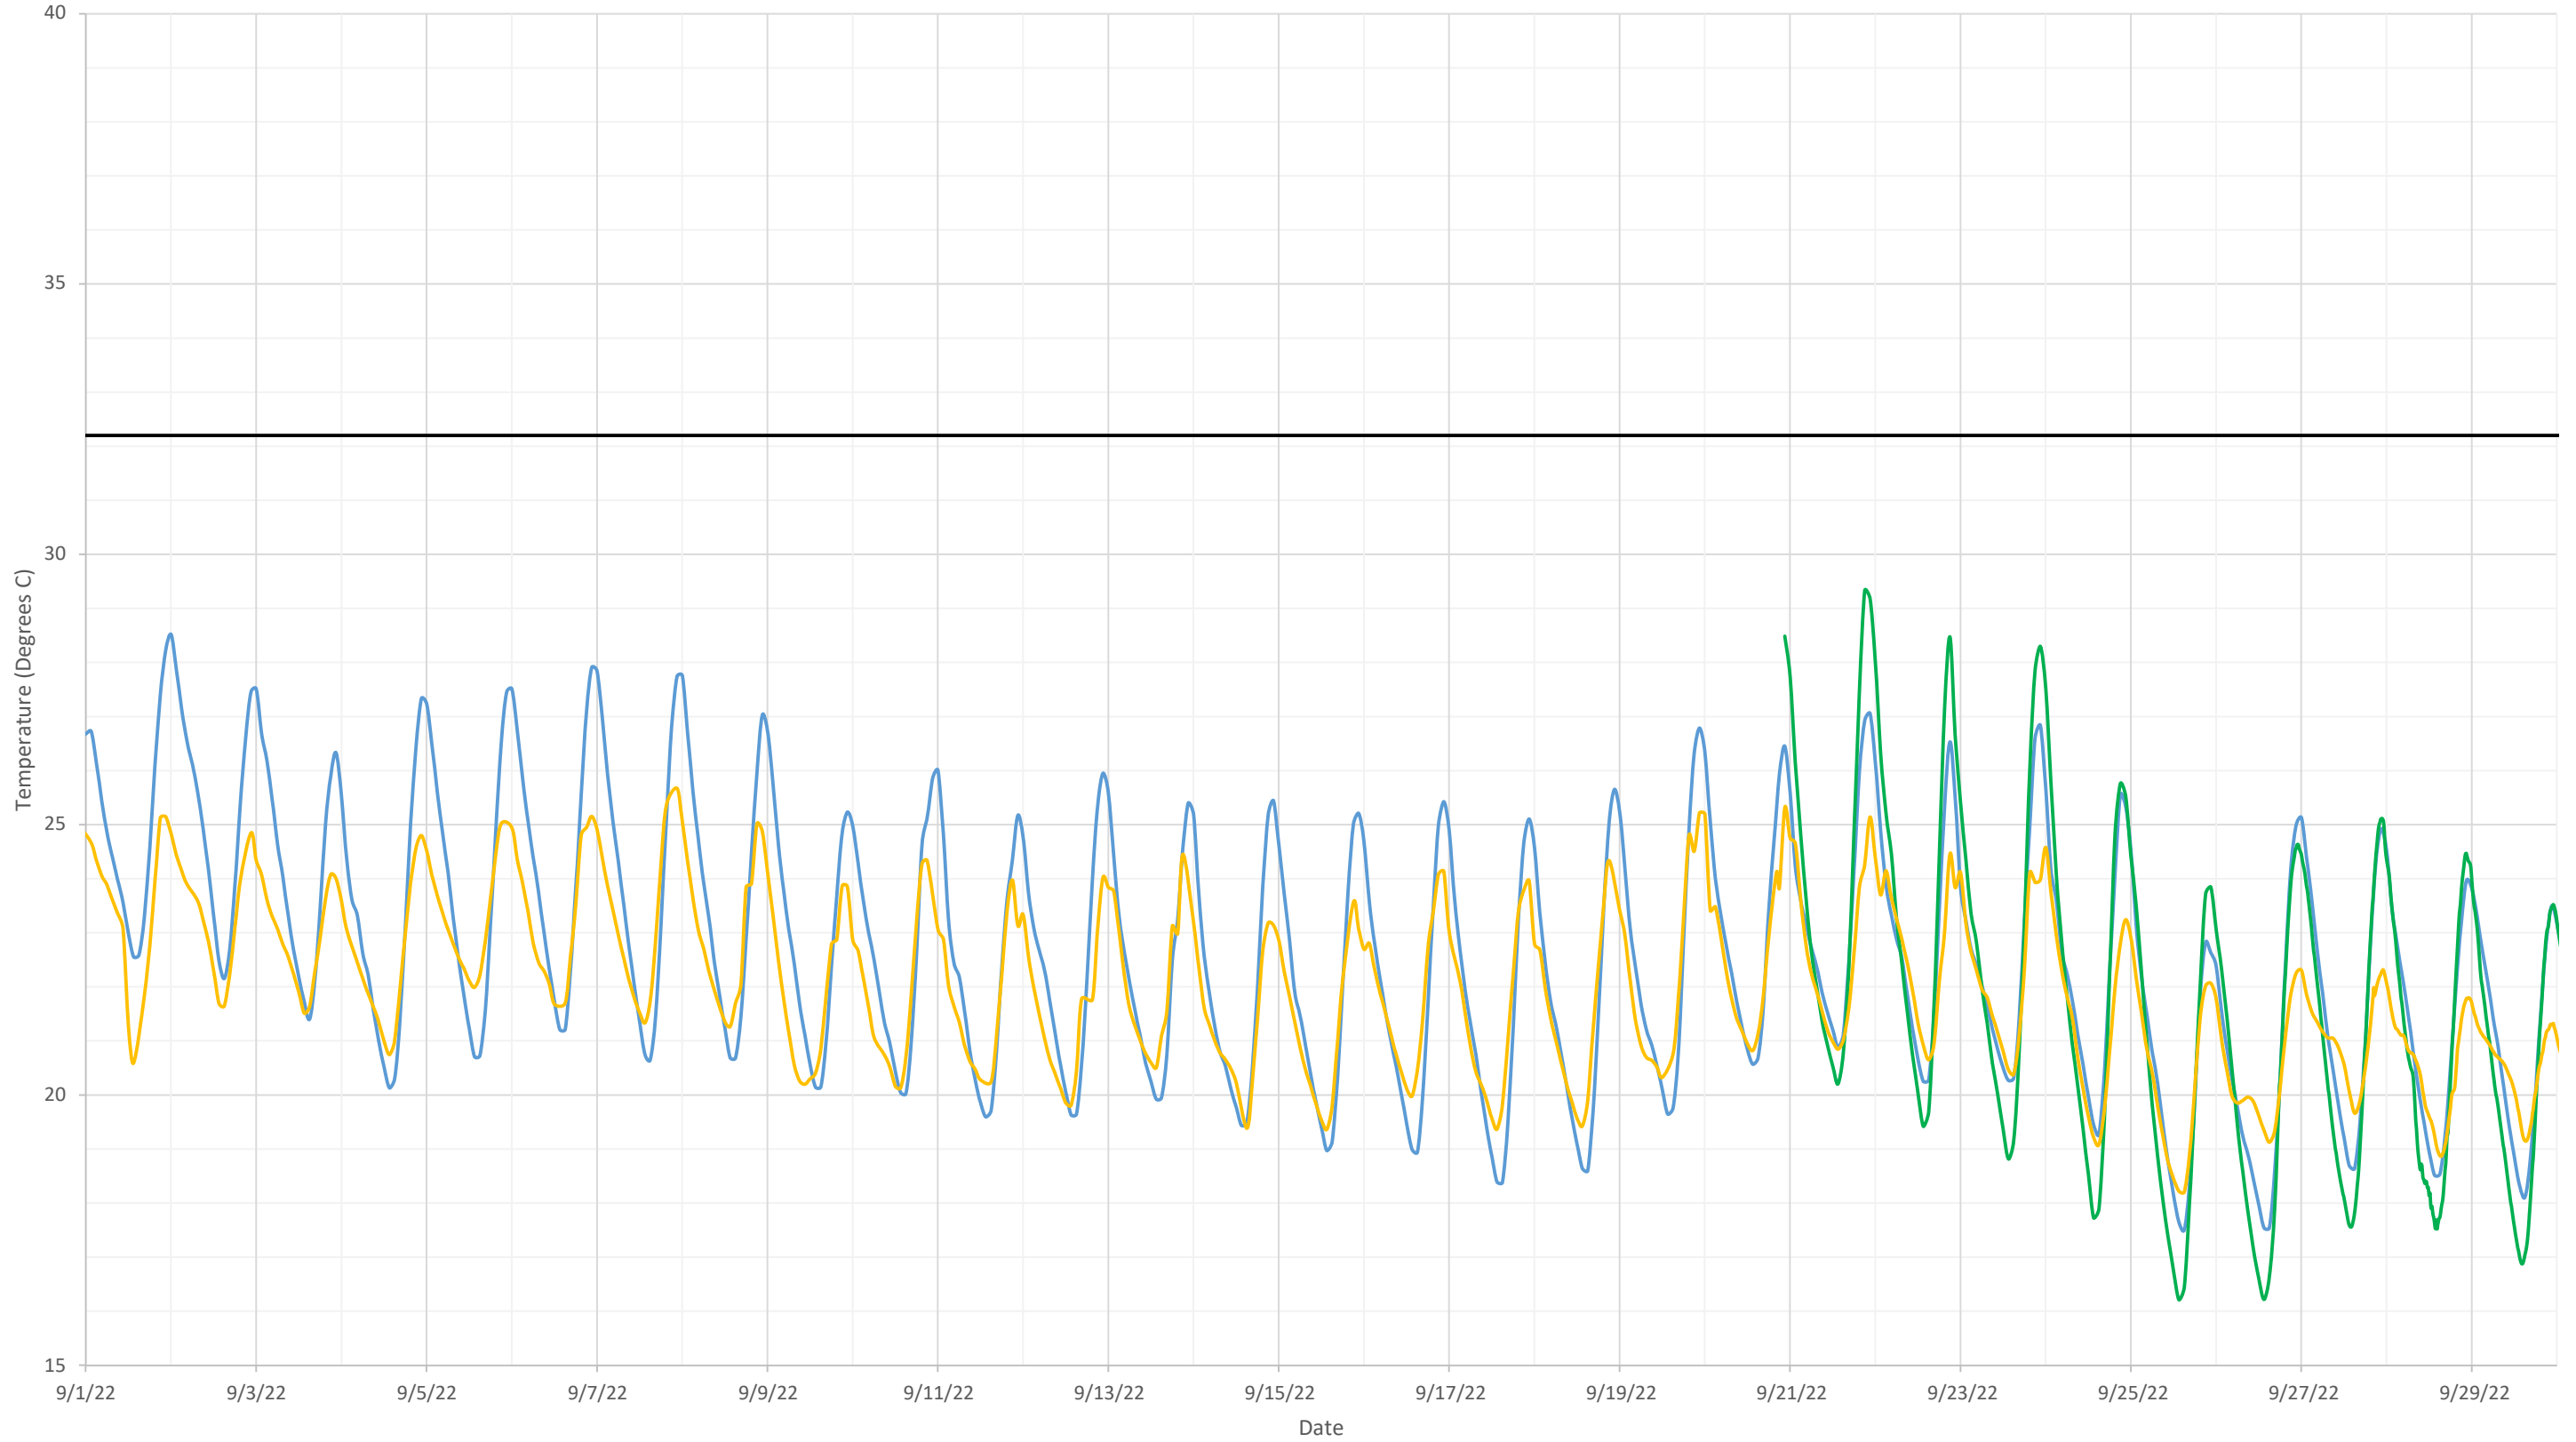
Temperature - All Sondes - September 2022

Isleta Central Sandia 550 Temperature Exceedance (32F)

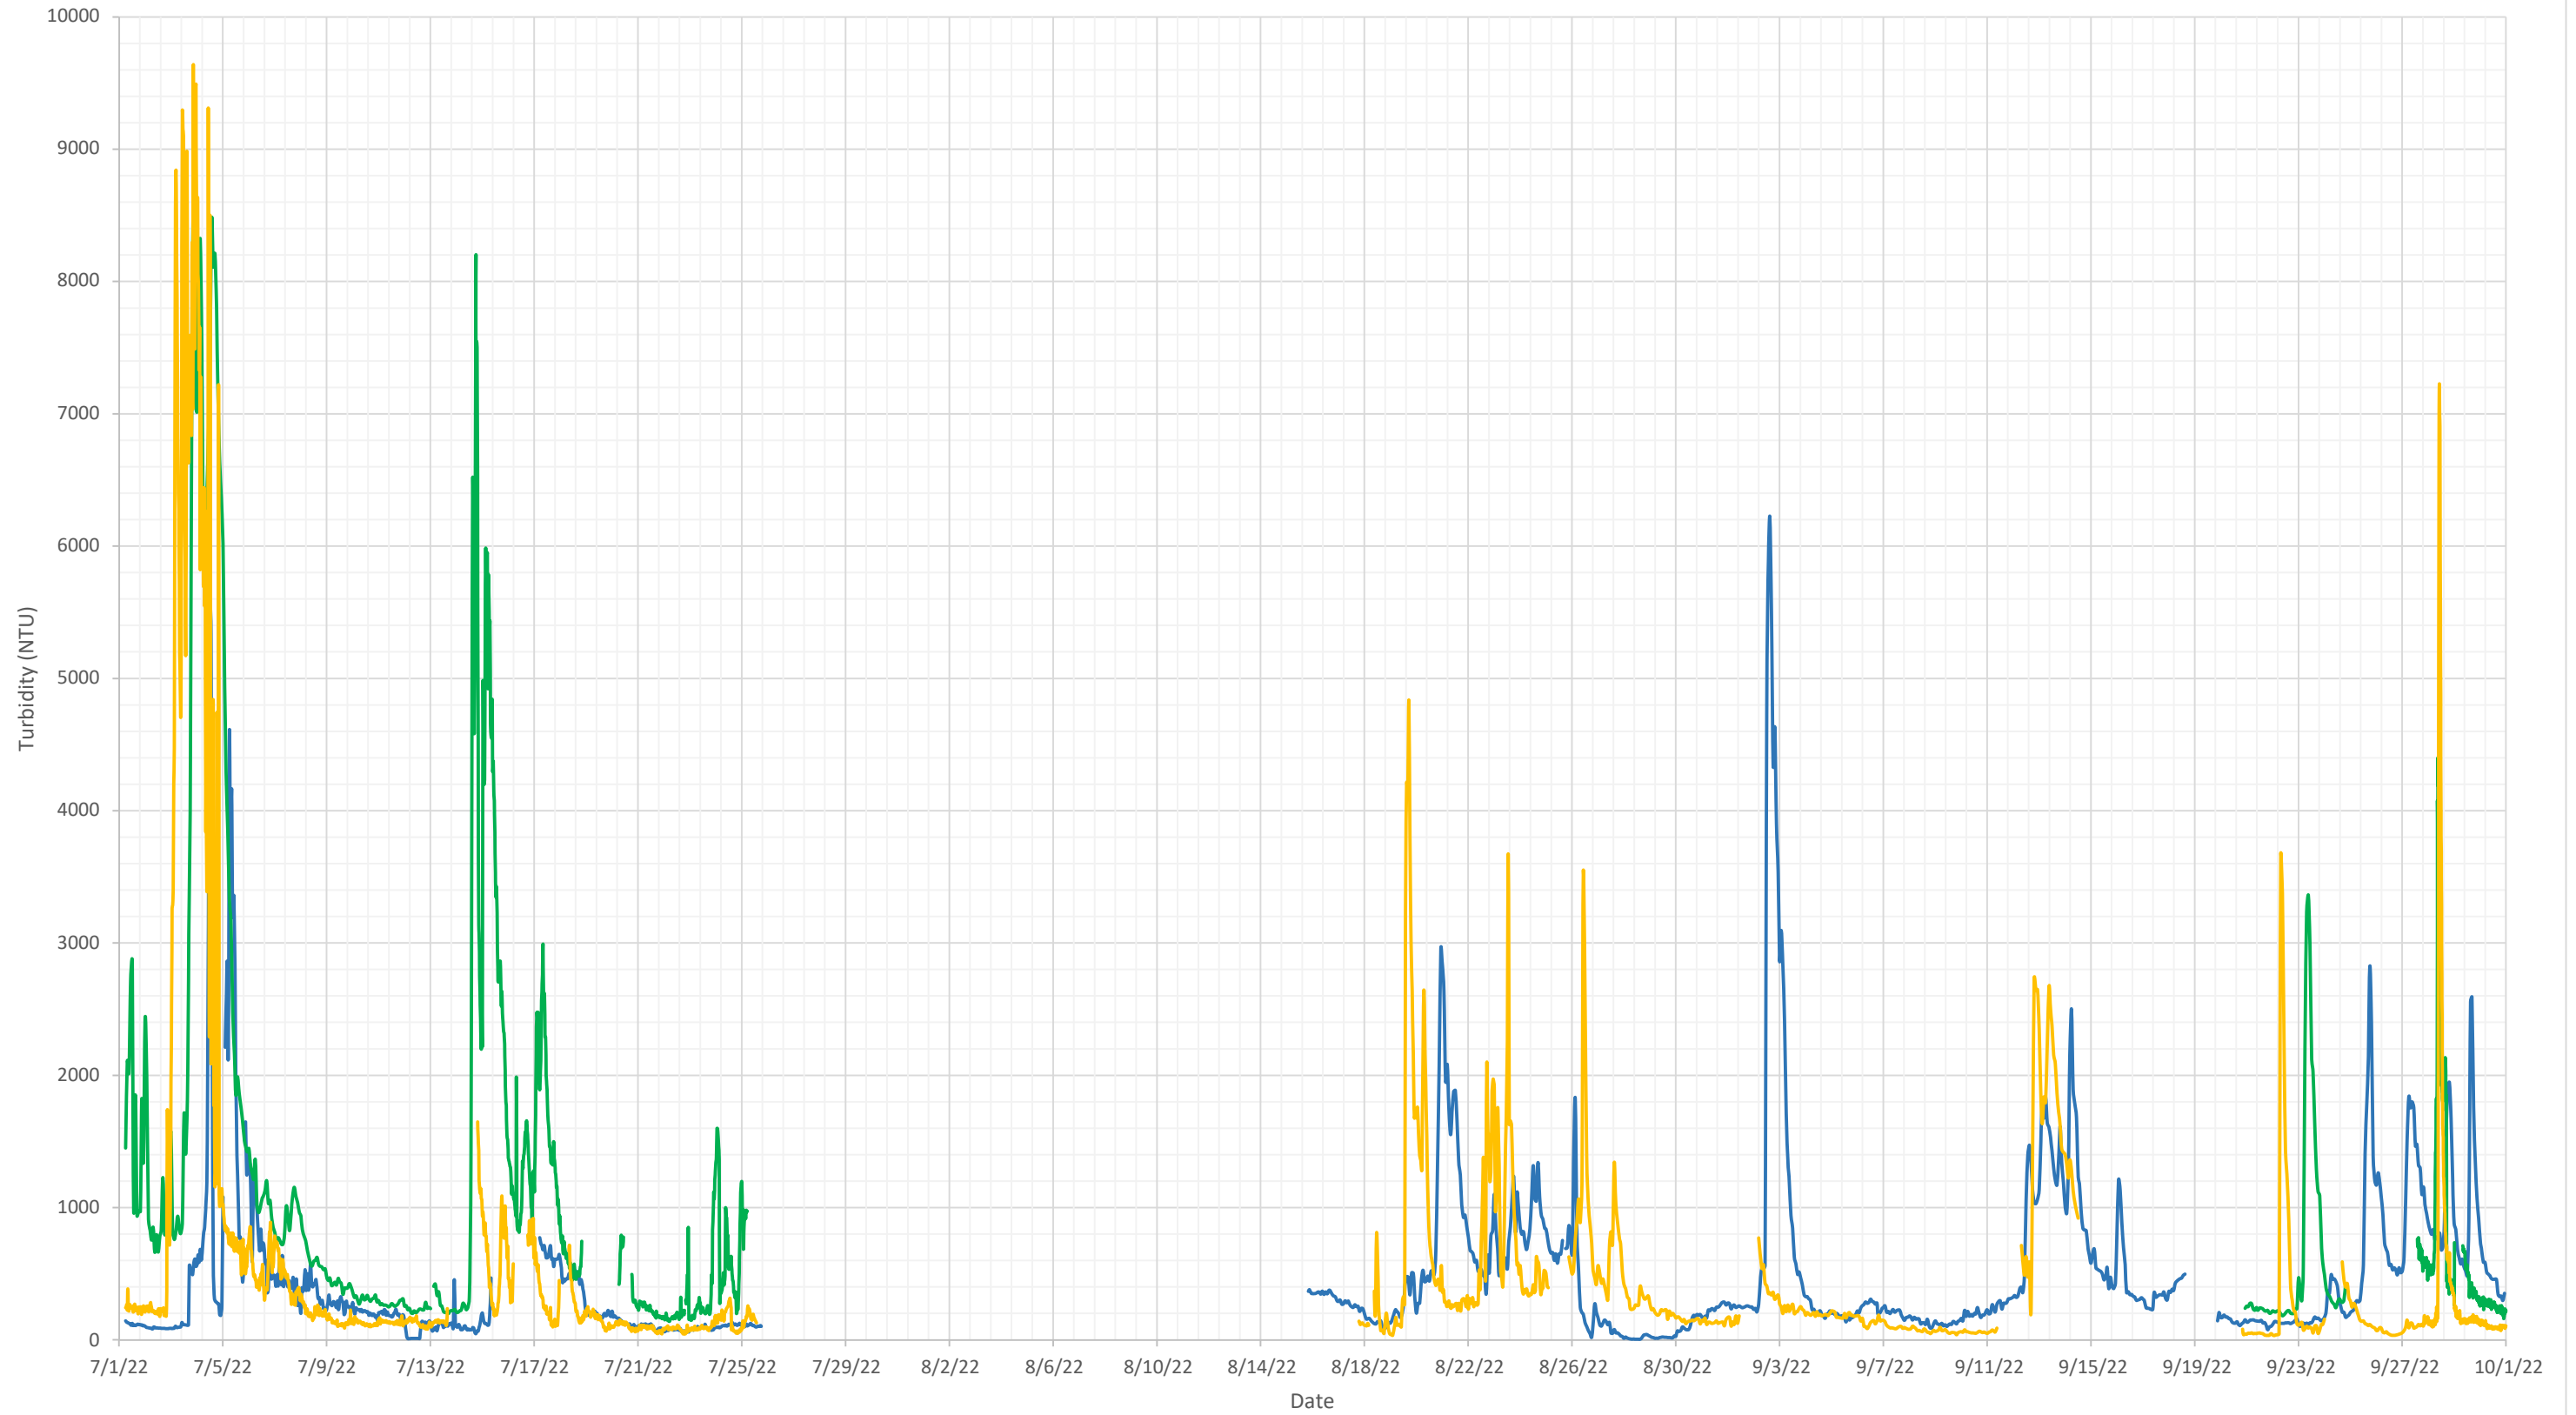
Turbidity - All Sondes - Quarter 3, 2022

Isleta Central Sandia 550

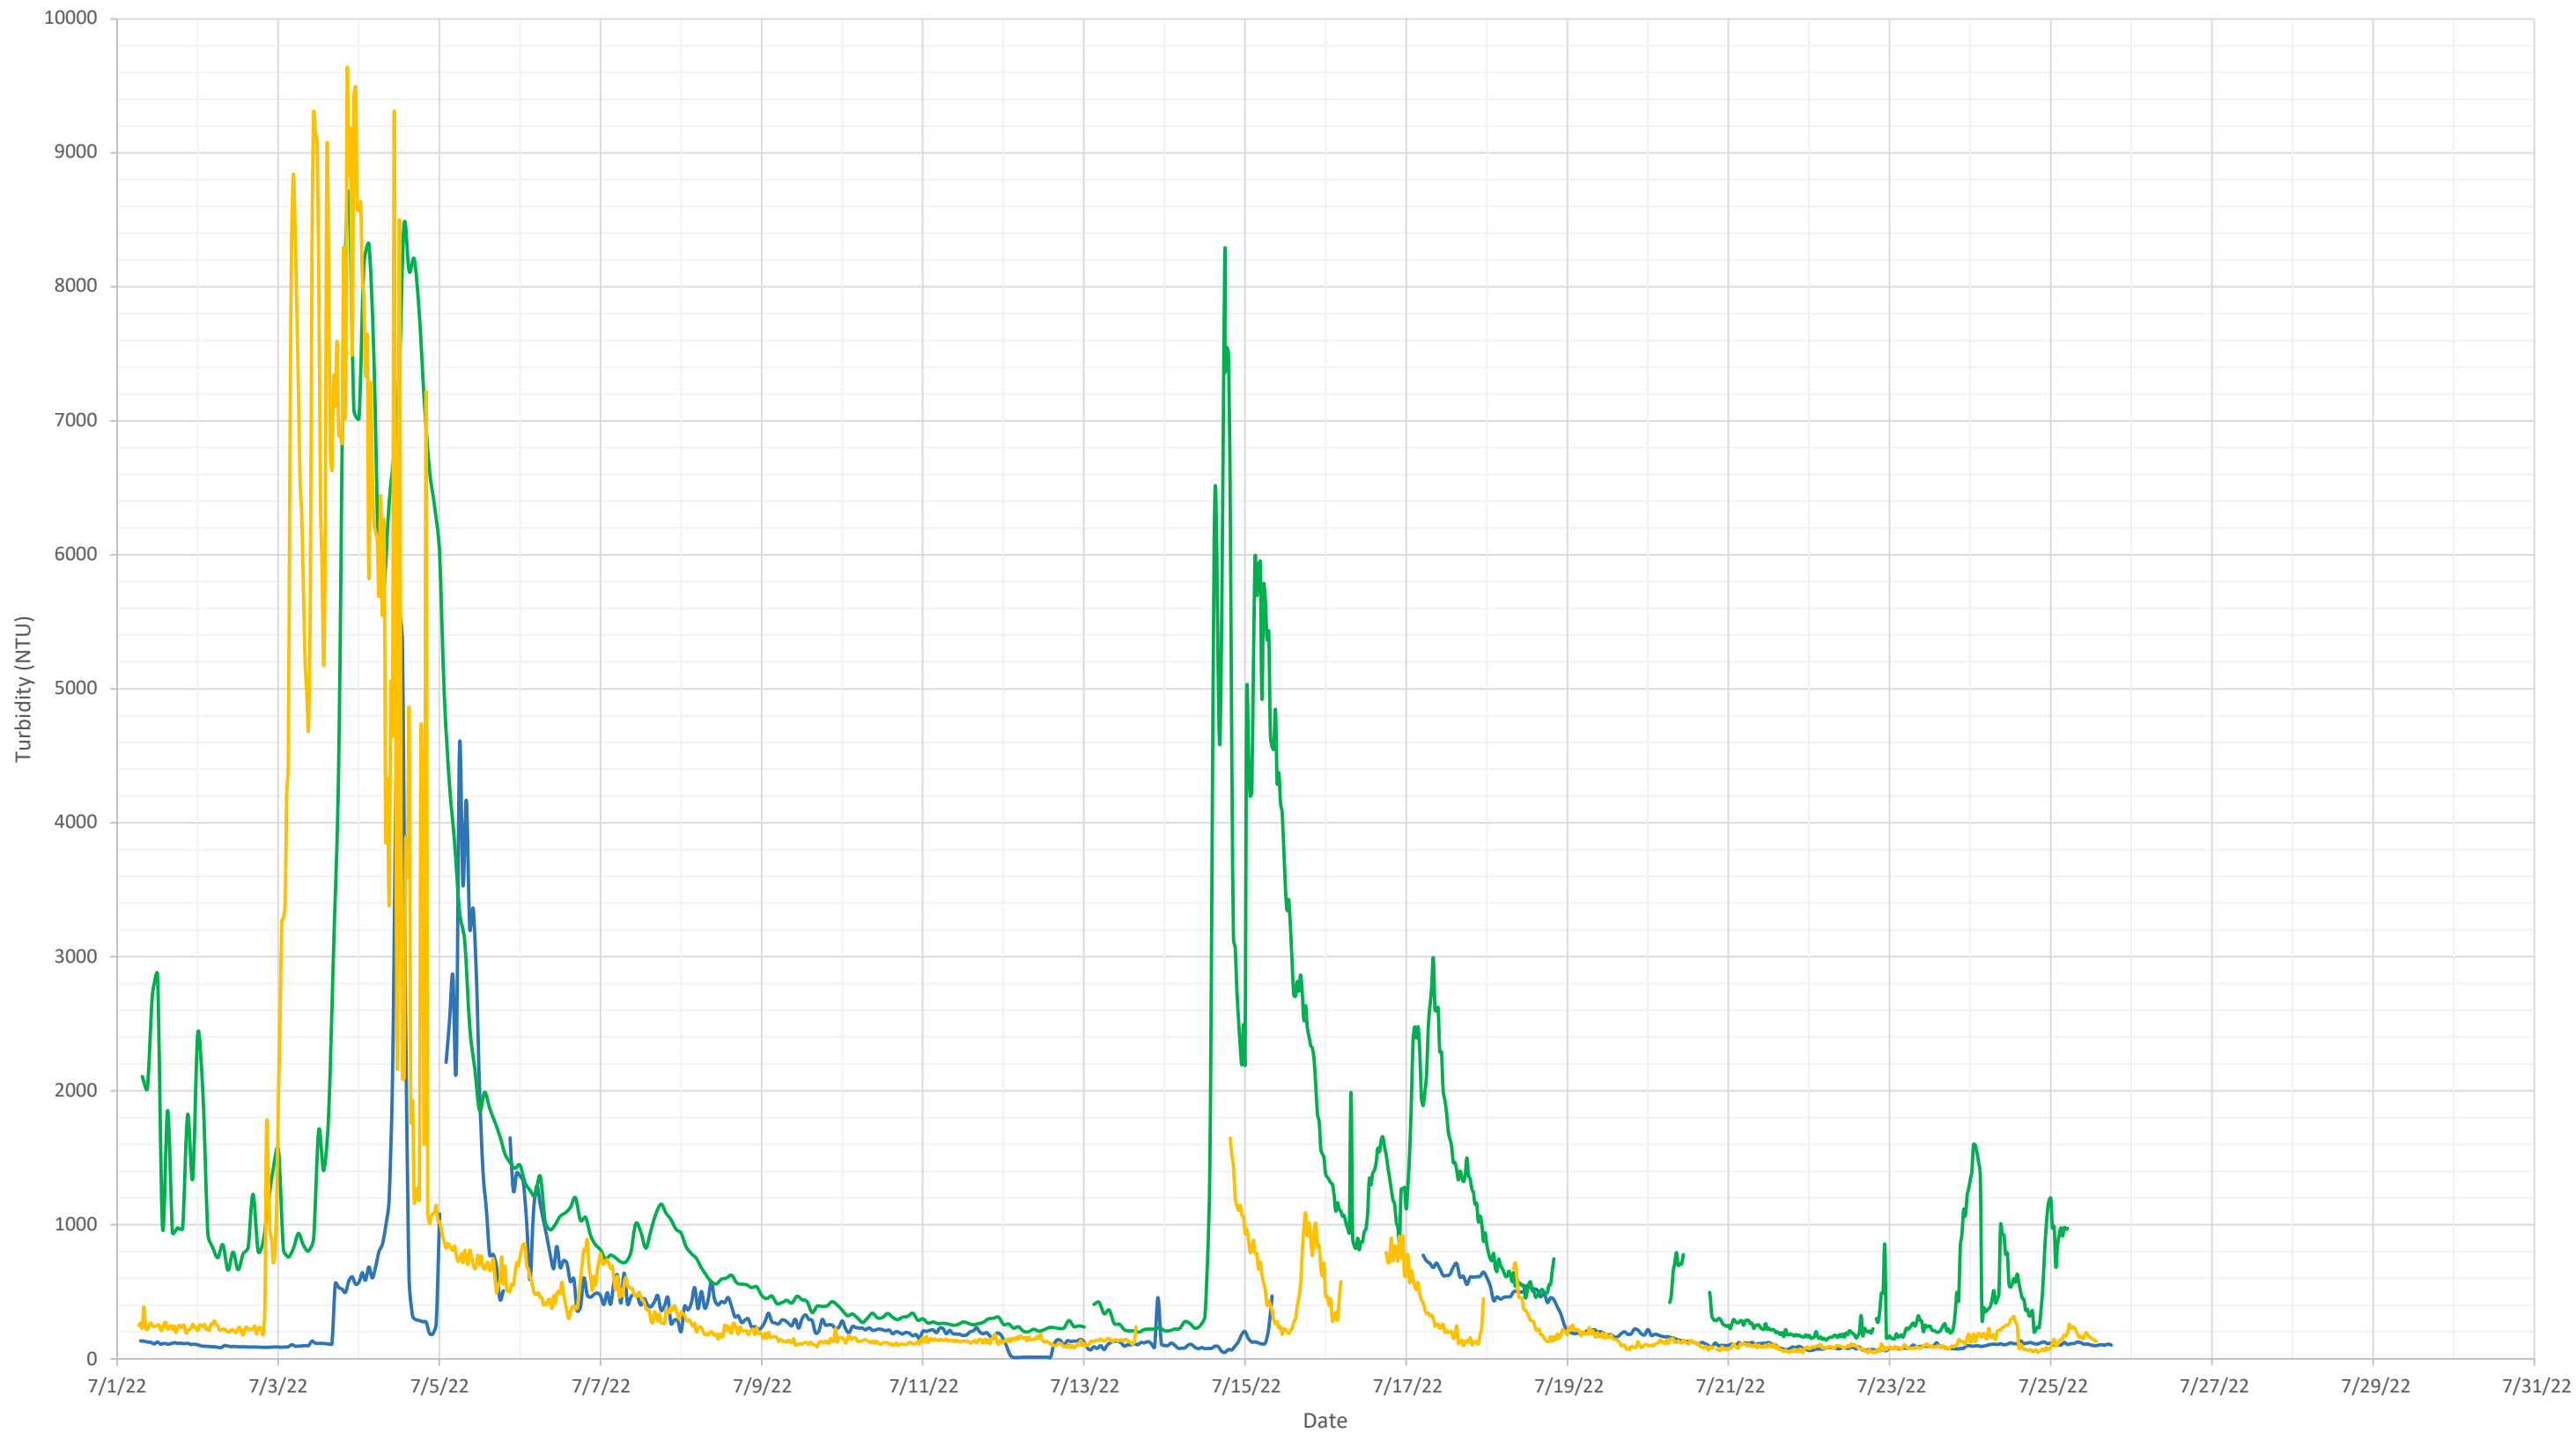
Turbidity - All Sondes - July 2022

Isleta Central Sandia 550

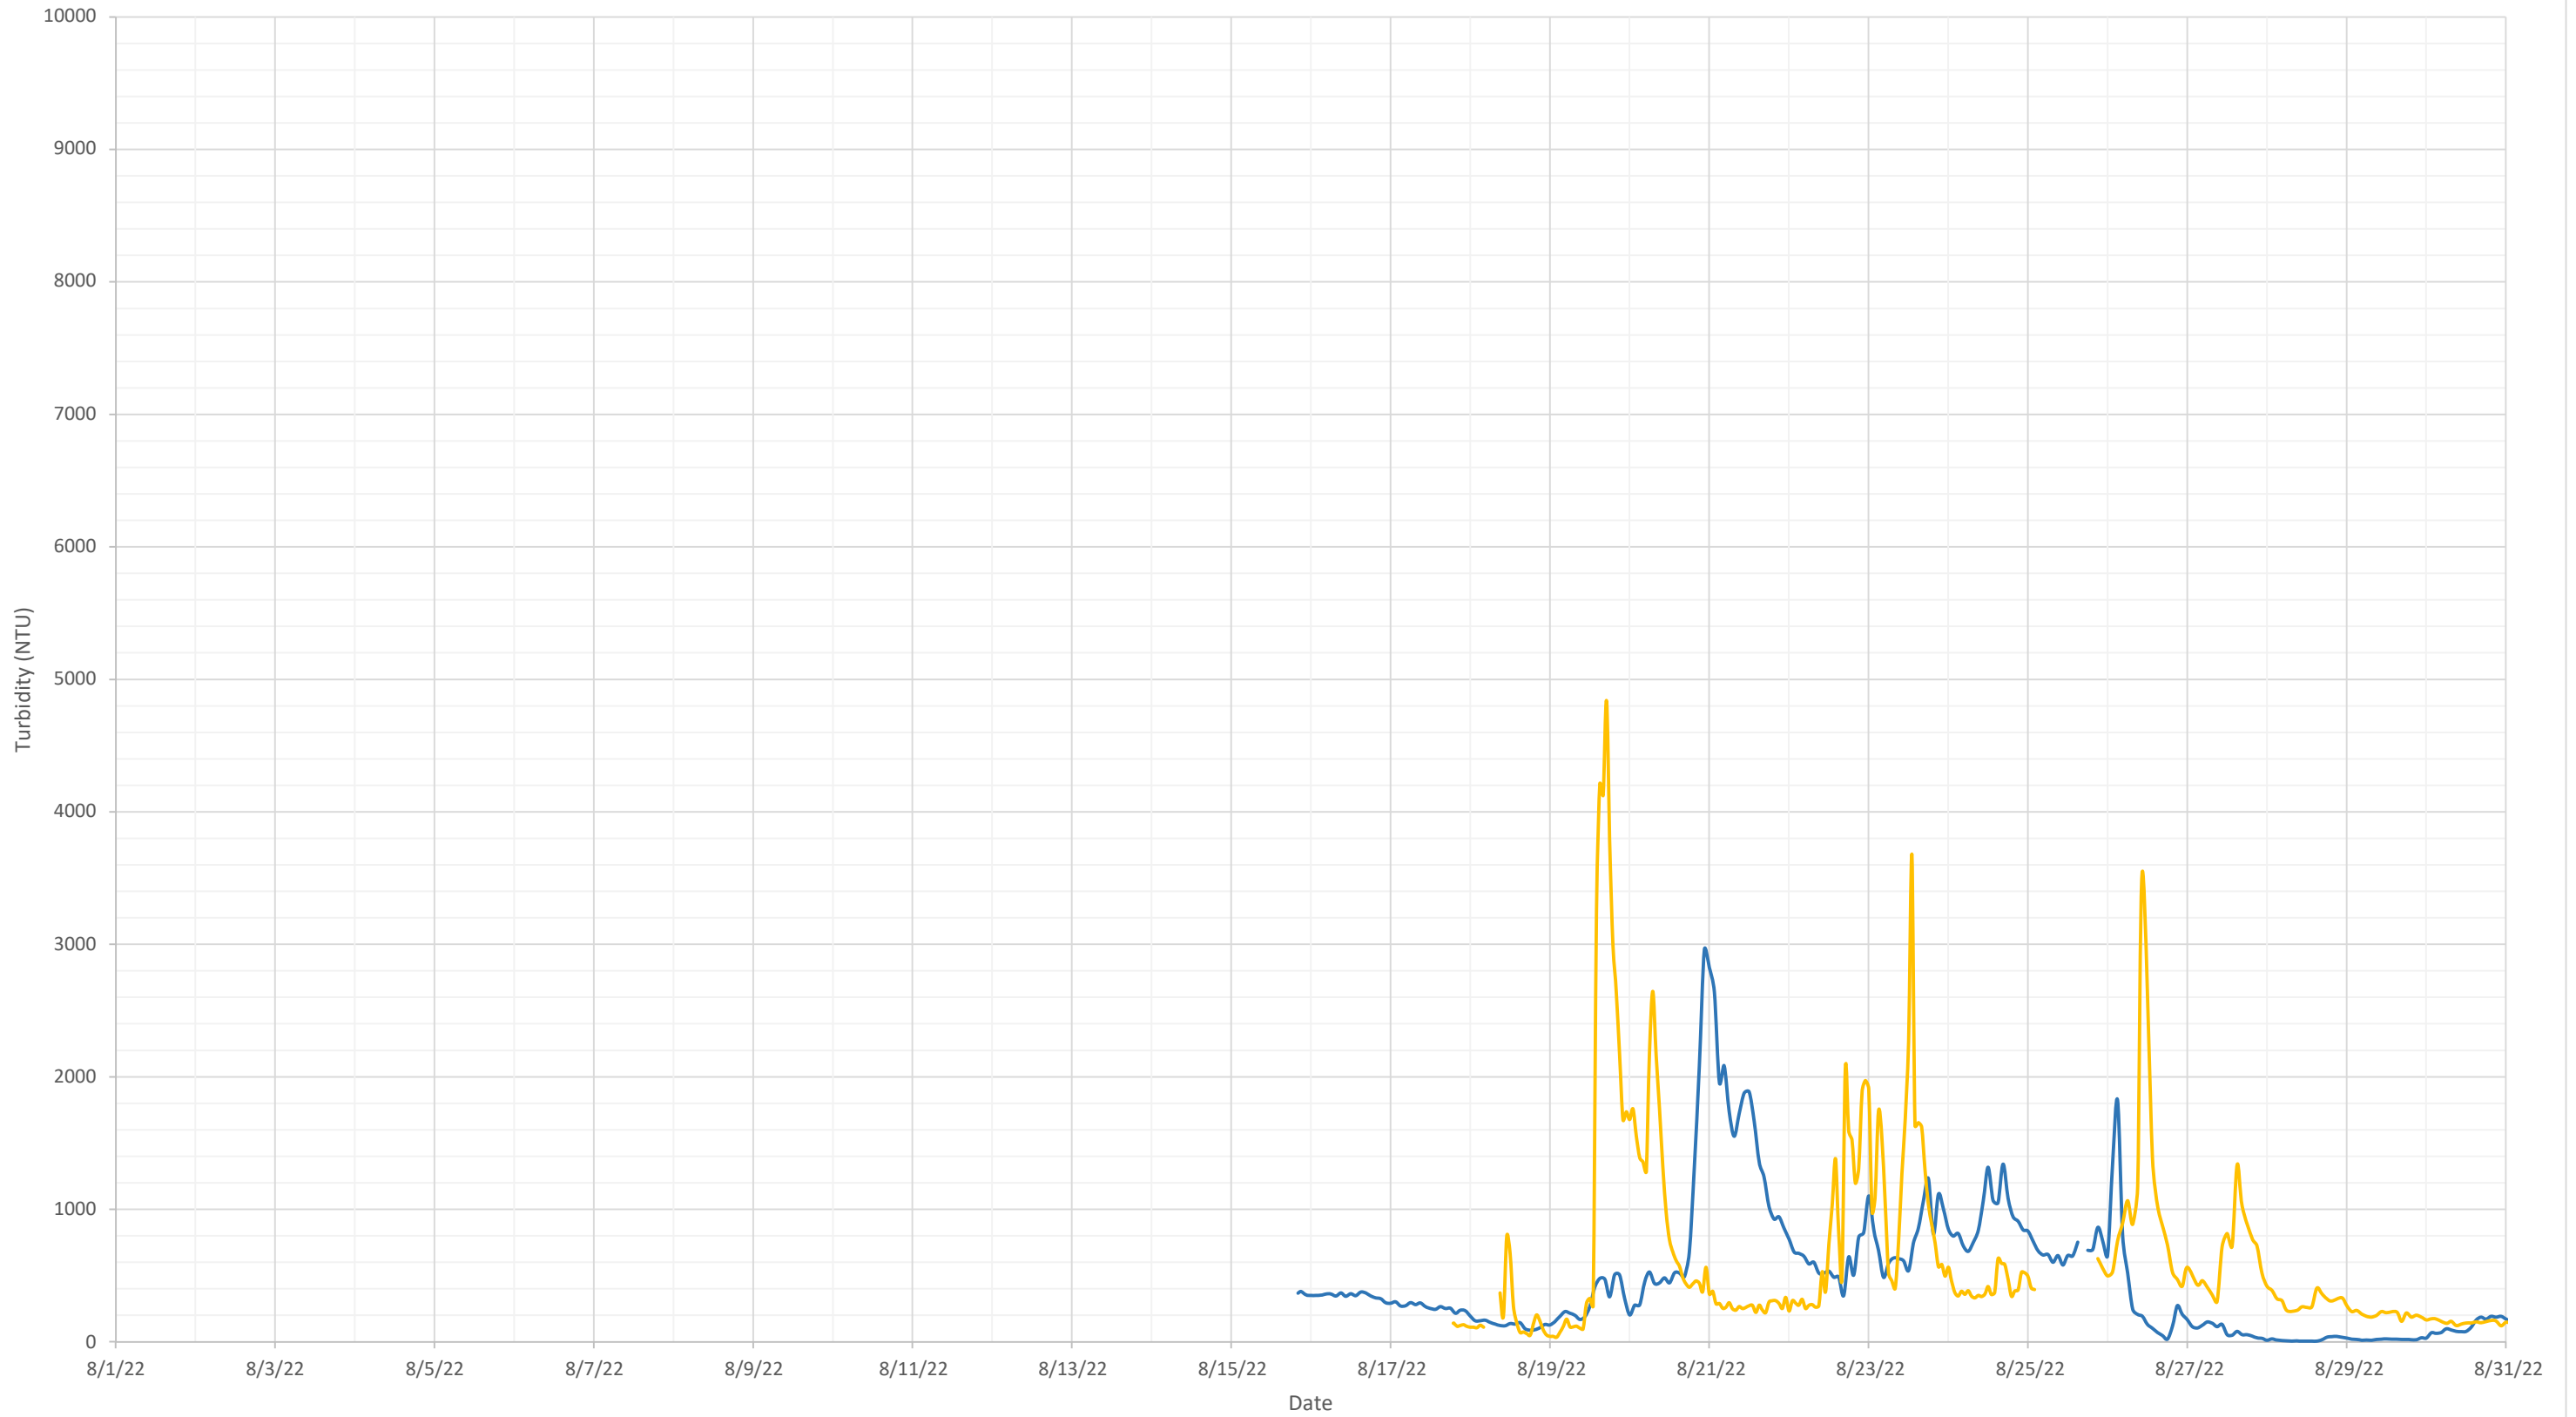
Turbidity - All Sondes - August 2022

Isleta Central Sandia 550

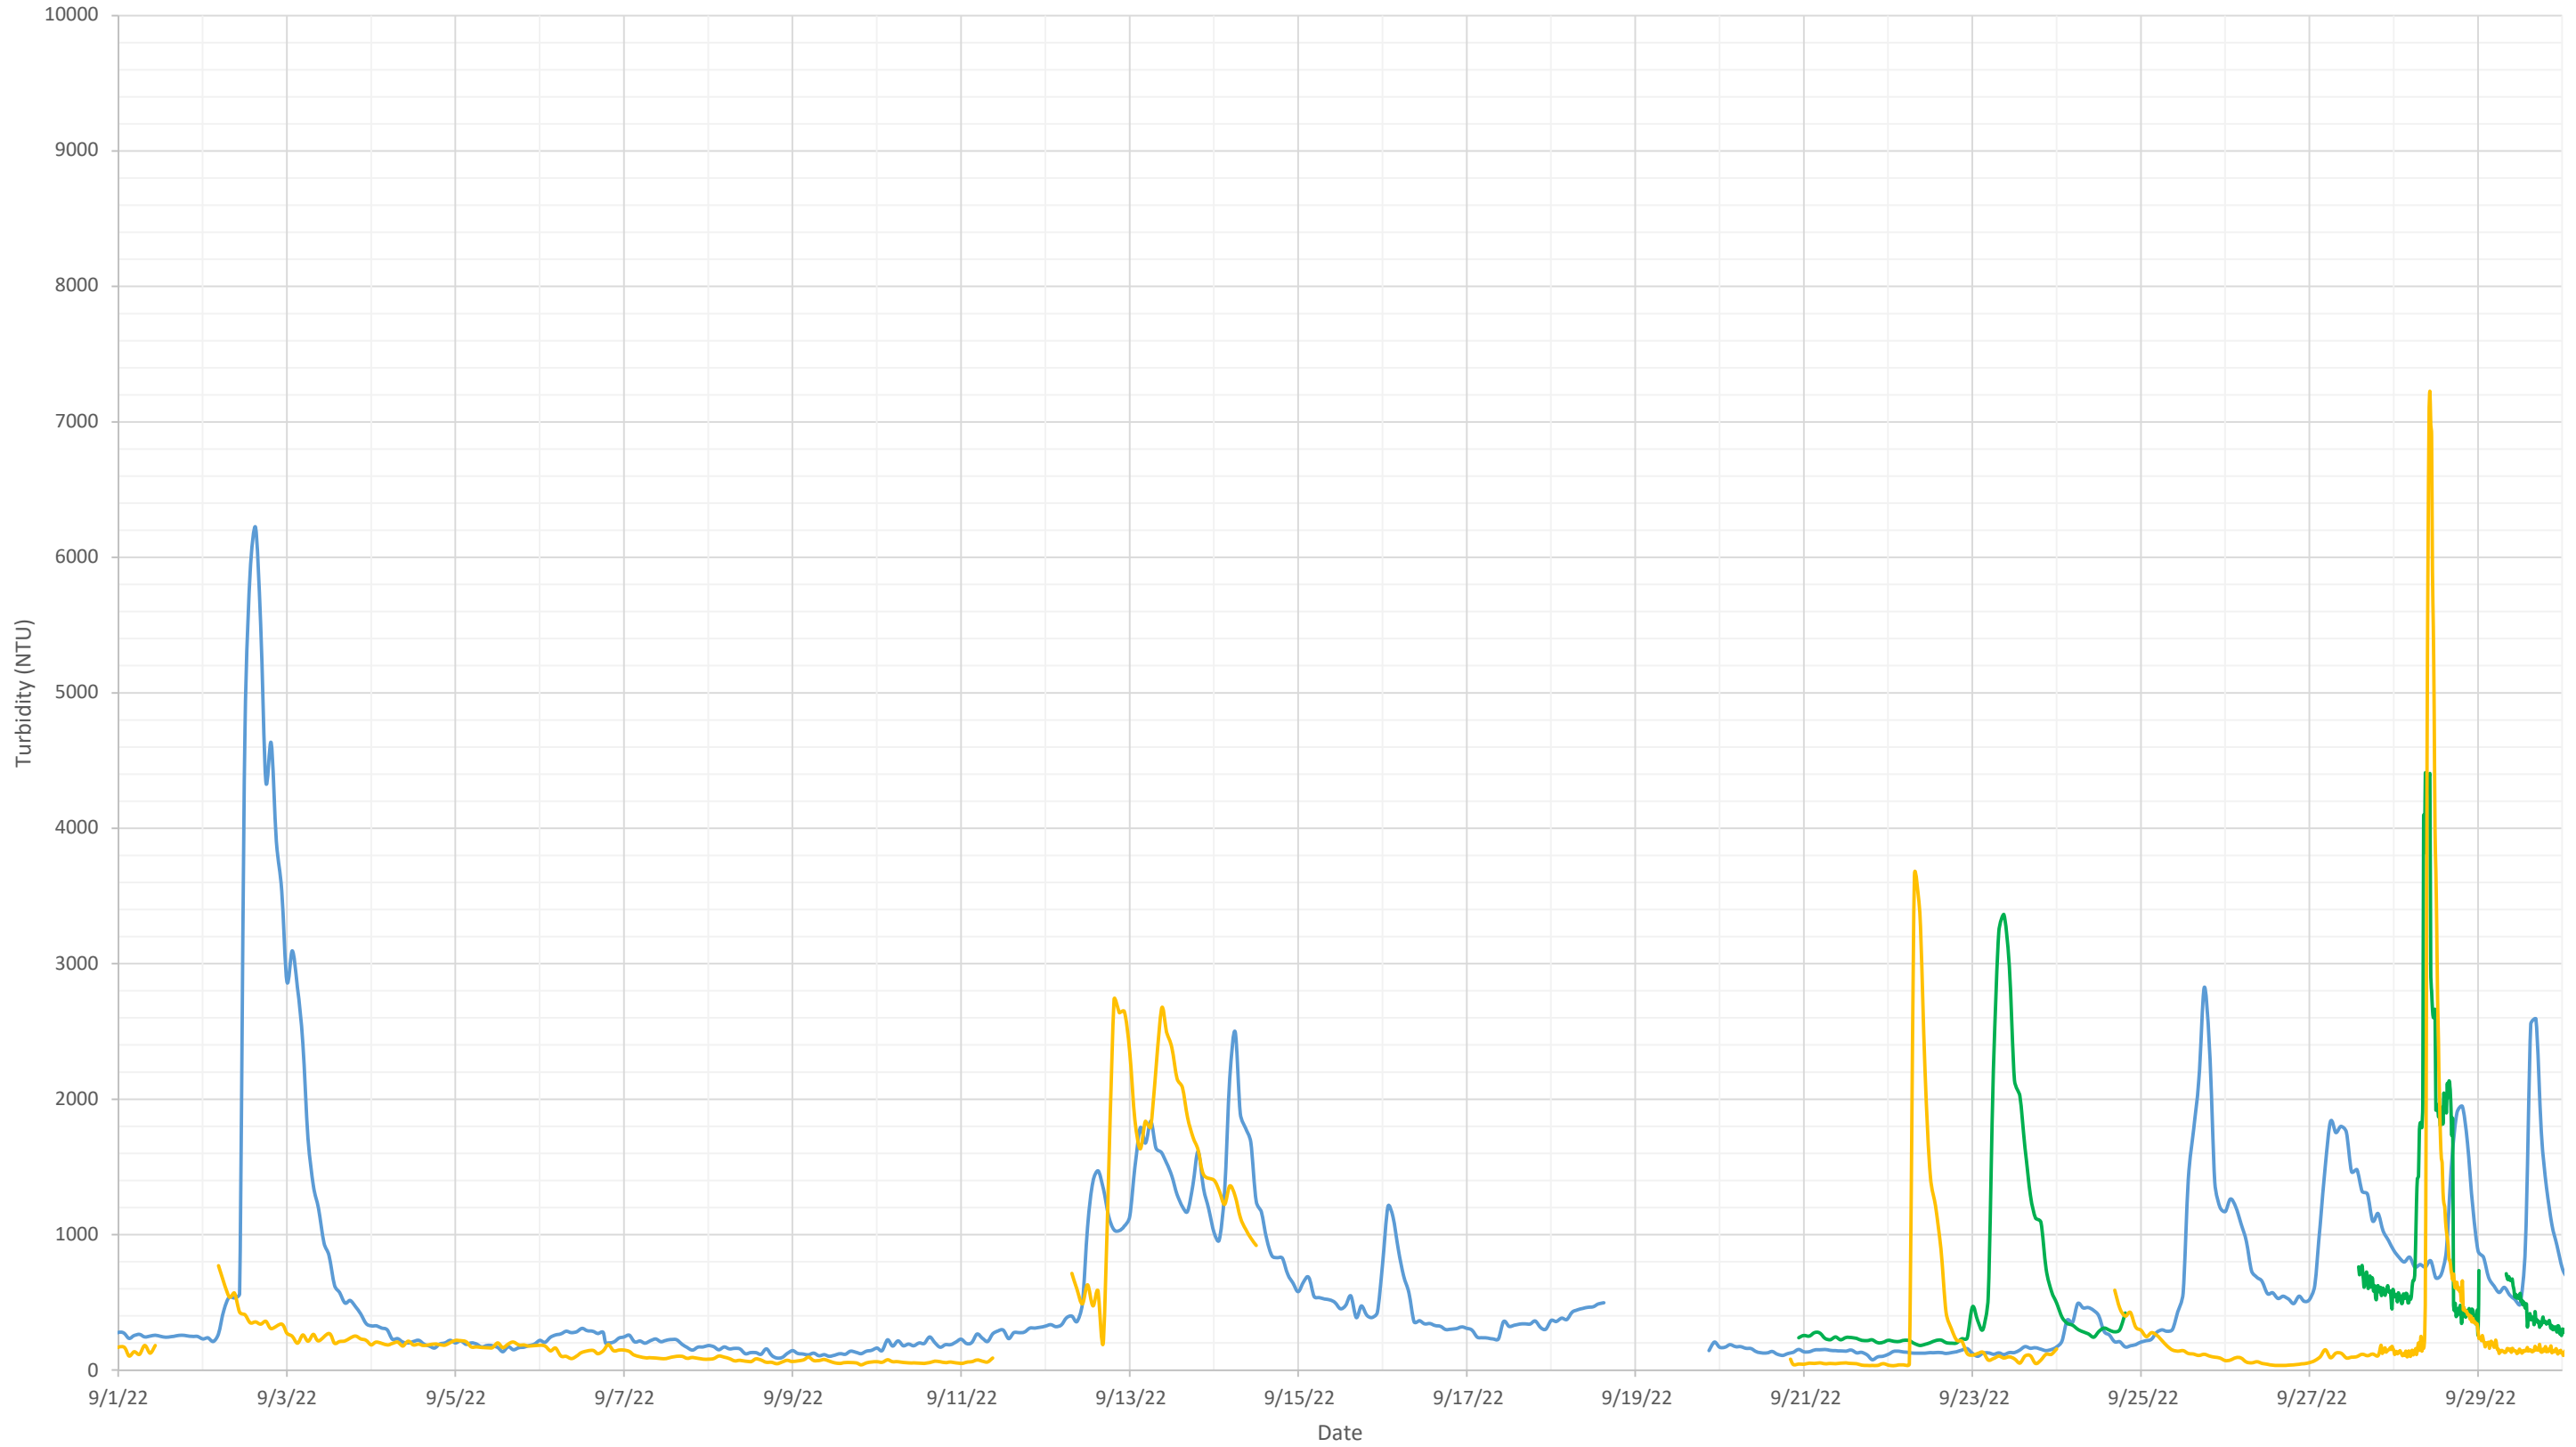
Turbidity - All Sondes -September 2022

Isleta Central Sandia 550
