**Summary of AMAFCA's MS4  
Dry Weather Discharge Screening Program  
FY 2022 (July 1, 2021 - June 30, 2022)**

NPDES Permit No. NMR04A000  
Part III.A.2 - Dry Weather Discharge Screening of MS4

**Dry Weather Screening  
of Outfalls  
2022**

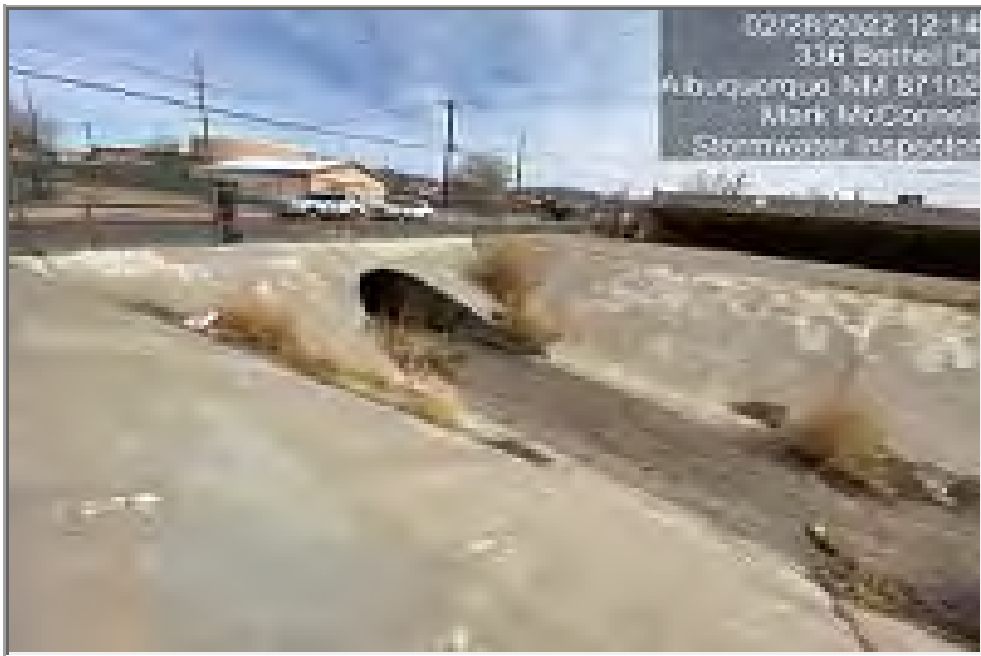
LOCATION **SAN JOSE DRAIN AT BETHEL SE**

WEATHER **SUNNY** flow **NO FLOW** FLOW\_GPM **0**

APPEARANCE **na** GROSS POLLUTANT **na**

Source of Flow **na**

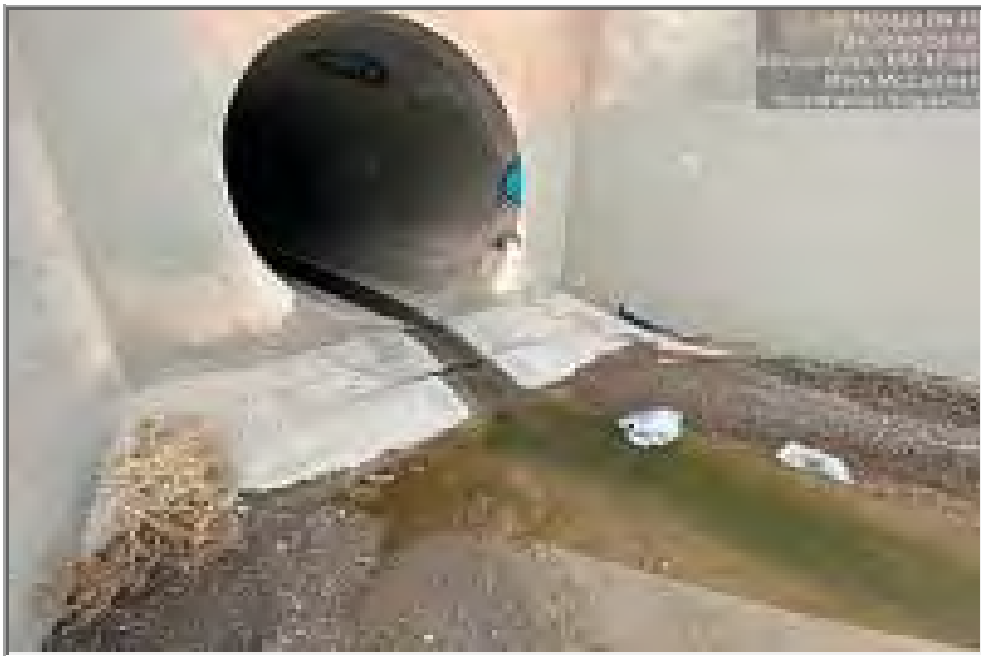
LOCATION **BROADWAY POND INFLOW CHANNEL**

WEATHER **CLOUDY** flow **YES** FLOW\_GPM **1**

APPEARANCE **clear** GROSS POLLUTANT **No odor, no observable particulates, no sheen**

Source of Flow **Irrigation, carwash, Water Hydrant flushing,**

AIR_TEMP_F	48	Lab	HALL ENVIRONMENTAL
WATER_TEMP_F	41	Lab_Report	2203901
pH	8.0	E_coli_Coliform_mpn/100ml	1553.1
CONDUCTIVITY_Umos/cm	760	Ammonia_mg/l	<1
BOD_mg/l	20.0	Nitrite_NO2_mg/l	<0.5
COD_mg/l	42	Nitrate_NO3_mg/l	0.82
TSS_mg/l	<4	TKN_Tot_Kjeld_N_mg/l	<1
TDS_mg/l	464	Phosphorus_total_mg/l_P	0.26
N-Hexane Extractable-(Oil_Grease)_mg/l	<9.12	Hardness_mg/l_CaCO3	170
Fluoride_mg/l	0.97	Chlorine_mg/l	<0.05

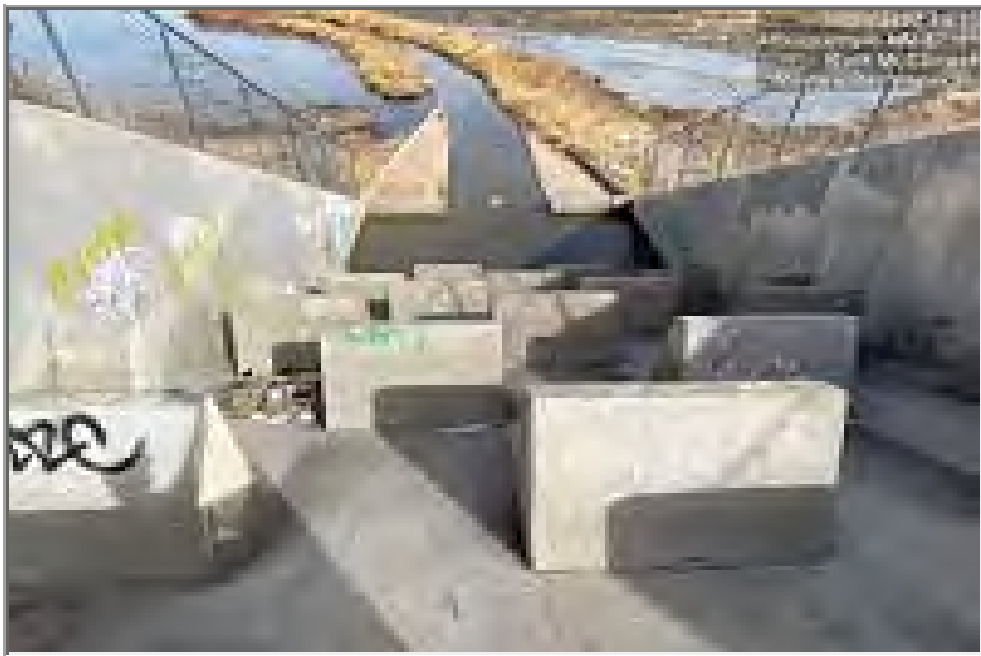
LOCATION **MENAU POND INFLOW CHANNEL**

WEATHER **PARTLY CLOUDY** flow **NO FLOW** FLOW\_GPM **0**

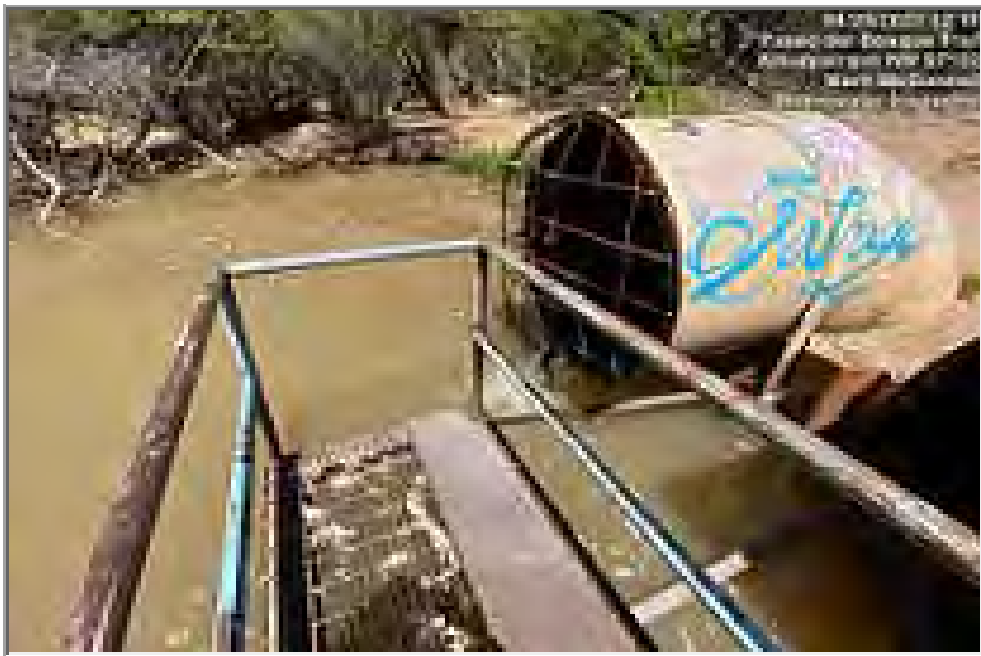
LOCATION **BARELAS PUMPING PLANT INFLOW**

AIR_TEMP_F	<input type="text" value="74"/>	Lab	<input type="text" value="HALL ENVIRONMENTAL"/>
WATER_TEMP_F	<input type="text" value="59"/>	Lab_Report	<input type="text" value="22004D38"/>
pH	<input type="text" value="8.23"/>	E_coli_Coliform_mpn/100ml	<input type="text" value="&gt;2419.6"/>
CONDUCTIVITY_Umos/cm	<input type="text" value="790"/>	Ammonia_mg/l	<input type="text" value="&lt;1.0"/>
BOD_mg/l	<input type="text" value="6.1"/>	Nitrite_NO2_mg/l	<input type="text" value="&lt;0.5"/>
COD_mg/l	<input type="text" value="26.3"/>	Nitrate_NO3_mg/l	<input type="text" value="&lt;0.5"/>
TSS_mg/l	<input type="text" value="&lt;4"/>	TKN_Tot_Kjeld_N_mg/l	<input type="text" value="1.1"/>
TDS_mg/l	<input type="text" value="534"/>	Phosphorus_total_mg/l_P	<input type="text" value="0.21"/>
N-Hexane Extractable-(Oil_Grease)_mg/l	<input type="text" value="&lt;9.35"/>	Hardness_mg/l_CaCO3	<input type="text" value="270"/>

Fluoride_mg/l	<input type="text" value="&lt;0.5"/>	Chlorine_mg/l	<input type="text" value="&lt;0.05"/>

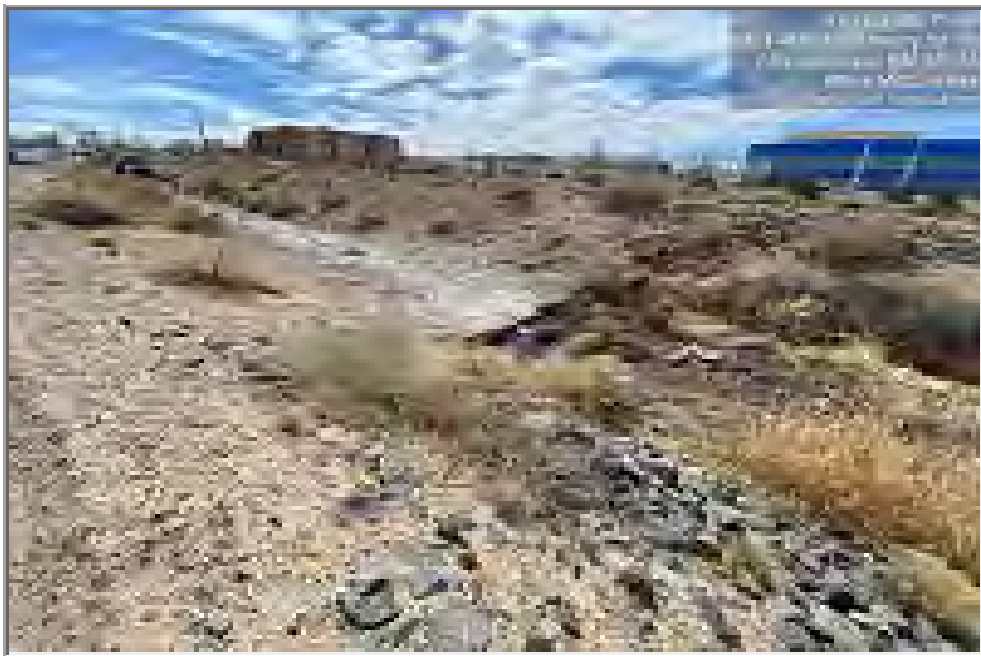
LOCATION	<b>KIRTLAND CHANNEL AT MULBERRY NE</b>						
OUTFALL_NO	5	QUAD	SE	GRID	M-15	SAMPLED	<input type="checkbox"/>
DATE_INSP	3/28/2022	TIME	11:05	Inspected by	MM		
WEATHER	PARTLY CLOUDY	flow	NO FLOW	FLOW_GPM	0		
APPEARANCE	na		GROSS POLLUTANT	na			
Source of Flow	na

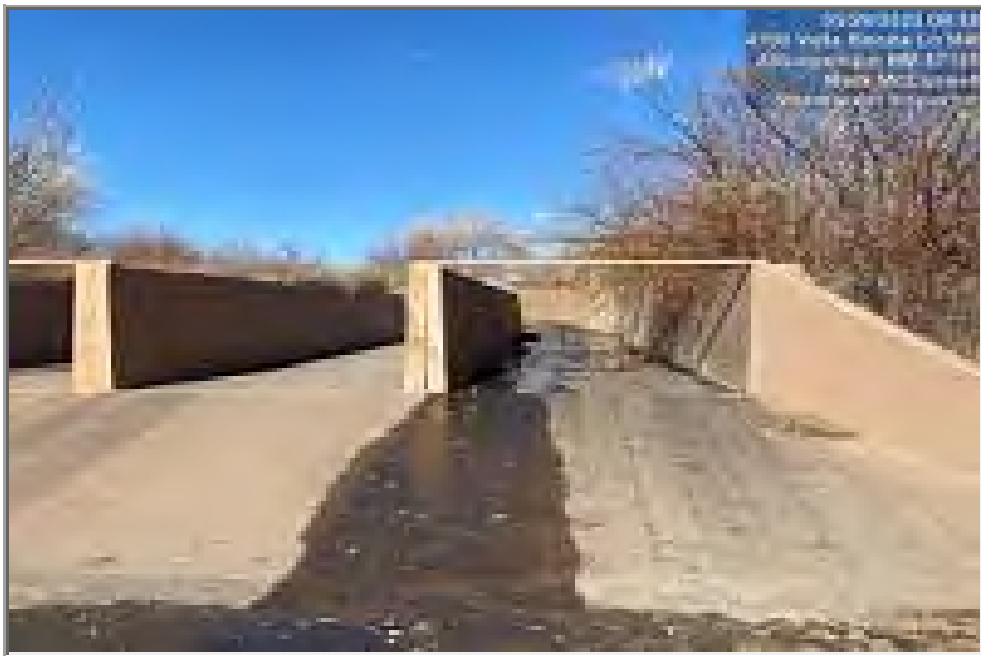
LOCATION **SAN ANTONIO ARROYO AT RIO GRANDE**

WEATHER **SUNNY** flow **NO FLOW** FLOW\_GPM **0**

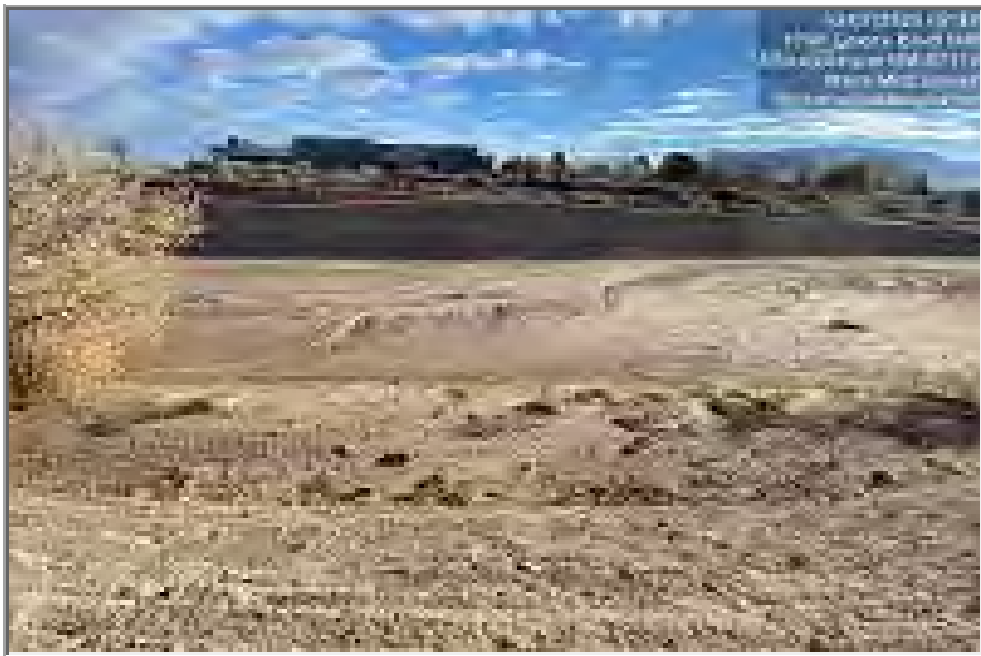
LOCATION	<b>CALABACILLAS ARROYO AT RIO GRANDE</b>						
OUTFALL_NO	7	QUAD	NW	GRID	C-14	SAMPLED	<input type="checkbox"/>
DATE_INSP	3/7/2022	TIME	7:47	Inspected by	MM		
WEATHER	PARTLY CLOUDY	flow	NO FLOW	FLOW_GPM	0		
APPEARANCE	na		GROSS POLLUTANT	na			
Source of Flow	na

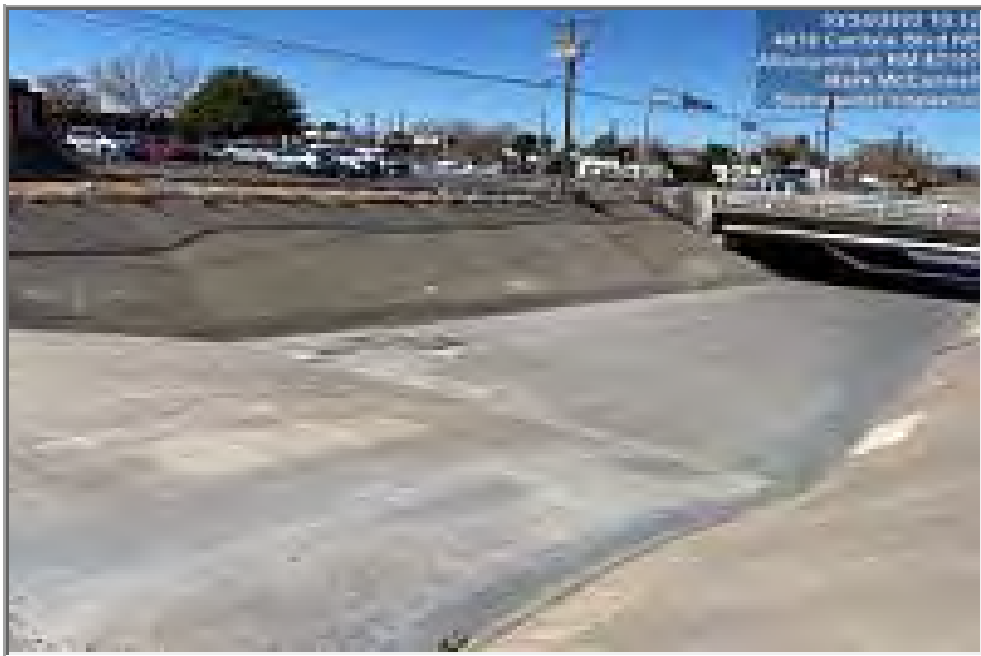
LOCATION **HAHN ARROYO AT CARLISLE NE**

WEATHER **SUNNY** flow **NO FLOW** FLOW\_GPM **0**

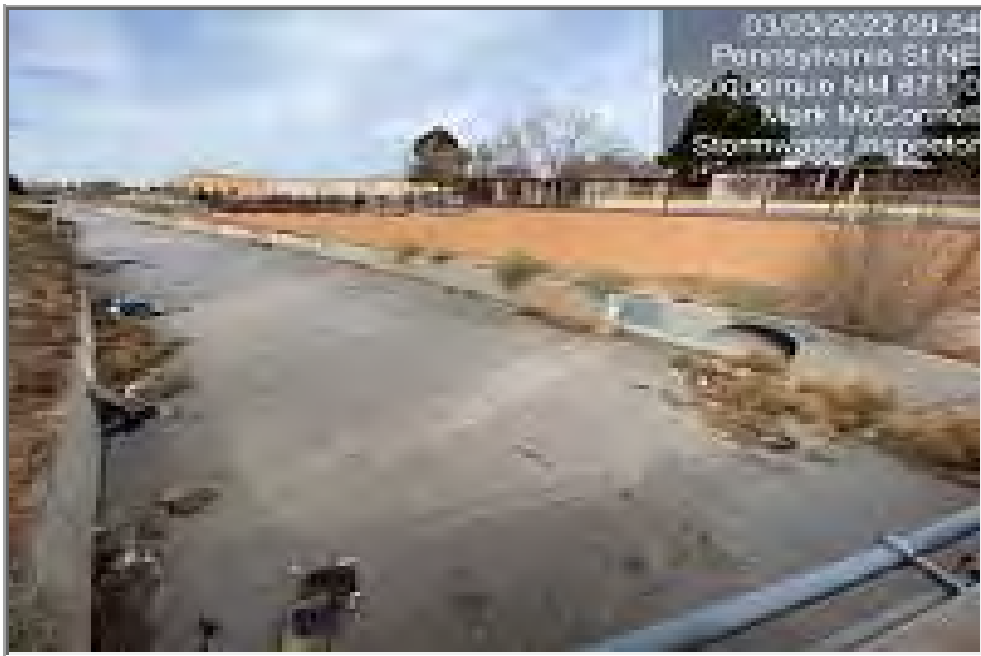
LOCATION **EMBUDO AT PENNSYLVANIA SOUTH OF MENCAL NE**

WEATHER **SUNNY** flow **NO FLOW** FLOW\_GPM **0**

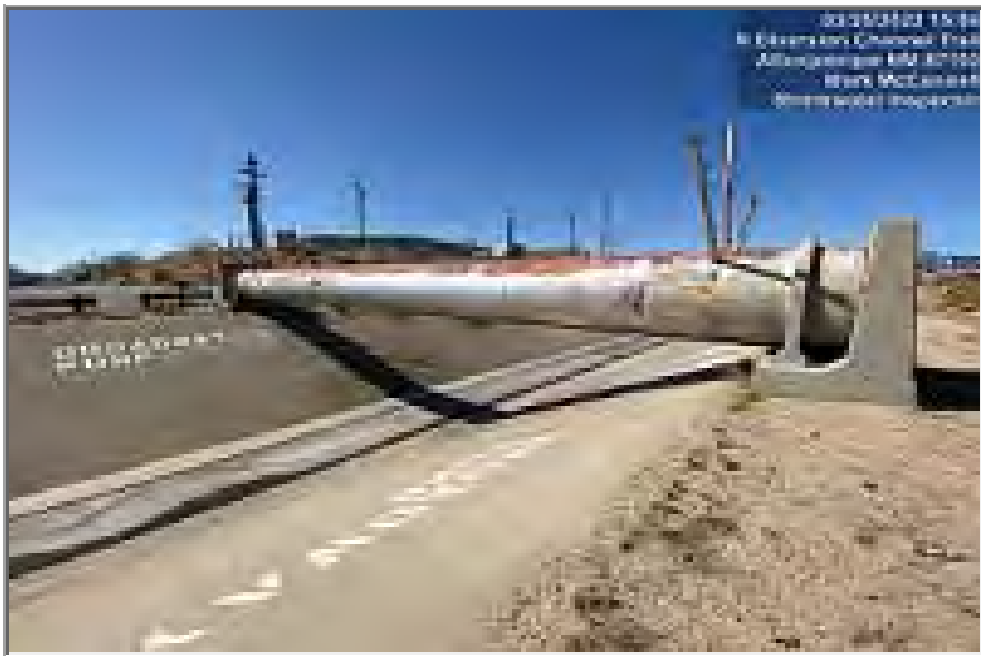
LOCATION **NDC AT TUCKER**

WEATHER **SUNNY** flow **NO FLOW** FLOW\_GPM **0**

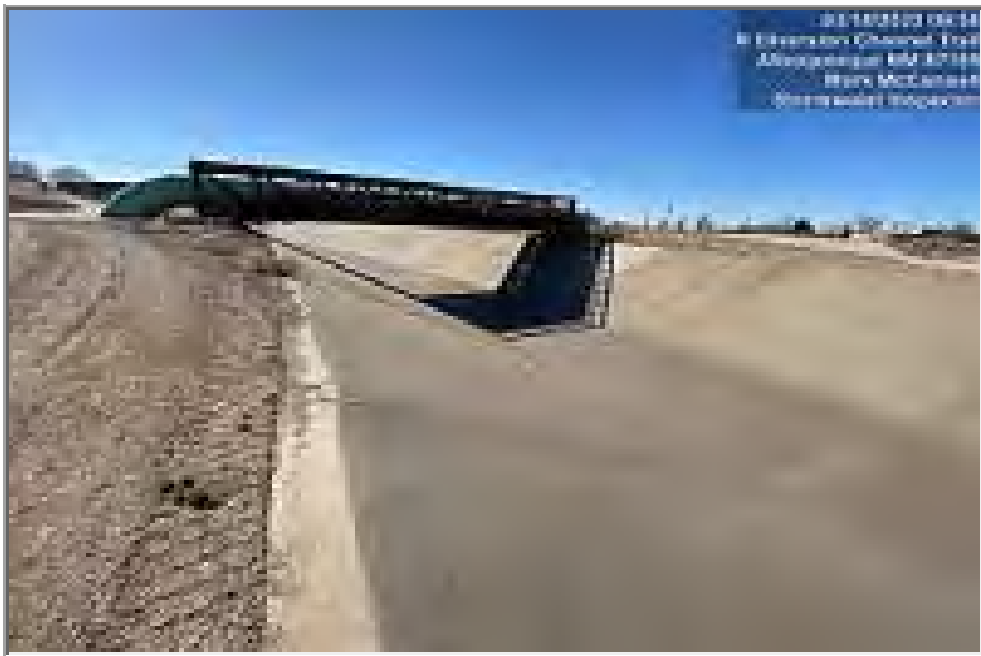
LOCATION **BEAR CANYON ARROYO AT NDC**

WEATHER **SUNNY** flow **NO FLOW** FLOW\_GPM **0**

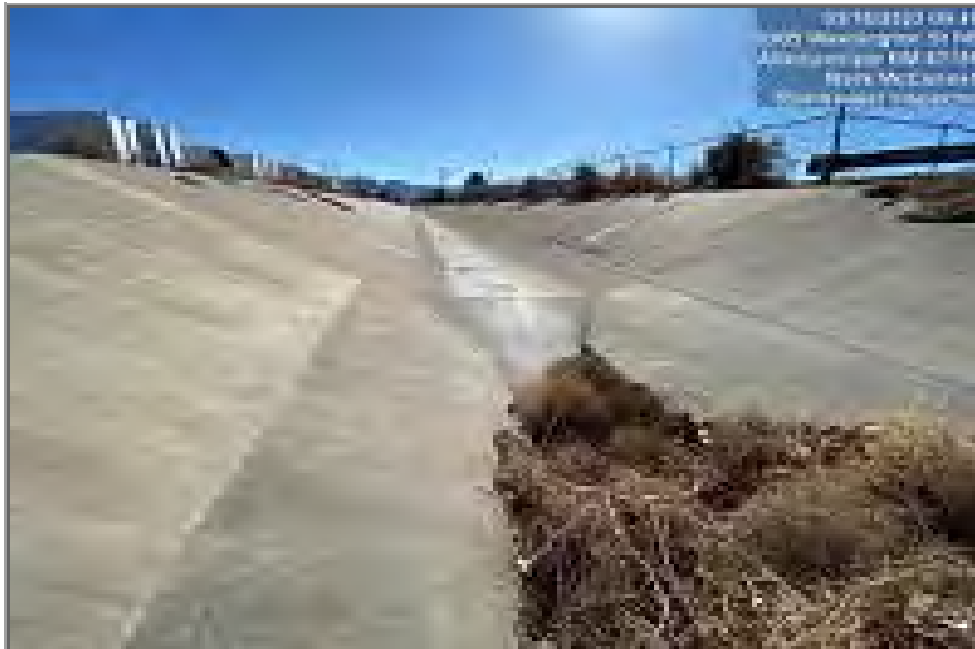
LOCATION	<b>SOUTH PINO ARROYO AT WASHINGTON NE</b>						
OUTFALL_NO	12	QUAD	NE	GRID	D-17	SAMPLED	<input type="checkbox"/>
DATE_INSP	3/18/2022	TIME	9:48	Inspected by	MM		
WEATHER	SUNNY	flow	NO FLOW	FLOW_GPM	0		
APPEARANCE	na		GROSS POLLUTANT	na			
Source of Flow	na

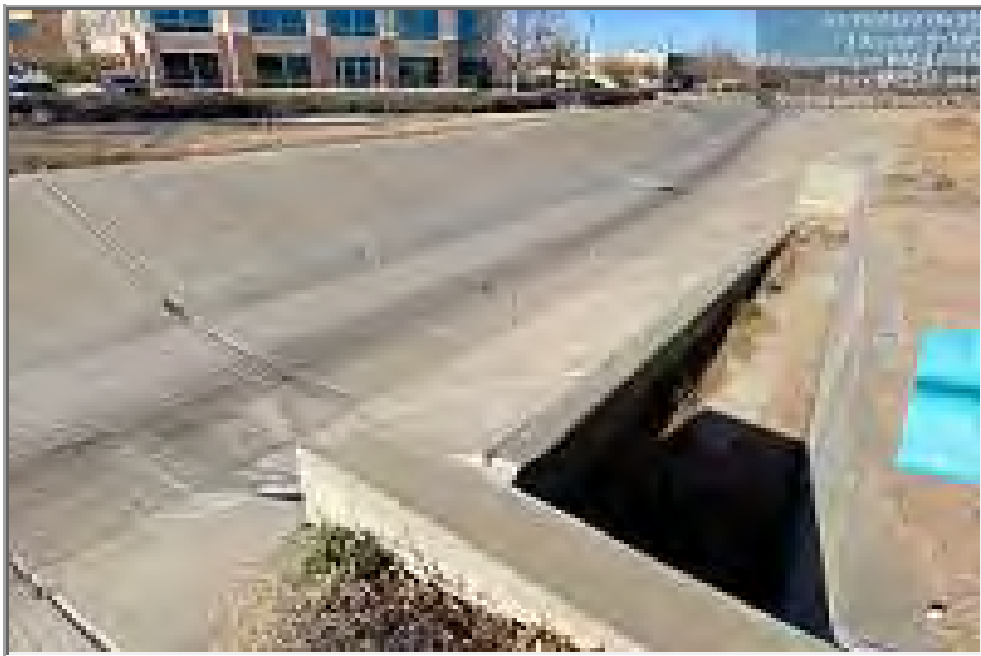
LOCATION **NORTH PINO ARROYO AT TIBURON NE**

WEATHER **SUNNY** flow **NO FLOW** FLOW\_GPM **0**

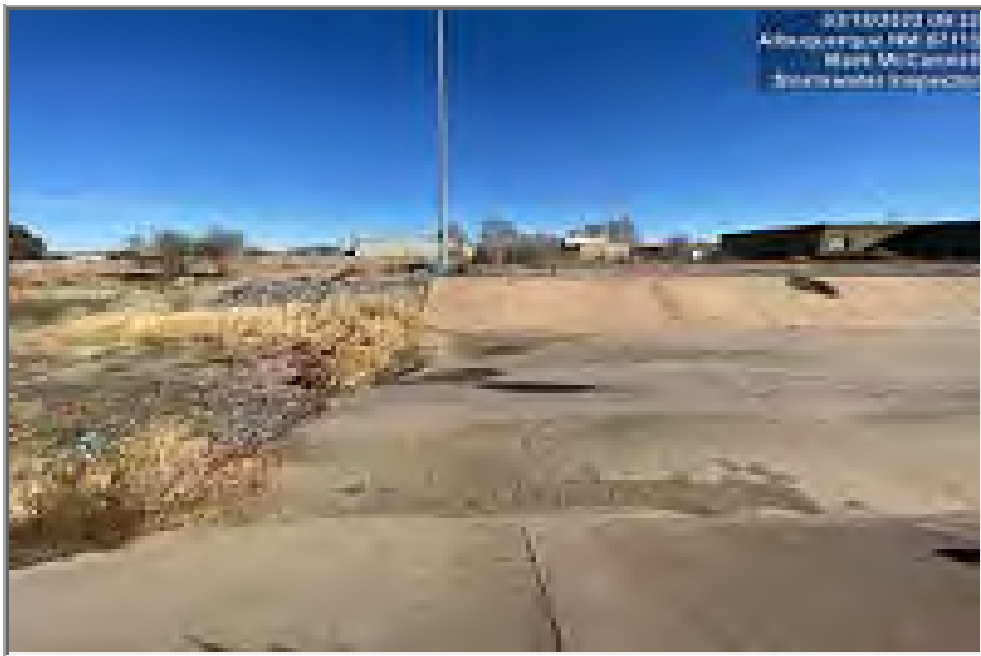
LOCATION **SOUTH DOMINGO BACA ARROYO AT WASHINGTON NE**

WEATHER **SUNNY** flow **NO FLOW** FLOW\_GPM **0**

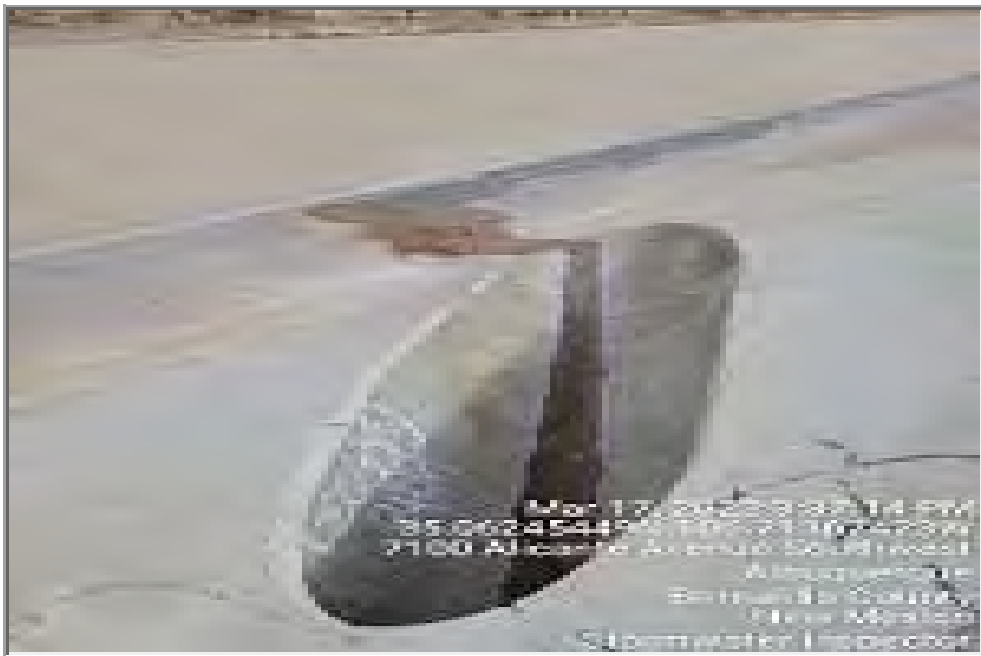
LOCATION **AMOLE DEL NORTE CHANNEL AT BLAKE SW**

WEATHER **CLOUDY** flow **NO FLOW** FLOW\_GPM **0**

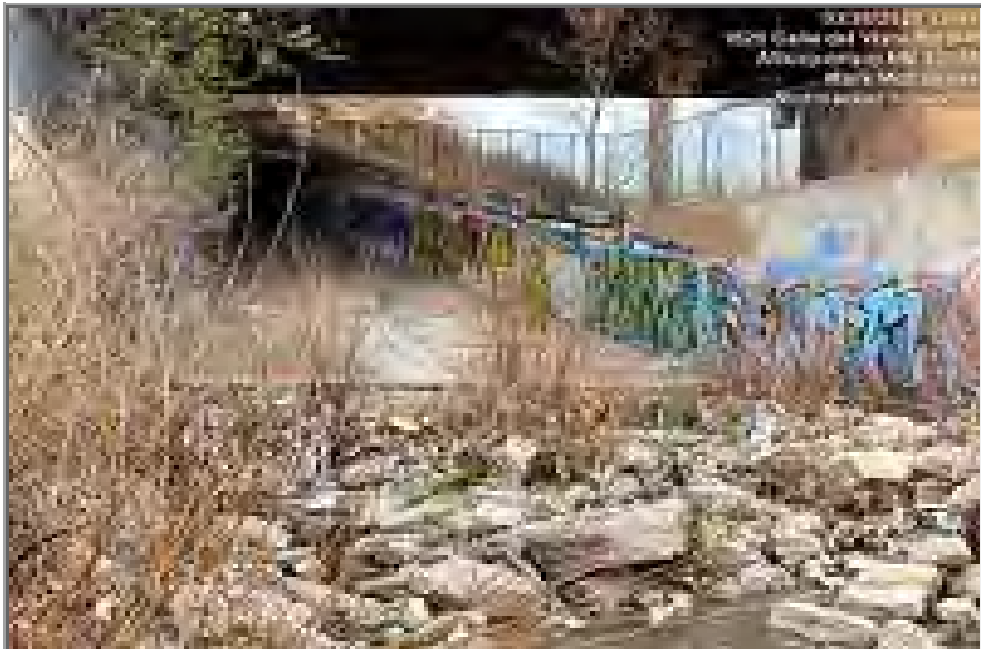
LOCATION **WEST BLUFF NW OUTFALL AT RIO GRANDE**

WEATHER **PARTLY CLOUDY** flow **NO FLOW** FLOW\_GPM **0**

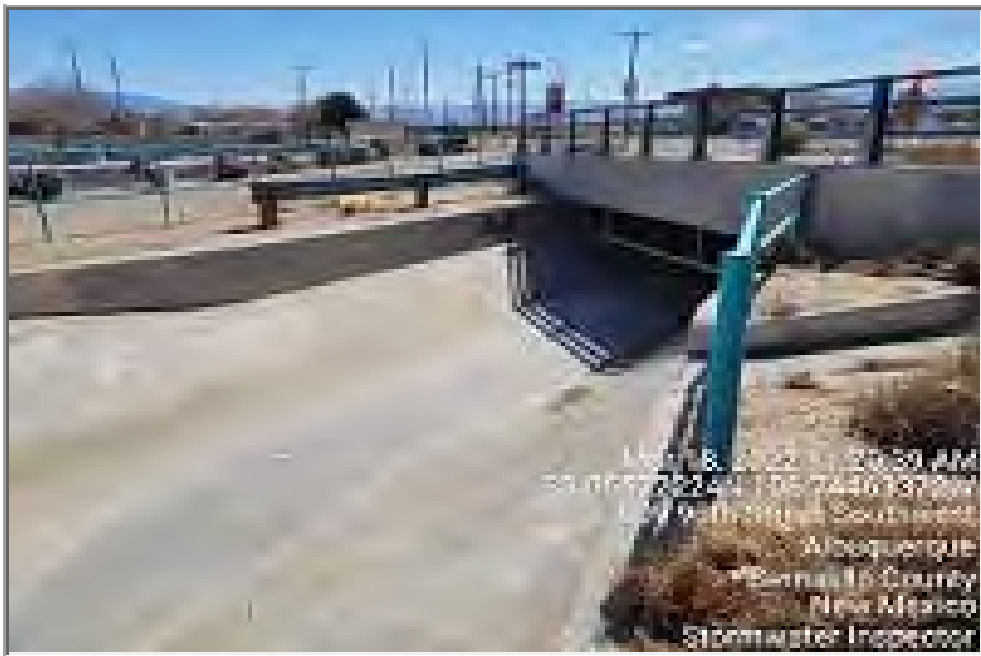
LOCATION **SNOW VISTA ARROYO AT DE VARGAS SW**

WEATHER **SUNNY** flow **NO FLOW** FLOW\_GPM **0**

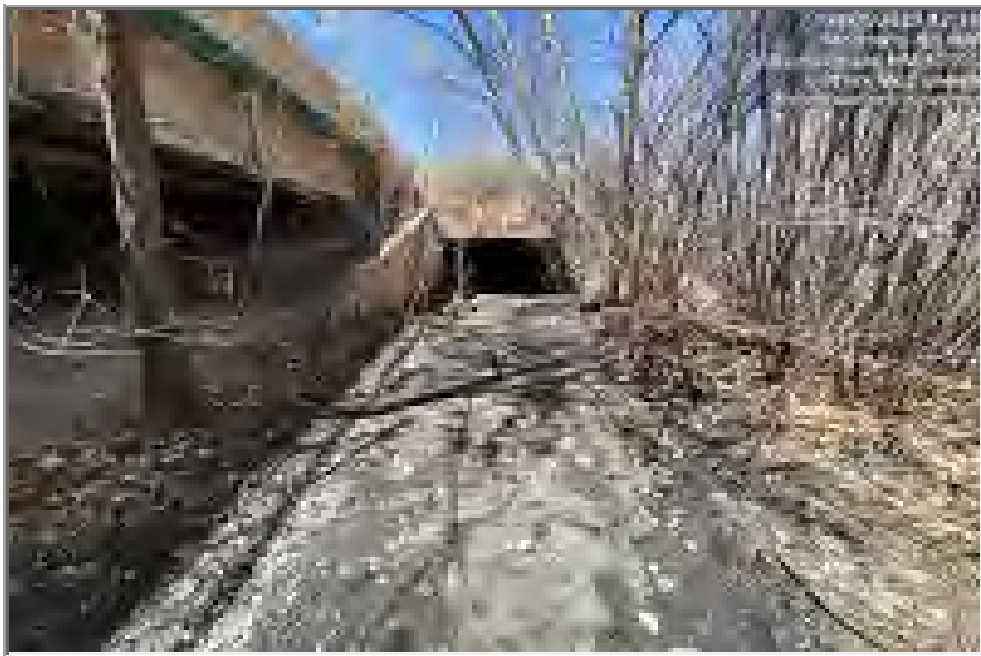
LOCATION **MONTANO EAST OF COORS NW**

WEATHER **SUNNY** flow **NO FLOW** FLOW\_GPM **0**

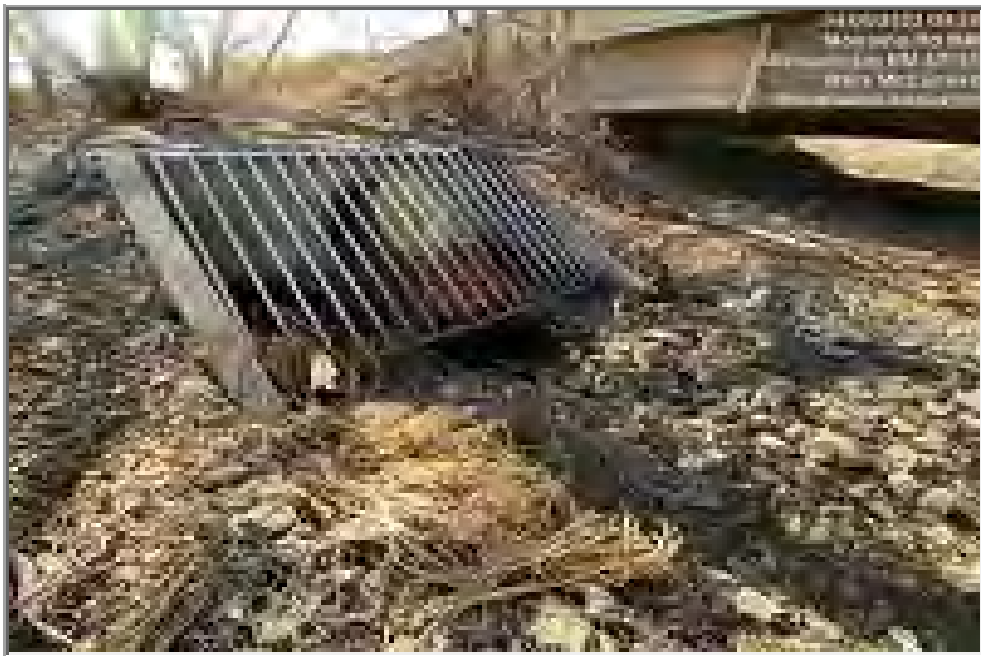
LOCATION **MONTANO NW PS-47 WEST OF RIO GRANDE BLVD**

WEATHER **SUNNY** flow **YES** FLOW\_GPM **1**

APPEARANCE **cloudy** GROSS POLLUTANT **Musty odor, small particulates, no sheens**

Source of Flow **groundwater Infiltration**

AIR_TEMP_F	54	Lab	HALL ENVIRONMENTAL
WATER_TEMP_F	46	Lab_Report	2204257
pH	7.10	E_coli_Coliform_mpn/100ml	677
CONDUCTIVITY_Umos/cm	450	Ammonia_mg/l	<1
BOD_mg/l	39	Nitrite_NO2_mg/l	<0.5
COD_mg/l	104	Nitrate_NO3_mg/l	<0.5
TSS_mg/l	<4	TKN_Tot_Kjeld_N_mg/l	1.4
TDS_mg/l	335	Phosphorus_total_mg/l_P	0.27
N-Hexane Extractable-(Oil_Grease)_mg/l	<9.56	Hardness_mg/l_CaCO3	140
Fluoride_mg/l	1.0	Chlorine_mg/l	<0.05

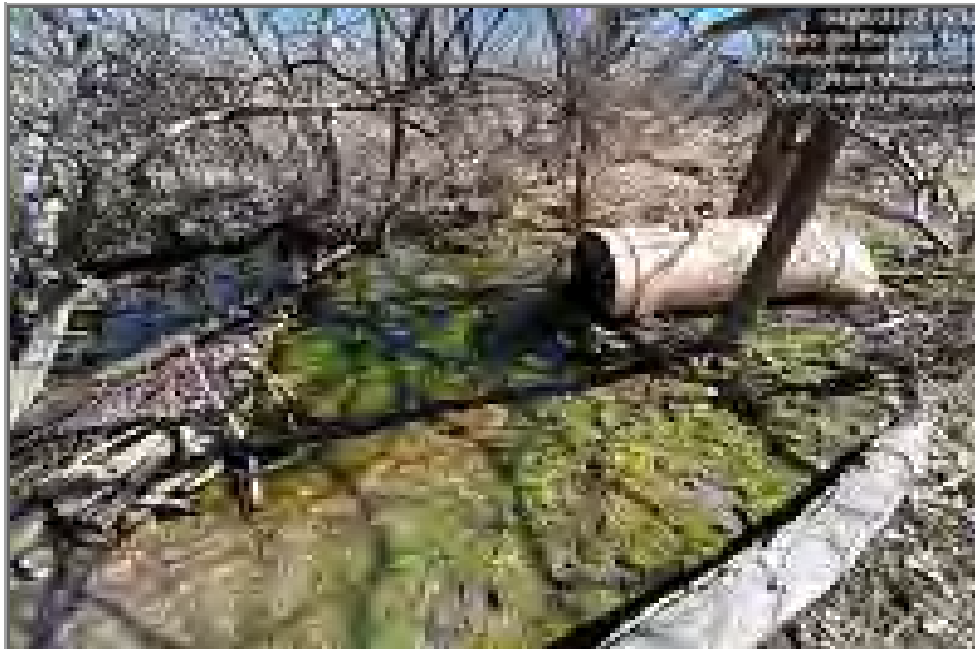
LOCATION **CANDELARIA NW PS-40 AT RIO GRANDE**

WEATHER **SUNNY** flow **YES** FLOW\_GPM **1**

APPEARANCE **clear** GROSS POLLUTANT **No odor, fine particulates, no sheen**

Source of Flow **well wash water**

AIR_TEMP_F	59	Lab	HALL ENVIRONMENTAL
WATER_TEMP_F	55	Lab_Report	2204257
pH	7.89	E_coli_Coliform_mpn/100ml	56.5
CONDUCTIVITY_Umos/cm	420	Ammonia_mg/l	<1
BOD_mg/l	30	Nitrite_NO2_mg/l	<0.1
COD_mg/l	<20	Nitrate_NO3_mg/l	<0.1
TSS_mg/l	<4	TKN_Tot_Kjeld_N_mg/l	<1
TDS_mg/l	285	Phosphorus_total_mg/l_P	0.063
N-Hexane Extractable-(Oil_Grease)_mg/l	<9.46	Hardness_mg/l_CaCO3	150
Fluoride_mg/l	0.34	Chlorine_mg/l	<0.05

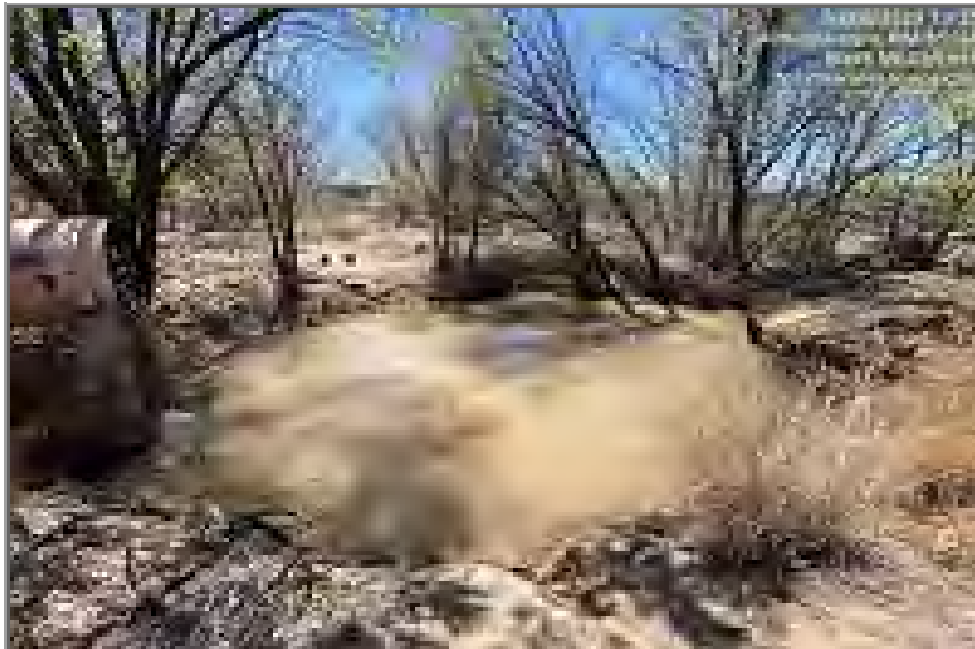
LOCATION **DURANES NW PS AT RIO GRANDE**

WEATHER **SUNNY** flow **YES** FLOW\_GPM **5**

APPEARANCE **clear** GROSS POLLUTANT **No Odor, minimal Particulates, No Sheen**

Source of Flow **well wash water**

AIR_TEMP_F	69	Lab	HALL ENVIRONMENTAL
WATER_TEMP_F	55	Lab_Report	2204419
pH	8.09	E_coli_Coliform_mpn/100ml	488.4
CONDUCTIVITY_Umos/cm	520	Ammonia_mg/l	<1
BOD_mg/l	2.0	Nitrite_NO2_mg/l	<0.5
COD_mg/l	<400	Nitrate_NO3_mg/l	<0.5
TSS_mg/l	<4	TKN_Tot_Kjeld_N_mg/l	<1
TDS_mg/l	371	Phosphorus_total_mg/l_P	0.056
N-Hexane Extractable-(Oil_Grease)_mg/l	<9.93	Hardness_mg/l_CaCO3	180
Floride_mg/l	<0.5	Chlorine_mg/l	<0.05

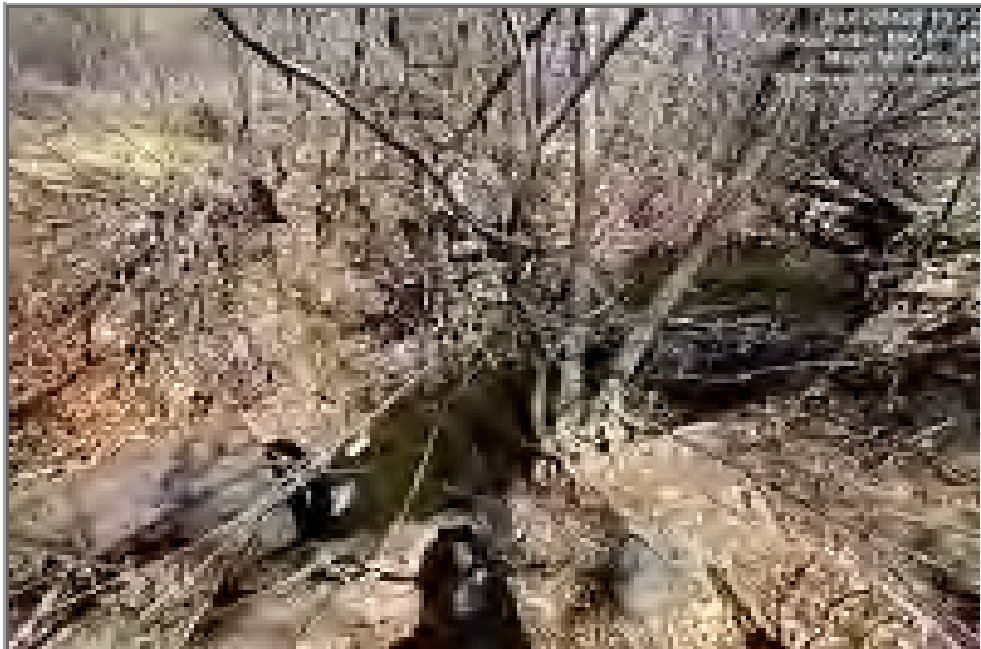
LOCATION LABAJADA-ATRISCO-NORTH 30 IN PIPE

AIR_TEMP_F	63	Lab	HALL ENVIRONMENTAL
WATER_TEMP_F	69	Lab_Report	2204360
pH	7.53	E_coli_Coliform_mpn/100ml	5.2
CONDUCTIVITY_Umos/cm	590	Ammonia_mg/l	<1
BOD_mg/l	5.6	Nitrite_NO2_mg/l	<0.5
COD_mg/l	43	Nitrate_NO3_mg/l	<0.5
TSS_mg/l	54	TKN_Tot_Kjeld_N_mg/l	1.3
TDS_mg/l	378	Phosphorus_total_mg/l_P	0.32
N-Hexane Extractable-(Oil_Grease)_mg/l	<9.64	Hardness_mg/l_CaCO3	170
Fluoride_mg/l	0.67	Chlorine_mg/l	<0.05

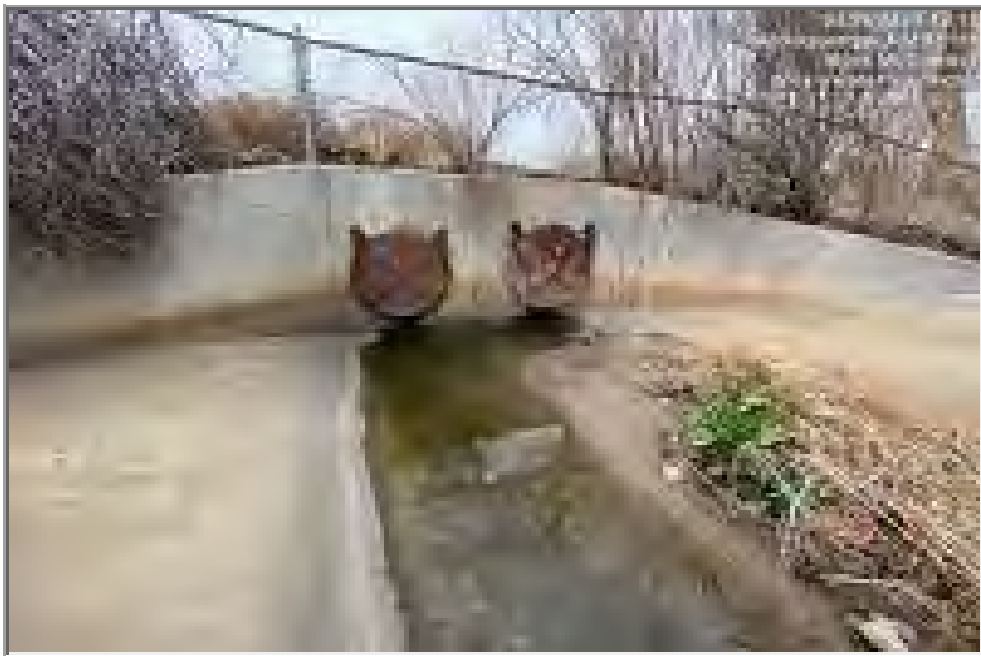
LOCATION **CENTRAL-SUNSET-OSAGE PS-44 TWO PIPES 36 AND 42 IN**

AIR_TEMP_F	63	Lab	HALL ENVIRONMENTAL
WATER_TEMP_F	69	Lab_Report	2204360
pH	8.16	E_coli_Coliform_mpn/100ml	4.1
CONDUCTIVITY_Umos/cm	590	Ammonia_mg/l	<1
BOD_mg/l	<2	Nitrite_NO2_mg/l	<0.5
COD_mg/l	<20	Nitrate_NO3_mg/l	<0.5
TSS_mg/l	4	TKN_Tot_Kjeld_N_mg/l	<1
TDS_mg/l	398	Phosphorus_total_mg/l_P	0.11
N-Hexane Extractable-(Oil_Grease)_mg/l	<9.69	Hardness_mg/l_CaCO3	210
Fluoride_mg/l	0.68	Chlorine_mg/l	<0.05

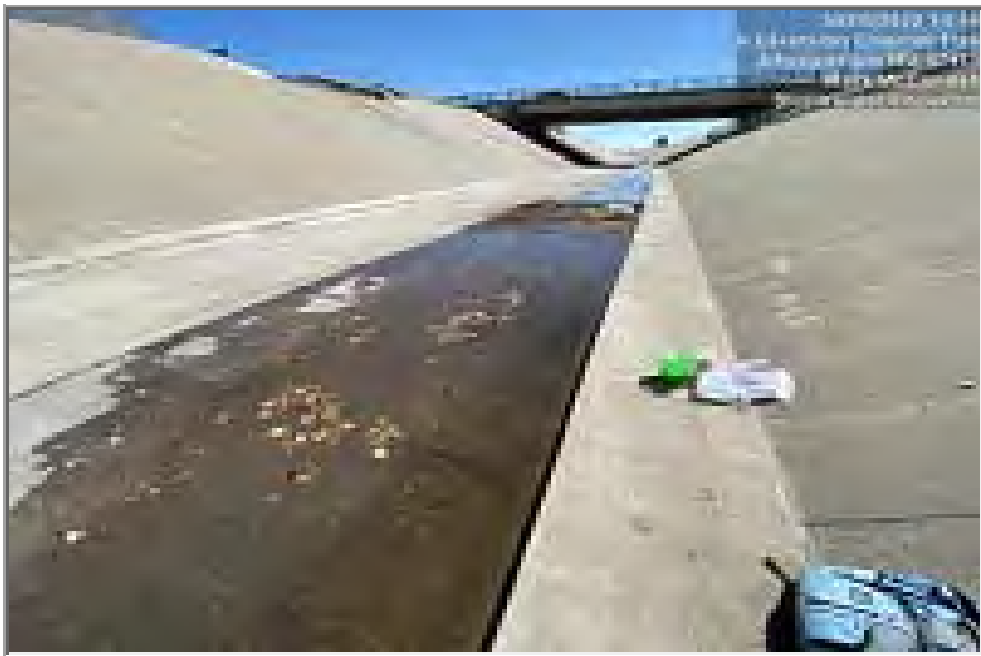
LOCATION **NDC AT ALAMEDA NE**

Source of Flow **well wash water, irrigation, water hydrant flushing and broken waterlines**

AIR_TEMP_F	78	Lab	HALL ENVIRONMENTAL
WATER_TEMP_F	70	Lab_Report	2204419
pH	9.98	E_coli_Coliform_mpn/100ml	18.9
CONDUCTIVITY_Umos/cm	1100	Ammonia_mg/l	<1
BOD_mg/l	6.1	Nitrite_NO2_mg/l	<0.5
COD_mg/l	62.2	Nitrate_NO3_mg/l	<0.5
TSS_mg/l	<4	TKN_Tot_Kjeld_N_mg/l	1.8
TDS_mg/l	726	Phosphorus_total_mg/l_P	0.074
N-Hexane Extractable-(Oil_Grease)_mg/l	<9.76	Hardness_mg/l_CaCO3	190
Fluoride_mg/l	1.4	Chlorine_mg/l	<0.05
